**612 KANE ST LA CROSSE**

## EXECUTIVE SUMMARY

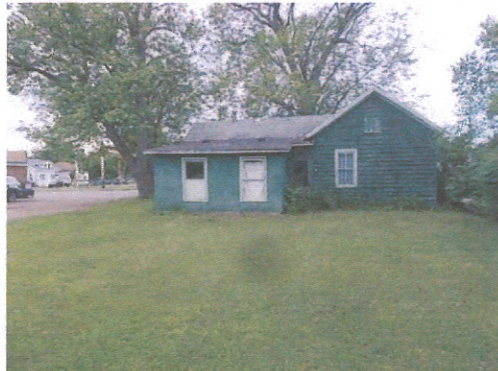
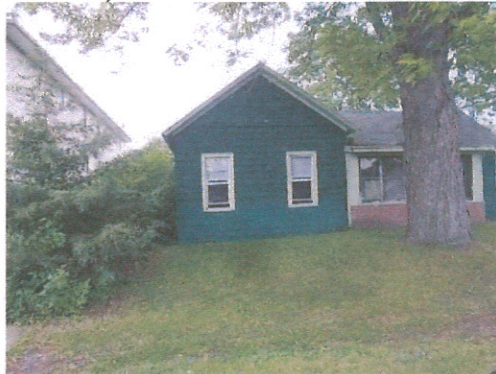
1. Visibility Limits: Visibility limited and/or blocked by the following: Vegetation, leaves, bushes/branches, vines or ground cover
2. Appears Functional: Walks: Concrete
3. Appears Functional: Entry Steps/Stoops/Stairs: Concrete
4. Appears Functional: Driveway: Earth/Ground
5. Maintenance Suggested:, Note Drainage & Grade Slope: Maintenance items noted: NEGATIVE SLOPE: (excessive settling) noted on one and/or more sides of the structure. A negative slope (sloping toward the foundation) has the potential during an excessive and/or prolonged downpour to pool water at the foundation wall, thus increasing the potential for moisture to enter lower level basement area(s). ALL SIDES

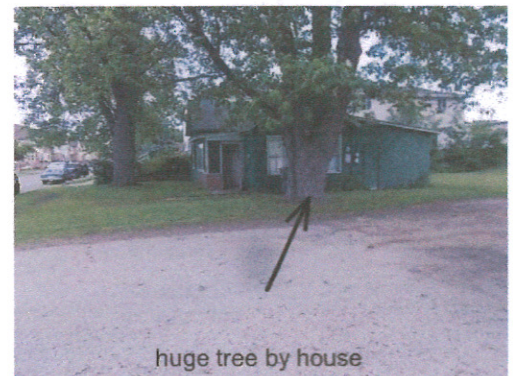
6. Maintenance Suggested:, Note Plants/Stored Items: Maintenance items noted: **Trees/Branches hanging over roof, recommend trim/remove branches, reduce/eliminate impact damage potential. Plants contacting siding materials. Recommend trim maintain a clearance of 15-24 inches from all wall surfaces. Contact Tree Removal Company: Recommend consult with a properly licensed and trained tree removal specialist to address situation and make recommendations., Close to Foundation: Tree(s) planted in close proximity to a foundation depending on the type of tree and root structure may negatively affect foundation long-term functionality. If severe weather damages the tree, falling branches and/or shifting root systems increase damage potential. Recommend removal of tree(s) close to structure.**

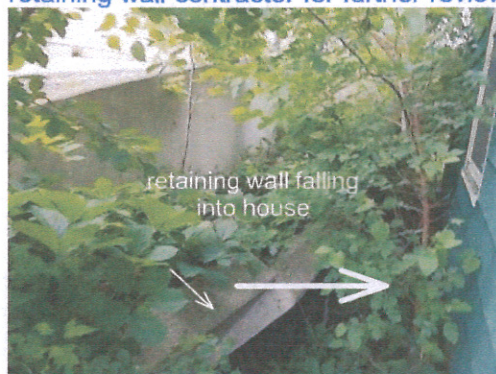
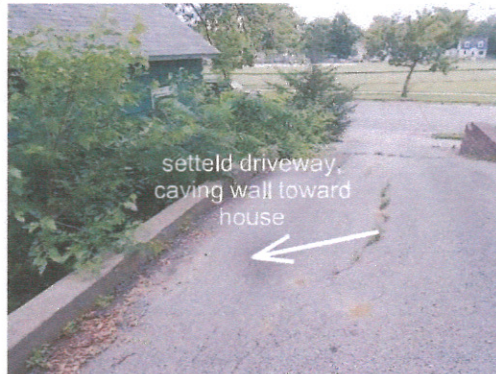
7. Maintenance Suggested:, Note Retaining Walls: Concrete -- Movement (Major): Wall movement noted. Lateral (horizontal) loads on retaining walls increases with height. Any wall over 3 ft will experience greater horizontal-movement loads. Movement is also influenced by the area soil characteristics, and type of backfill used during wall construction. Excessive moisture exposure (gutters), and experience level used during construction also play a factor in wall movement. **NEIGHBOR WALL VERY CLOSE TO HOUSE, FAILING , Erosion noted, washing out of materials, Excessive Plant Growth: Excessive vegetation/plant-root size may/will over time cause undue-not designed pressure/shifting on retaining wall surface(s). Contact A Specialist: Recommend further evaluation by a qualified/knowledgeable retaining wall contractor for further review and recommendations.**

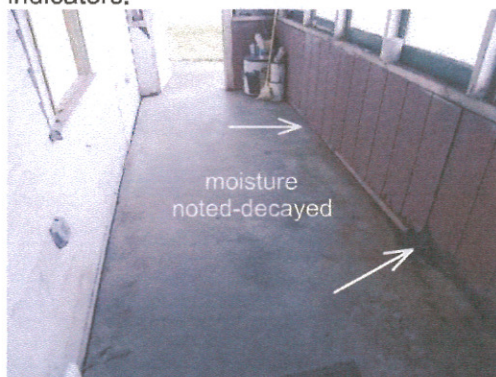
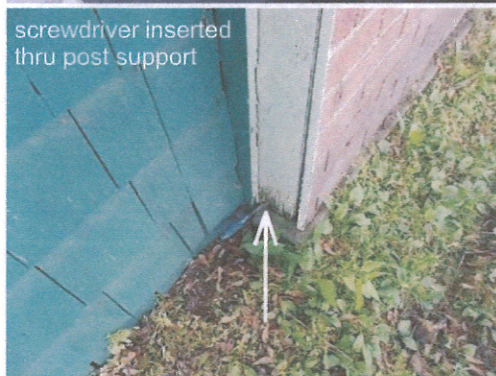
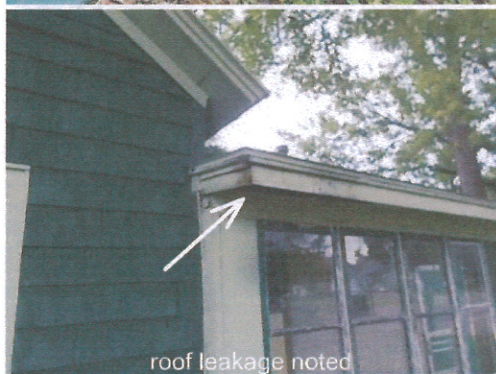
8. Maintenance Suggested:, Note Porches & Breezeways: Wood, Enclosed, Storms in place -- Damage and/or deterioration noted, Leakage (past/present) ceilings/walls/floors, Weak Supports: Consider additional support/modification to ensure long-term functional stability, Paint chipping and/or peeling, cracking in checkerboard fashion, likely lead based paint, not confirmed. Others areas throughout home also showing lead paint visual indicators.

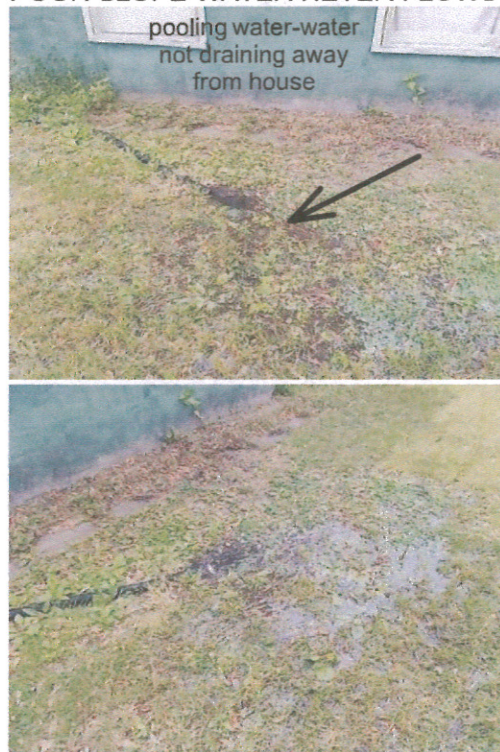
11. Functional-with Maintenance: Vents: Dryer Vent: Dryer venting into the porch (Items stored in the garage will likely experience higher moisture/humidity levels.
12. Maintenance Suggested:, Note Plumbing: Spigots, Sump Pump -- Water turned off at spigots, Sump Pump not OK: Sump Pump discharge pipe discharging next to foundation, running on-off every 3-5 minutes. Recommend extend piping a minimum 5-10 feet from foundation wall.

**POOR SLOPE WATER NEVER FLOWS AWAY FROM STRUCTURE**

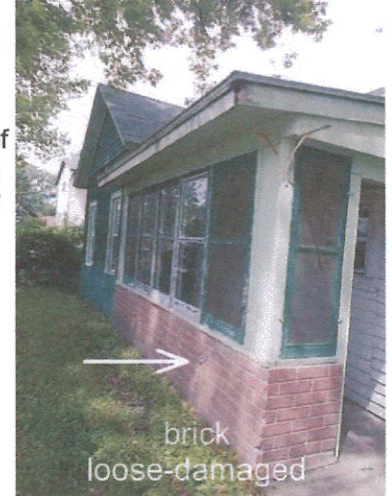
### West Exterior Surface

2. Maintenance Suggested: Type: Brick Veneer Wall: Construction specifics may vary. Limited Visibility Please Note: The brick wall noted in this report is non-structural-aesthetic in nature. Brick naturally absorbs moisture and must be allowed to breathe dry/out in a systematic-efficient manner. Many of the variables (air space, weep holes, flashing, sheathing paper, etc.) associated with this successful breath ability are either concealed during construction and/or blocked from view by homeowner activities such as with landscaping, shrubbery, etc. Damage noted, Larger cracks noted, Loose attachment noted, Holes noted

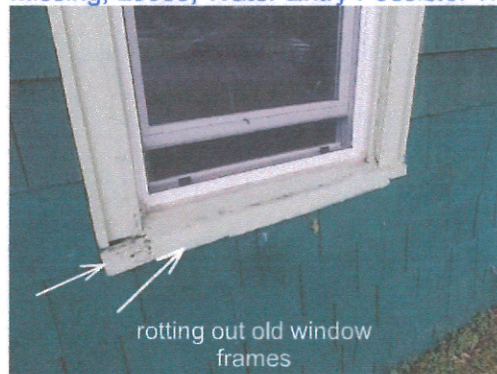
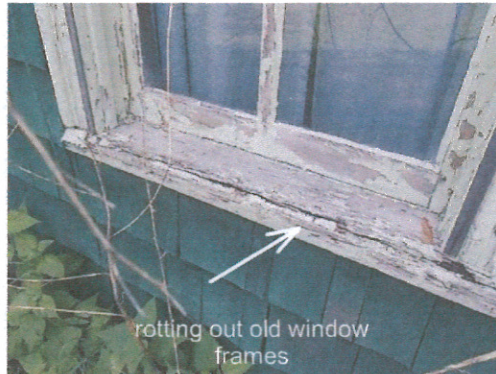
### East Exterior Surface

3. Maintenance Suggested: Type: Stucco (2 or 3 coat): Depending on time of construction, remodeling verses original construction, and base material status stucco may be used in a new or repair fashion. Ascertaining specifics is typically beyond the scope of this inspection. Inquire through our post-inspection support service for additional resources/documents. Damage noted
4. Visibility Limits: Visibility limited and/or blocked by the following: Vegetation, leaves, bushes/branches, vines or ground cover
5. Maintenance Suggested: Door Trim: Wood -- Paint Chipping and/or Peeling, Decay Noted, Damaged
6. Maintenance Suggested:, Note Window Trim: Wood -- **Paint Chipping and/or Peeling, Decay Noted, Damaged, Missing, Loose, Water Entry Possible: The potential for water entry is present.**

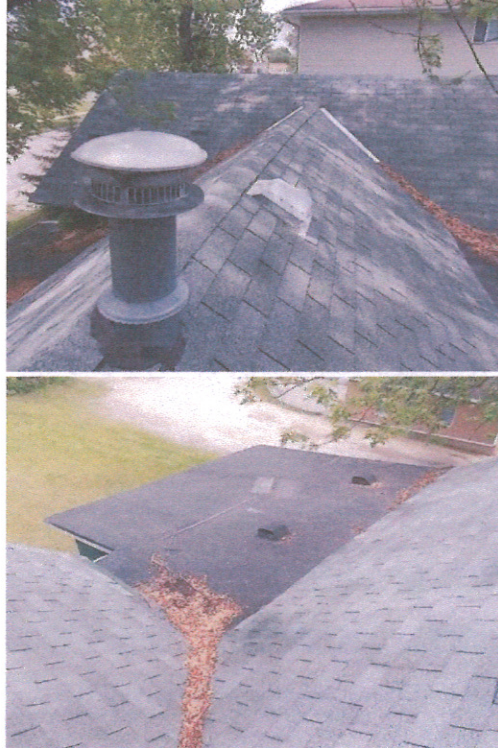
4. Maintenance Suggested:, Note Material: Composite Shingles -- Damage Noted: (torn, gouged and/or other surface imperfections), Missing Granules

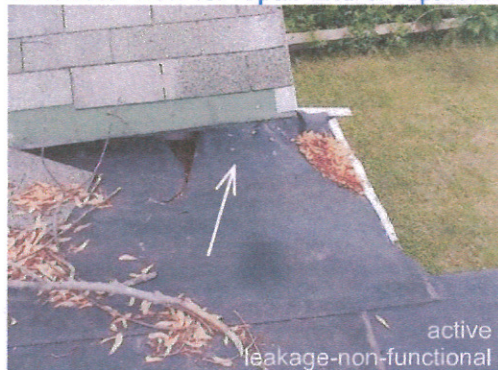
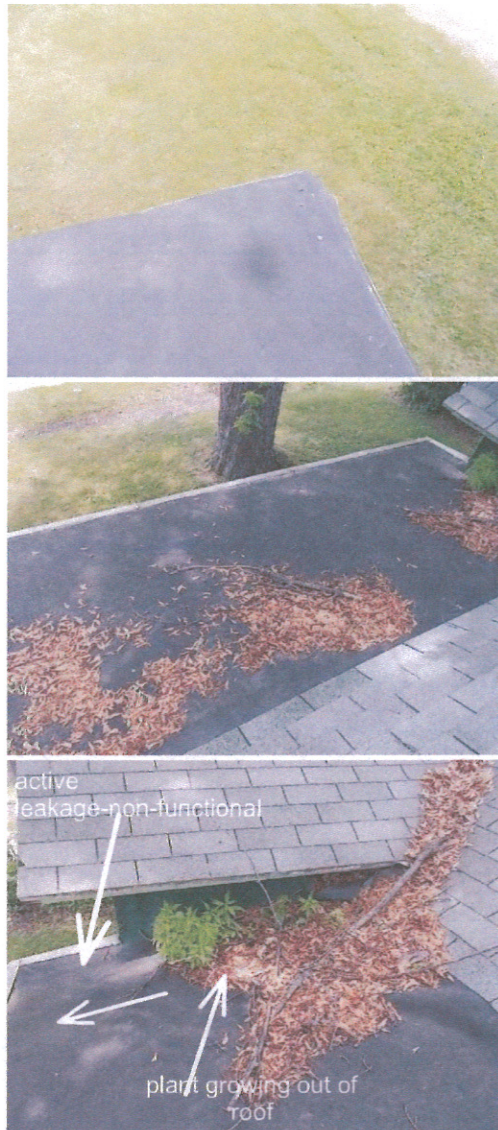
## Front, Rear Roof Surface

5. Method of Inspection: On roof, walked on roof  
6. Roof Visibility Limited By: Debris/growth (trees/leaves/moss etc.)  
7. Type: Shed  
8. Maintenance Suggested:, Note Material: Rubber Membrane EDPM (Ethylene Propylene Diene Monomer) This type of roof requires special tools, training and materials to install and maintain a water tight seal. EDPM roofs require special adhesives such as "Butyl" and sealants designed specifically for a "rubber to rubber" bond. Asphalt/petroleum based caulks/adhesives will often damage/deteriorate the EDPM membrane. For more information on EDPM roof installation and maintenance please go to <http://phiinspect.com/> click on the "Post Inspection Support" page and request information about EDPM roofs. Recommend consult with a licensed roofing contractor familiar with this roofing material and design for additional insight, recommendations, and maintenance suggestions. Soft, spongy spot(s) noted when walking on roof, Leakage concerns: The potential for water entry is present, loose attachment, holes noted, plant growing on roof. NONFUNCTIONAL , Contractor required: Consider consulting with a licensed roofing contractor now for repair and/or replacement options.

NONFUNCTIONAL , Contractor required: Consider consulting with a licensed roofing contractor now for repair and/or replacement options.

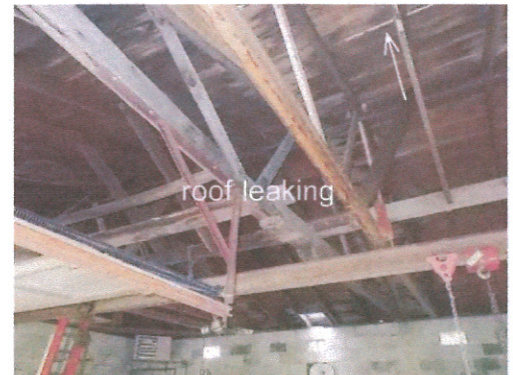
Maintenance Suggested:, Note Roof & Attic Structure: Boards as Sheathing & Rafter Framing -- Active leakage noted, (wet/dampness)

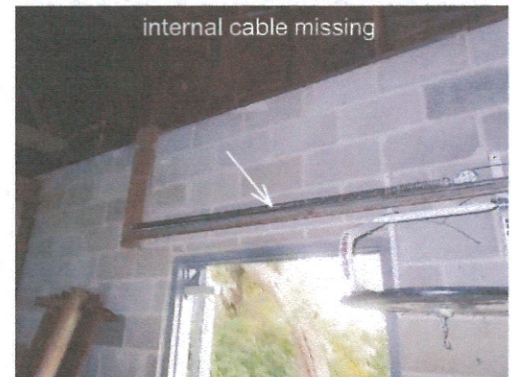
Maintenance Suggested: Vehicle Door(s): Wood Overhead type Door(s) -- Safety Cable missing, Safety Concern: (A safety cable is installed down the inside of a tension spring. Its purpose is to contain/hold the spring in place if the spring were to break/separate. Without the cable in place, a broken spring may/will move in any direction causing possible damage and/or injury). Lacks Lubrication, Adjustment needed for track and/or door

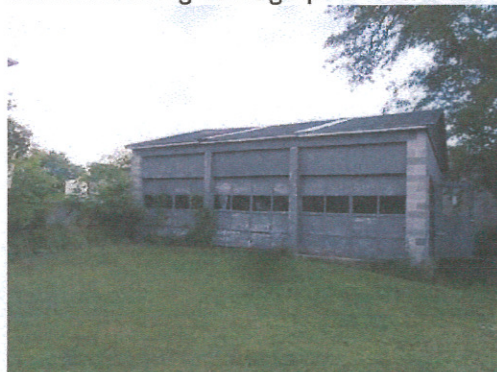
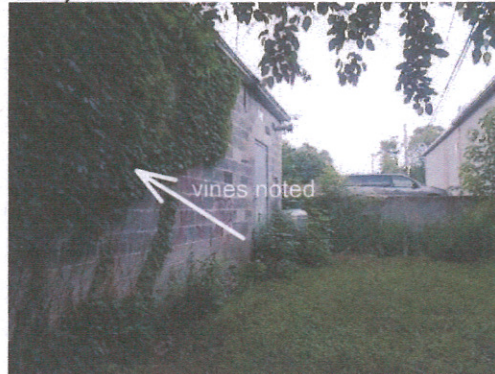
1. Appears Functional: Electrical Service Wires: Underground (wire not visible)
2. Maintenance Suggested: Plants/Stored Items: Maintenance items noted: Tree branches touching/rubbing roof, and/or soffit/fascia surfaces. Trees/Branches hanging over roof, recommend trim/remove branches, reduce/eliminate impact damage potential. Contact Tree Removal Company: Recommend consult with a properly licensed and trained tree removal specialist to address situation and make recommendations., Vine Issues: Vines growing/attaching on finished wall surfaces will damage surface, reduce normal drying, both increasing damage potential. Recommend remove all vines.

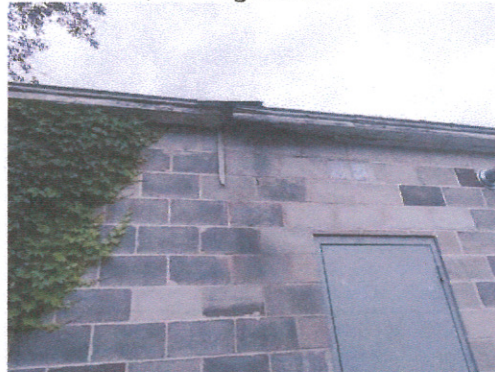
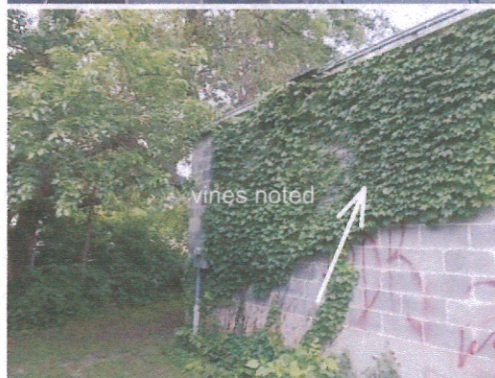
Fascia & Soffits: Wood Boards, Wood (plywood/chipboard) -- Decayed, Loose Attachment, Damage noted

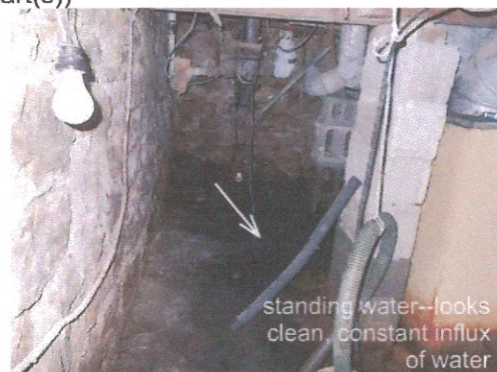
STANDING WATER AND MUD

1. Maintenance Suggested:, Safety Concern: Basement Stairs/Railings: Wood -- Damage Noted: (broken, surface eroded and/or cracked piece(s)/part(s))
2. Maintenance Suggested: Floor-Lower Level: Earth, mud, WATER

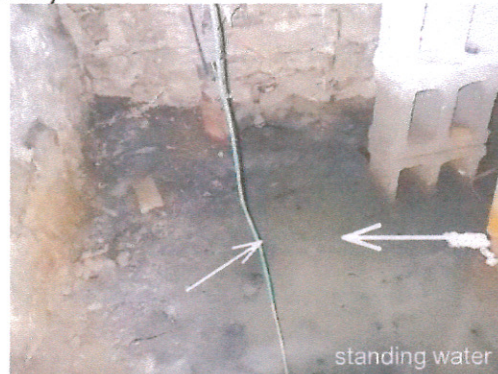
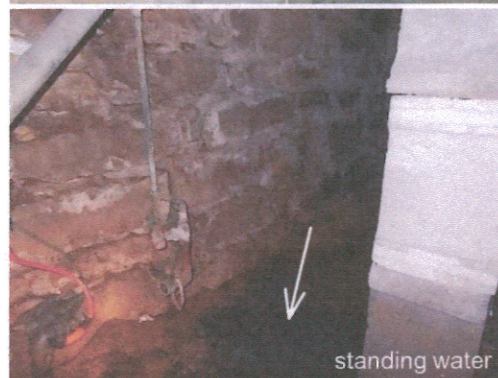
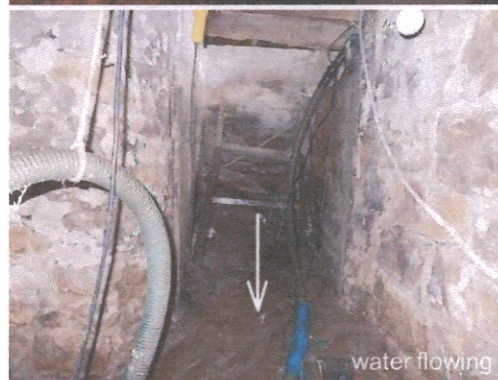
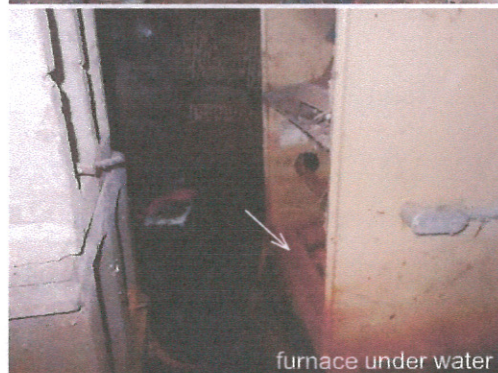
4. Maintenance Suggested:, Note Moisture Indications: Floor(s), Wall(s) -- [Standing Water](#), Review ["Drainage/Grade slope and Gutters/Downspout areas on the Grounds Stoops & Steps section of the report."](#) Also review the ["Foundation Drainage"](#) handout. Proper grade slope will help reduce freeze/thaw pressure on foundation wall thus reducing the potential for cracking, bowing, movement etc. of the foundation wall(s). Recommend operate a dehumidifier in the basement during the warm summer months and review our website newsletter titled ["Mold Walk-Thru"](#) for additional common sense practical advice. **CONSTANT WATER ENTRY, WATER CLEAN WHEN VIEWING THE FLOOR suggesting ongoing and continuous, sump never stops running.**

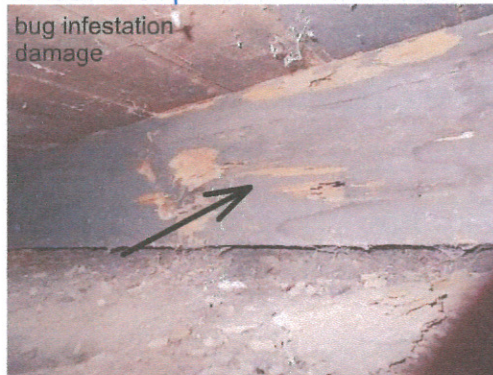
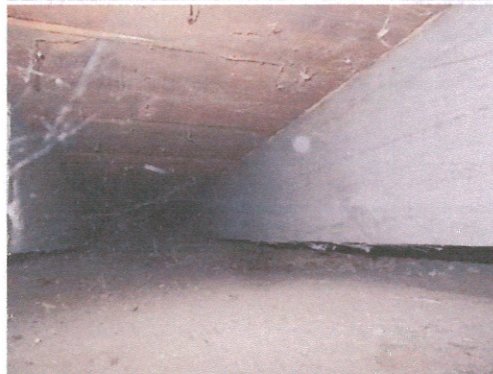
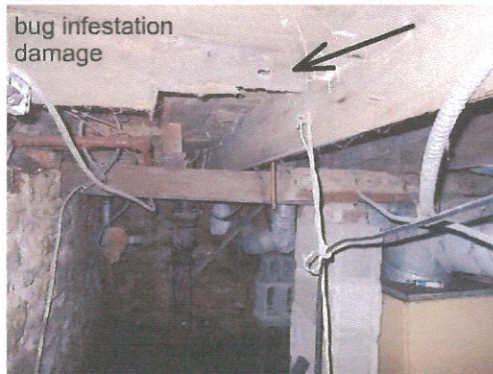
7. Maintenance Suggested:, Note Horizontal Supports: Solid Wood -- **Damaged/deteriorated, Wood destroying organism(s) past/present activity noted, Recommend a licensed/qualified contractor/carpenter to evaluate situation.**
8. Maintenance Suggested:, Note Main Floor Structure: Wood Joists (Dimensional lumber material 1.5-2 inch in width by 6-12 inch in height. Common spacing between each joist is typically 16 inches, but can be more or less dependent on variables outside the scope of this inspection. Wood joists are generally considered 1/3 as strong when compared to modern engineered lumber materials and designs) -- **Damage noted, Wood destroying organism(s) past/present activity noted, Decay noted, Recommend a licensed/qualified contractor/carpenter to evaluate situation.**

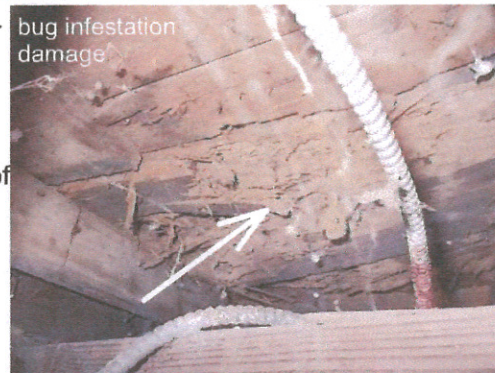
First Floor Sub-Floor: Dimensional Boards -- Damage noted, Wood destroying organism(s) past/present activity noted, Stains Noted-past leak: Stains are often in the areas below plumbing. Many leaks are slow and insidious in nature. There is often more than one layer of flooring, further slowing/hiding the status of a leak. Because of these variables, we are unable to determine if stains are dormant (in the past) or actively leaking.

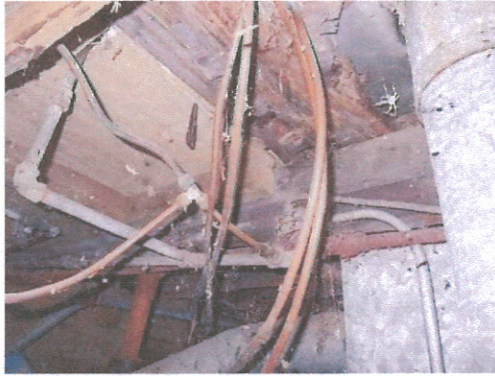
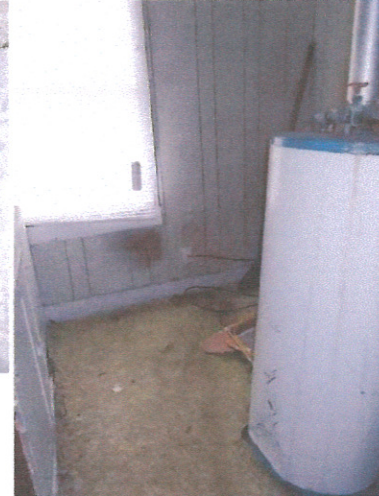
5. Functional-with Maintenance: Water Lines: Copper, Galvanized, Visual Limitations: Most, some and/or all of the plumbing pipes blocked from view with aesthetic finish materials, unable to perform full visual inspection. Piping Small In Diameter: Branch water line(s) appear smaller in diameter suggesting amateur workmanship (volume of water may be affected), Amateur workmanship noted

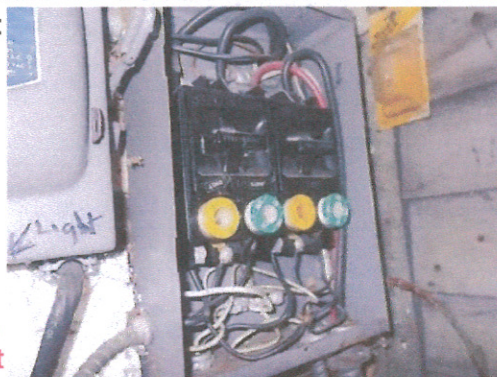
Fuses -- **Oversized fuse/breaker noted: 12 gauge wire(s) on a 30 amp service, too large for wire size, Consider Services of a Licensed Electrical Contractor: Work Involving Licensed Electricians:** When in the inspector's opinion a "Licensed Electrician" is required to further analyze a situation the electrician is considered an "Expert". Expert is defined as: "one who is very skillful or well-informed in some special field". The licensed electrician should review the specific inspector's concern(s) and the entire situation to ensure safety, functionality and compliance. The licensed electrician may identify additional maintenance items and make recommendations/solutions to ensure a functionally safe system. It is this inspector's opinion all maintenance items/suggestions identified by a licensed electrician should be followed.

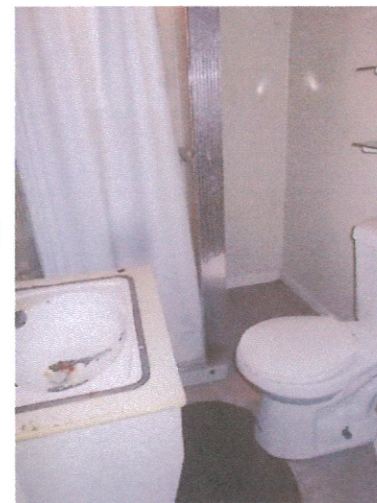
1. Maintenance Suggested:      Visibility/Walls-Floors: Wall Conditions:, Ceiling Conditions:, Floor Conditions:, Normal Visibility noted, little to no blockages noted -- Damaged Flooring Noted: (torn, missing parts, loose in disrepair) all areas in disrepair, Floors Not Level please note: Materials & methods of construction, age of structure, skill level at the time of construction, etc. may/will contribute to current status. Full determination is beyond the scope of this inspection.

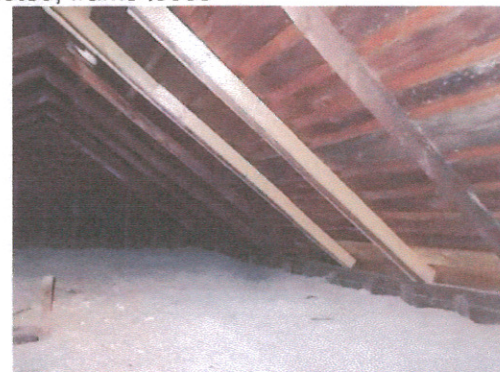
2. Maintenance Suggested:      Attic Entry Point: Wall Passage -- Damage noted, frame loose
3. Appears Functional:          Framing: Rafters -- Minor Repairs noted

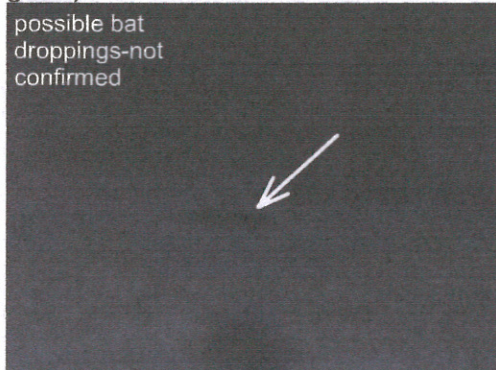
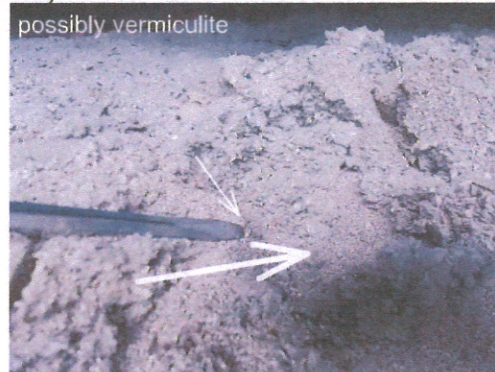
**Insulation & Depth:** 1-6 inches, Cellulose Blown, Vermiculite -- Lacks Adequate Insulation for climate, Openings, voids noted increasing heat loss reducing home energy efficiencies. Recommend seal and/or support accordingly. Cellulose Insulation recommend 10-12 inches of insulation (based on current utility costs & home efficiency goals)
