*ARCHITECTURAL AND ENGINEERING ANALYSIS
FOR
123 & 125-127 4th STREET S*

RE: 123/125/127 4th Street So. – Condition Survey
MBJ Project No R15.255.0

Mechanical and Electrical Building Condition Evaluation

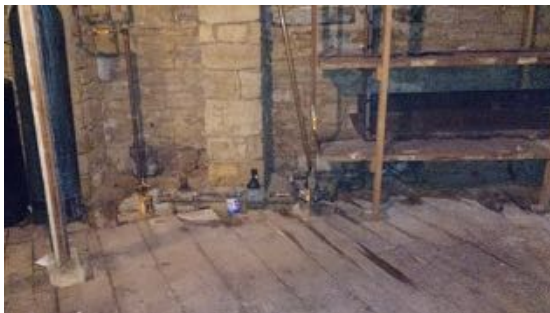
The above service is the domestic water service in the basement below the Rocky Rococo tenant suite. A galvanized steel water pipe penetrates the basement wall near the floor. There are multiple water meters connected to this service entrance. The water service piping is mostly copper and generally quite small in size. Valves around the meters are generally modern ball-type valves.

There is a water softener shown in the far left of the photograph above. This softener served the Rocky Rococo suite and appears to have softened both hot and cold water. The softener is showing some age and may not be functional.

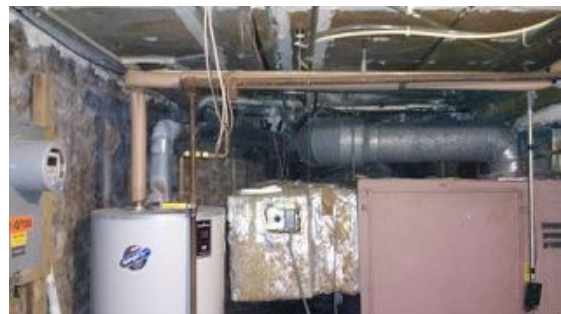
Of the active piping, we observed no leaks and piping was generally well constructed and supported. The water distribution piping is typically accessible in the basement levels as needed.

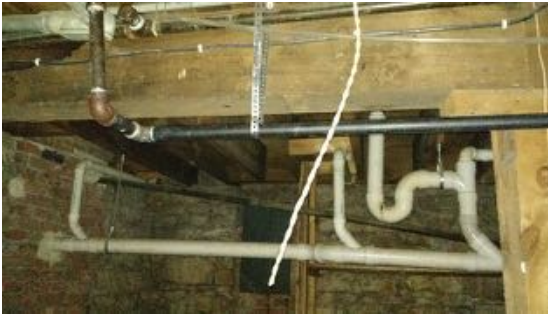
The drainage piping is fitted with many hub drains and indirect drains as commonly used in food service applications. If this tenant suite is renovated into another use, these indirect drains will require removal or capping as they tend to “dry up” (*evaporate water in the trap*) quickly within any use.

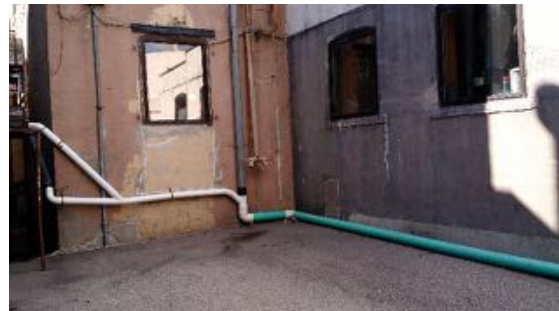
In the above photograph, the building is the Dale's Clothing Store. The vertical silver colored piping conveys water from this building. The white-colored PVC pipes at the left of the photograph collect water from the buildings above the Rocky Rococo tenant suite.

This arrangement is certainly less than ideal and any failure in this piping will allow much water to fall into the area between buildings.

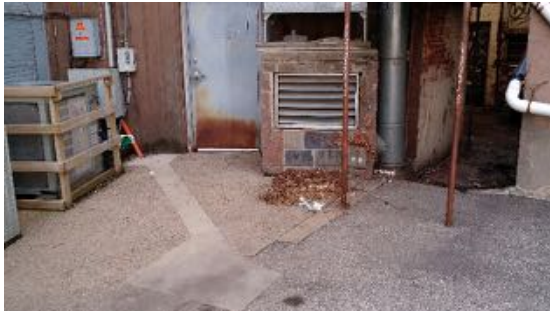
The rusted gray door opens from the Rocky Rococo tenant suite. There is a courtyard between these buildings that is at a lower elevation than the paved area behind Dales Clothing store and Rocky Rococo. Without question, this area must flood in a heavy rain event. No storm water basin was observed in this area.

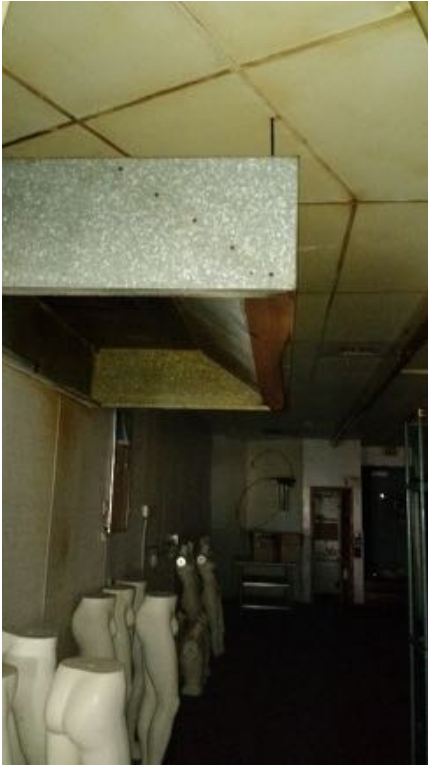
As a pizza oven hood, this hood was functional and relatively safe. This is not a cooking hood and cannot be used for common commercial cooking equipment. We would recommend removal and disposal of this hood, but as a “heat relief” hood, it could remain for some use.

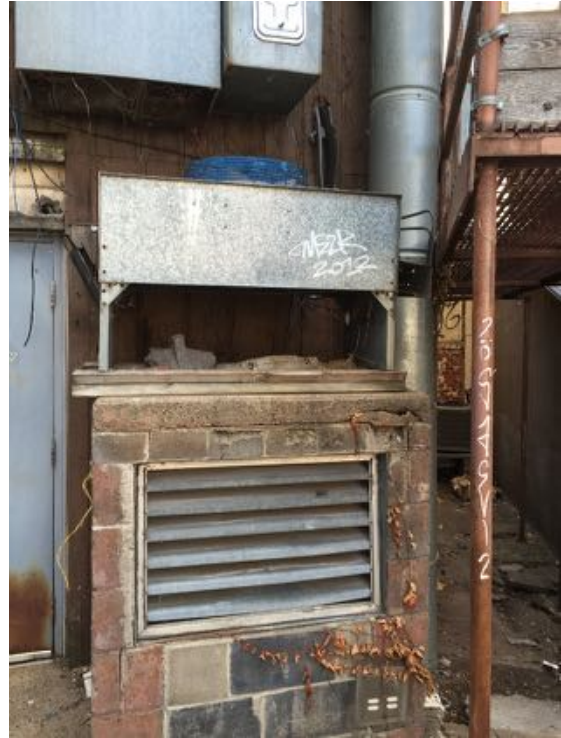
In the above photograph, the louver is the outside air intake connected to the Reznor heater. This louver is located approximately 30 inches above grade in the alley. This is a legal installation, but also susceptible to plenty of debris, dirt, etc. If this duct system is re-used, the louver should be removed and cleaned and the outside air path should be inspected and cleaned as necessary.

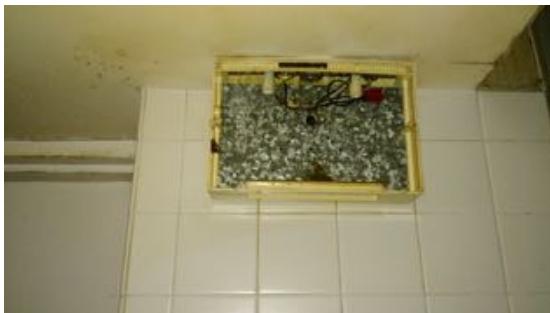
The above photograph shows an Exit light in the Rocky Rococo tenant suite that is

clearly not functional any more. There are minimal Exit lights on the upper floor levels and emergency lighting is generally absent in the spaces not normally used or occupied.
