ARCHITECTURAL AND ENGINEERING ANALYSIS
FOR
ODD FELLOWS TEMPLE
(A.K.A. DALE'S CLOTHING)
121 SOUTH 4TH STREET

III. STRUCTURAL/ SYSTEMS ANALYSIS

RE: 121 4th Street So. – Condition Survey
MBJ Project No R15.250.0

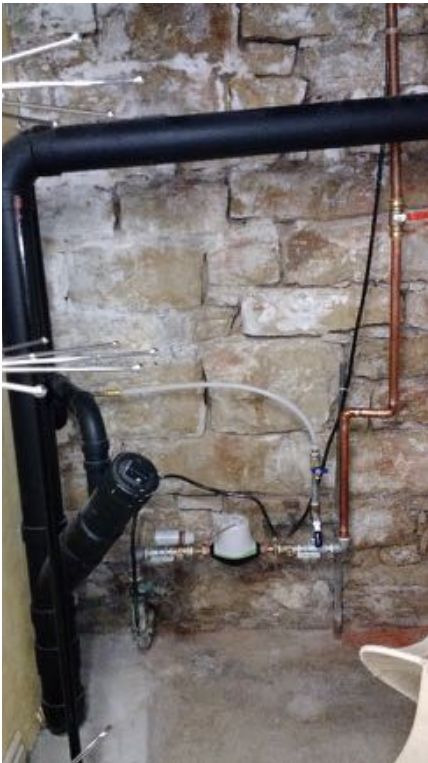
The above service is the domestic water supply and the sanitary drain connection to the sewer. The water service entrance is old galvanized steel pipe with an old bronze gate valve – very typical for many downtown La Crosse buildings.

Immediately downstream of the older water service and isolation valve, everything is new. Galvanized steel piping is used around the meter and then the distribution piping is changed to copper.

Note the lack of a dielectric fitting where the steel piping is joined to the copper piping. Dielectric fittings, typically unions, are used to join dissimilar metals. Without use of a dielectric fitting, domestic water flows past the connection of two different metals and, essentially, forms a battery. A small electrical current is created. This electrical current causes minerals to separate from the water, which in turn “stick” to the metal piping walls. Over time, this will obstruct the interior of the piping.

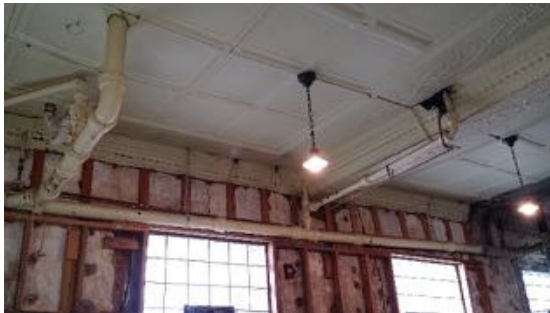
The above photograph shows some original drainage piping above the Dales Clothing store. As can be seen, the

original piping was traditional cast iron fabricated with bell and spigot joints. A bit of new PVC has been spliced in. Although this piping is not being used anymore, it is likely still connected to the sanitary drainage system and could pose a hazard if water seals are not maintained.

Most likely any future renovation of the upper level spaces will involve complete replacement of the old sanitary drainage and vent piping, but if any piping is considered for re-use, it should be inspected thoroughly for cracks. Cast iron piping is not tolerant of freezing and these spaces have not been heated for some time.

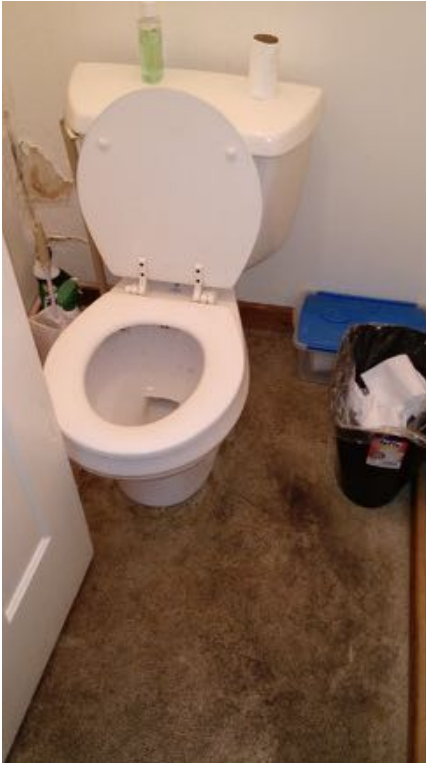
The connected plumbing fixtures and equipment within this building is limited to a public toilet room and a couple of other small uses. The active toilet room on the first floor is generally in good condition with modern fixtures and suitable for continued use.

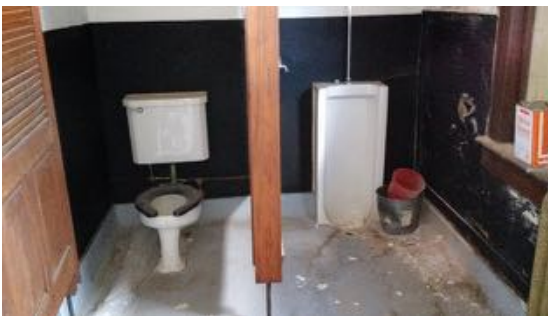
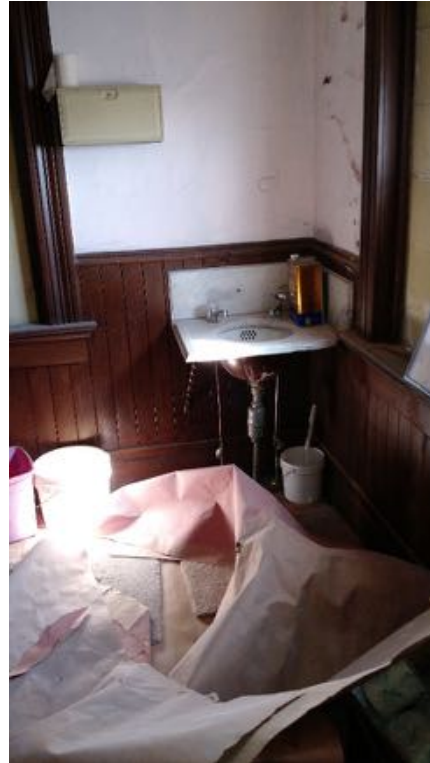
The plumbing fixtures on the upper levels above Dales Clothing store are mostly original. For the most part, these fixtures are antiquated and probably not suitable for future re-use. They were of heavy duty construction when originally installed, but none meet modern water conservation standards and years of being dry could result in significant restoration efforts. In addition, none were constructed to meet any ADA requirements.

Presumably any remodeling performed on the upper levels of this building would incorporate new toilet facilities to match the needs of the space and current ADA (handicapped) requirements.

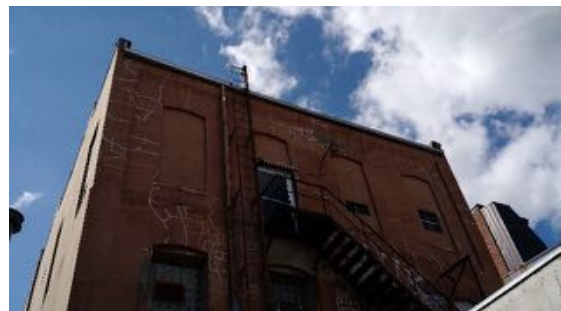
Like many of the buildings in downtown La Crosse, the roofs “mono-pitch” from the front of the buildings to the back. The rainwater is then collected with an open gutter at the back of the building and then conveyed to the street level where it discharges on grade to the alley.

In the case of this building, a significant amount of water is dropped onto a small area because of the bend in the street at the junction of this building and the adjacent buildings. The effect is a relatively small alley access as compared to the building area. Consequently, it is apparent this building and the adjacent buildings have suffered from rainwater problems.

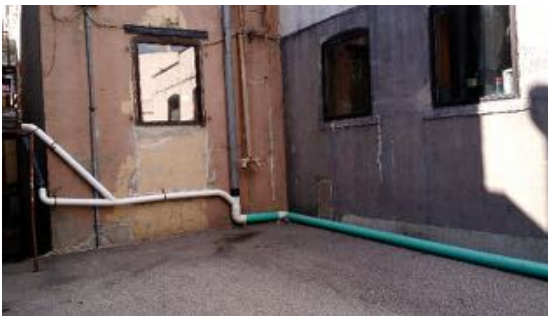
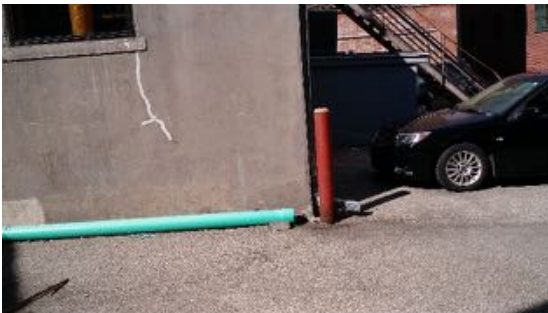
In the above photographs, it can be seen that the original rain conductors have been connected to PVC piping and the piping attempts to convey the water further back towards the alley.

While this likely works fine, PVC piping deteriorates in direct sunlight and will not last long in this condition. It will become brittle and break easily from a small impact. Direct sunlight can heat the piping enough to cause it to sag, losing the pitch and slowing the discharge of water.

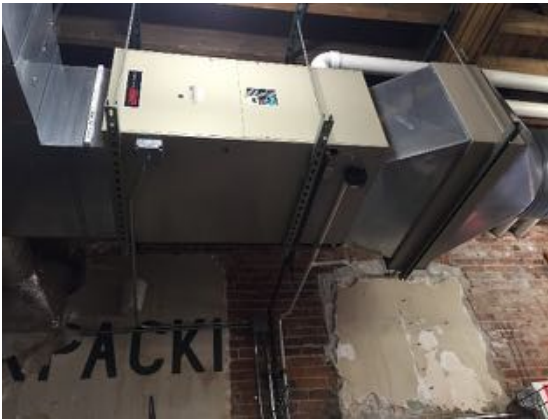
The Dales Clothing store is heated, cooled and ventilated with a single residential furnace.

The furnace is in very good condition and appears to be relatively new. The furnace is horizontally-mounted and accessible in the rear storage room. A direct expansion cooling coil and matching residential condensing unit provide mechanical cooling.

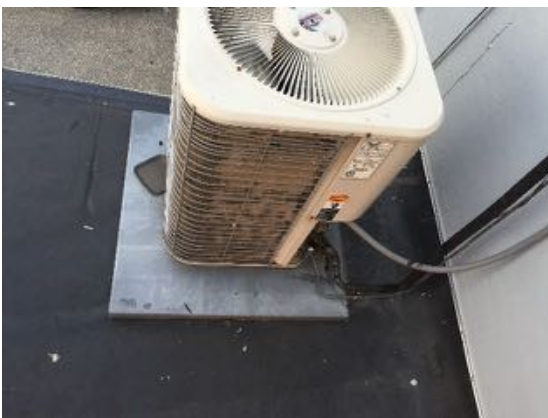
Note in the photograph above that the condensing coil is quite dirty and should be cleaned.

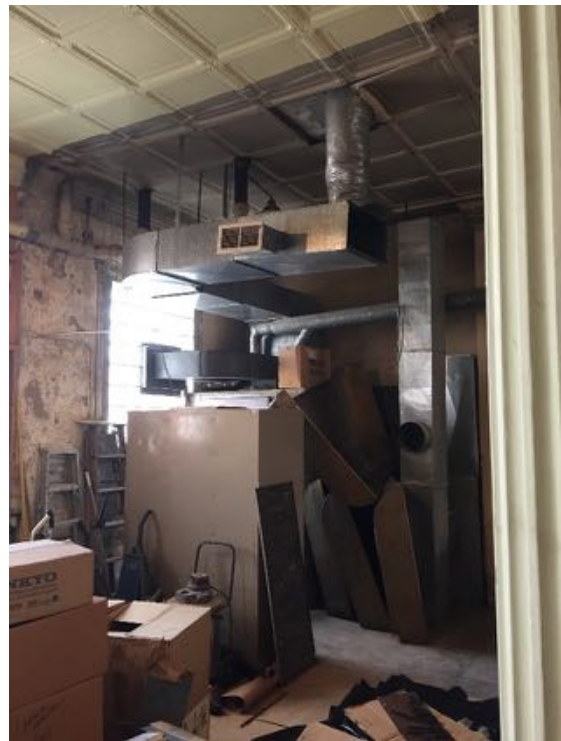
The upper levels above Dales Clothing store are currently not heated, but there is a variety of abandoned heating and ventilating equipment located in the space.

This equipment is not original to the building construction and nameplates may date it to the mid 1960's. It does not appear the equipment is operational, and we would not recommend use of this equipment for a permanent application.

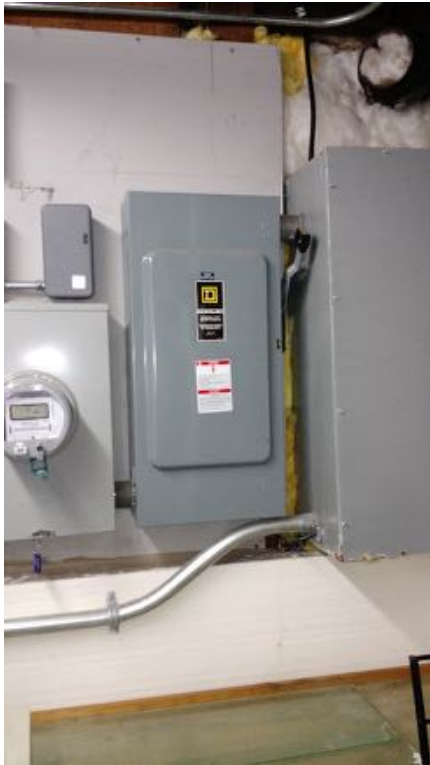
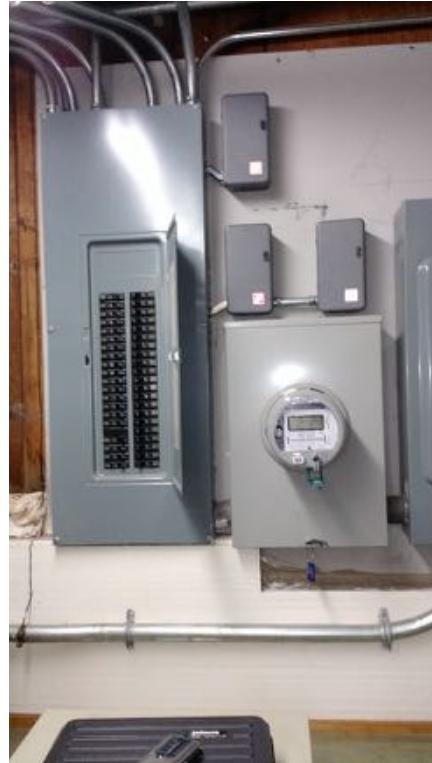
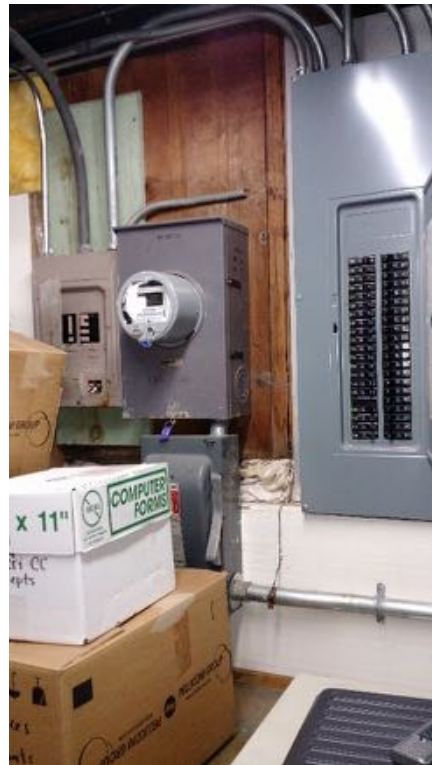
In Dale's Clothing store, the electrical service equipment and main distribution equipment serving the store is mostly new. The service enters into the basement in a pull box and terminates in two fused disconnect switches. There are two services and two meters at this location.

The configuration is “service entrance disconnect switch”, utility meter, and distribution panelboard. This configuration is known as “cold sequence metering” and is normally not allowed as the utility meter can be turned off and tampered with.

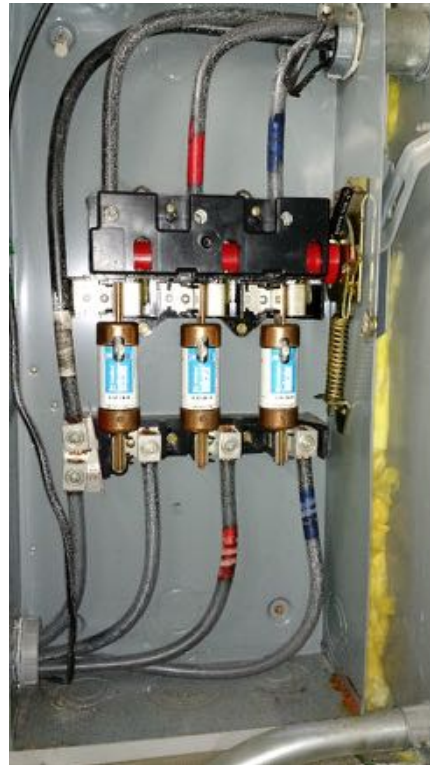
The equipment at the service entrance in Dale’s Clothing store is in very good condition and appears to be fully code compliant.

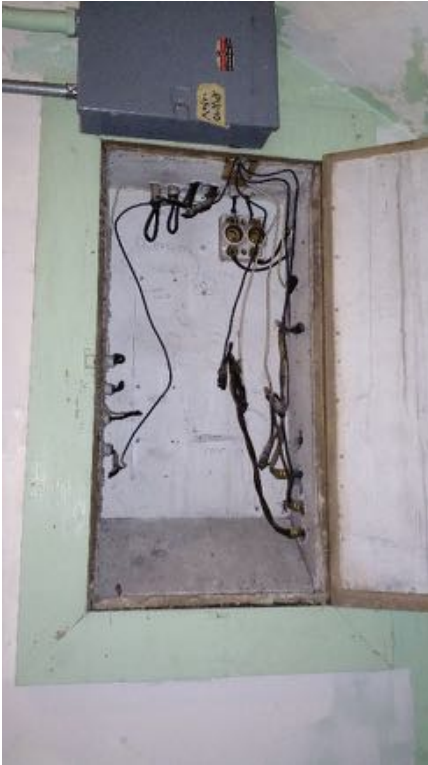
The above photograph shows an old fuse panel with remnants of knob and tube wiring. It appears that a few of these circuits have been routed into a newer metal fuse box and may still be energized. The original fuses are removed. Note that the white coloring in the box is likely asbestos.

The electrical systems located on floors and in areas that are not in use and haven't been renovated in recent decades should be replaced in their entirety. Certainly the intent would be to replace these electrical systems along with any significant renovation, but in the short term, it may be wise to de-energize any circuits that are not code-compliant and not required for minimal lighting.

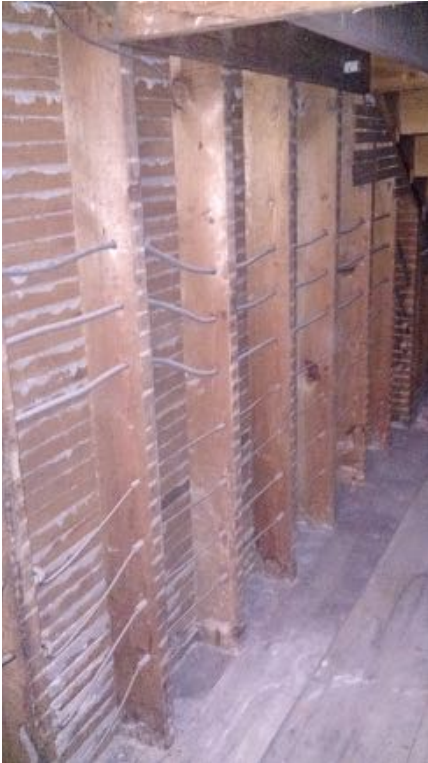
The photograph below shows a number of runs of knob and tube wiring, as well as some newer armored cable wiring. We don't know if any of these circuits are still active.

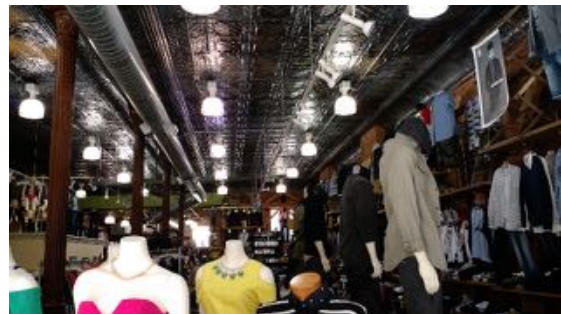
Lighting is a mixture of some new and much old or older. In Dale's Clothing store, the lighting is mostly new and generally is HID using industrial-style fixtures and metal halide lamps. The light levels are good and lighting is very uniform.

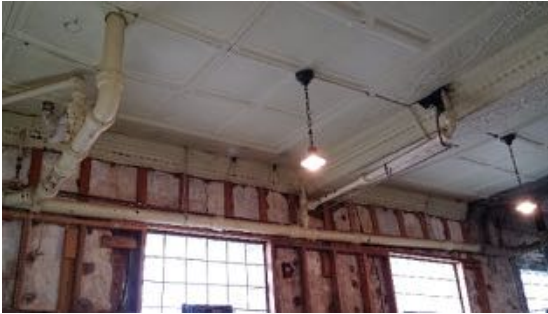
On the upper levels above Dale's clothing store, original incandescent lighting is still in place and still operational.

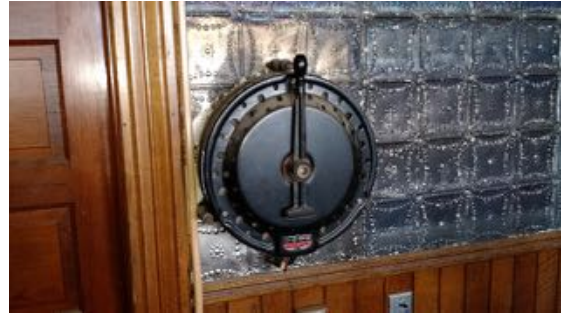
In the large room above Dale's Clothing store is this old Cutler Hammer manual dimming switch. It is unknown if it is still connected to any active lighting circuits and it may be best to retire it to artifact status, but it is a "neat" old switch. It would like to find a place to remain on display.
