*ARCHITECTURAL AND ENGINEERING ANALYSIS
FOR
123 & 125-127 4th STREET S*

RE: 123/125/127 4th Street So. – Condition Survey
MBJ Project No R15.255.0

Mechanical and Electrical Building Condition Evaluation

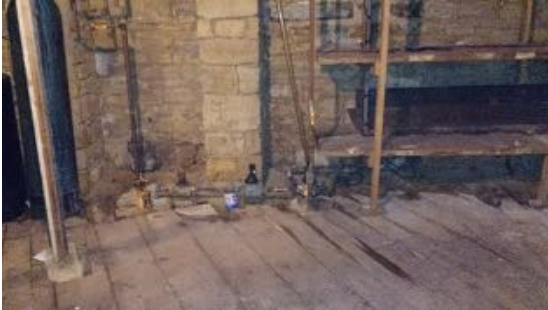
The above service is the domestic water service in the basement below the Rocky Rococo tenant suite. A galvanized steel water pipe penetrates the basement wall near the floor. There are multiple water meters connected to this service entrance. The water service piping is mostly copper and generally quite small in size. Valves around the meters are generally modern ball-type valves.

There is a water softener shown in the far left of the photograph above. This softener served the Rocky Rococo suite and appears to have softened both hot and cold water. The softener is showing some age and may not be functional.

The galvanized steel water service entrance piping is likely 40+ years old, but we don't see failure of this piping often in downtown La Crosse. Water pressure is typically in the 70-80 PSI range.

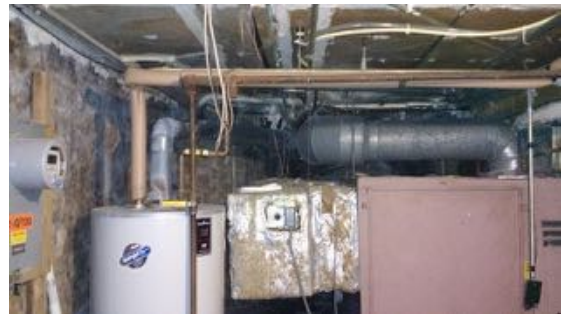
Of the active piping, we observed no leaks and piping was generally well constructed and supported. The water distribution piping is typically accessible in the basement levels as needed.

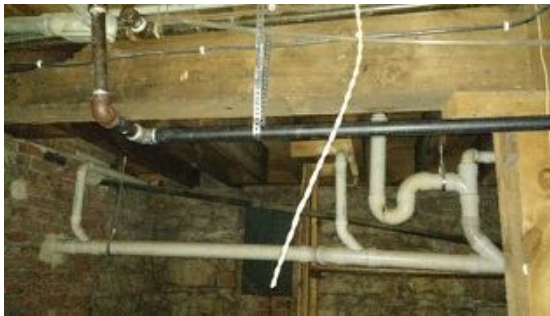
The drainage piping is fitted with many hub drains and indirect drains as commonly used in food service applications. If this tenant suite is renovated into another use, these indirect drains will require removal or capping as they tend to “dry up” (*evaporate water in the trap*) quickly within any use.

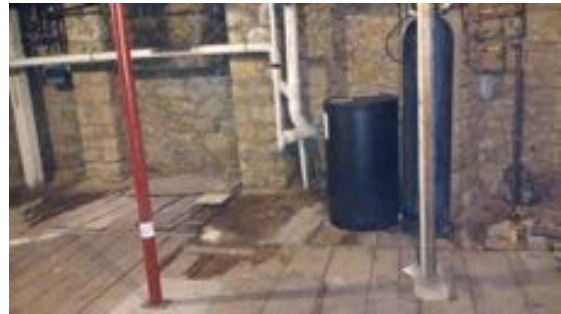
The sanitary sewers all discharge to the municipal sanitary sewer in 4th street. In the Rocky Rococo tenant suite, the sanitary service discharges through the sidewall of the basement approximately 30 inches above floor level.

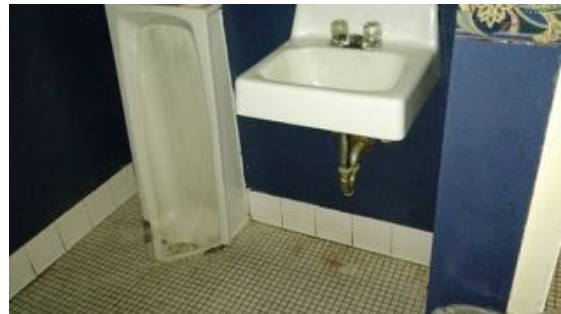
In the Rocky Rococo tenant suite, the toilet facilities are modern, but showing age from years of public use.

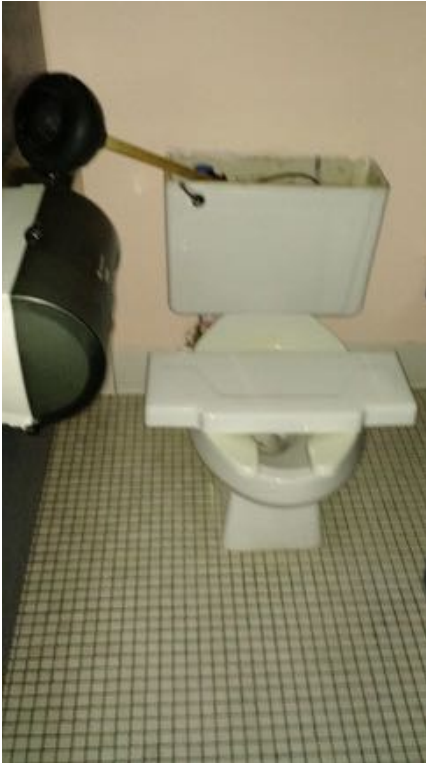
The toilet room fixtures were, essentially, residential in nature and probably have held up well considering their age. None are modern water-conserving type and it doesn't appear as they comply with current ADA requirements.

There are two remaining stainless steel commercial sinks in the Rocky Rococo kitchen. Both are functional and could be cleaned up well, but currently showing age and use. One is a typical 3-compartment scullery sink and one is a single hand wash sink.

It is recommended that toilet facilities be upgraded with new fixtures as tenant suites and spaces are renovated. Certainly some, if not all, of these fixtures could be cleaned up and re-used, but as new ADA requirements are implemented, it would likely be best to simply replace these fixtures.

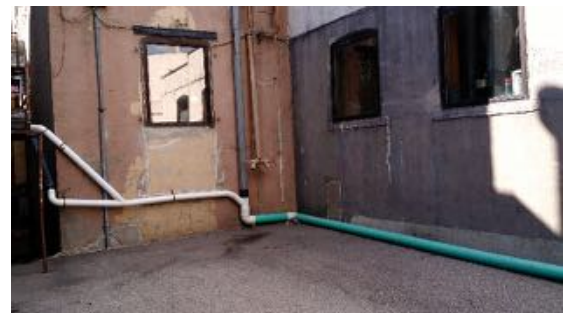
In the above photograph, the building is the Dale's Clothing Store. The vertical silver colored piping conveys water from this building. The white-colored PVC pipes at the left of the photograph collect water from the buildings above the Rocky Rococo tenant suite.

This arrangement is certainly less than ideal and any failure in this piping will allow much water to fall into the area between buildings.

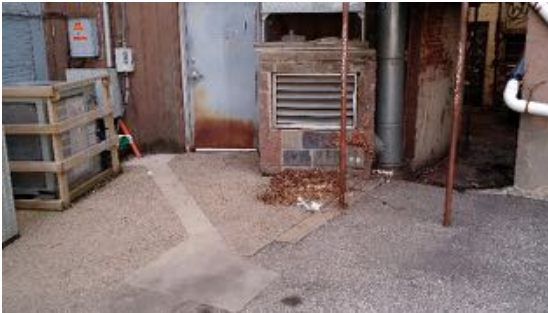
The rusted gray door opens from the Rocky Rococo tenant suite. There is a courtyard between these buildings that is at a lower elevation than the paved area behind Dales Clothing store and Rocky Rococo. Without question, this area must flood in a heavy rain event. No storm water basin was observed in this area.

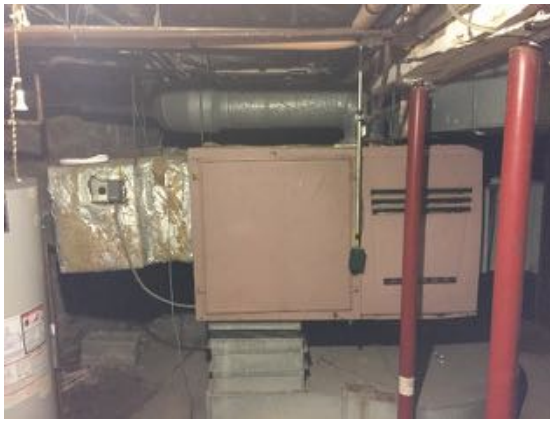
This unit is an indirect-fired make-up air unit meaning that it can operate with 100% return air (*like a home furnace*) or with 100% outside air to provide make-up air to the kitchen, or any value in between. The unit was installed to provide make-up air to the pizza oven in Rocky's kitchen.

The unit is operational and currently operating in 100% return air mode for minimal space heat only.

Even if a future tenant is a food service occupancy, replacement of this unit should be included in the renovation. It is clear the unit has been repaired multiple

times and with each repair, the unit becomes more worn.

In the Rocky Rococo tenant suite, our recommendation would be to replace all existing equipment with new equipment, regardless of any new occupancy. If the space transitions to retail similar to the adjacent occupancies, another residential furnace would likely be the best value.

Other occupancies may dictate something different, but re-use of the old Reznor make-up air unit is not recommended.

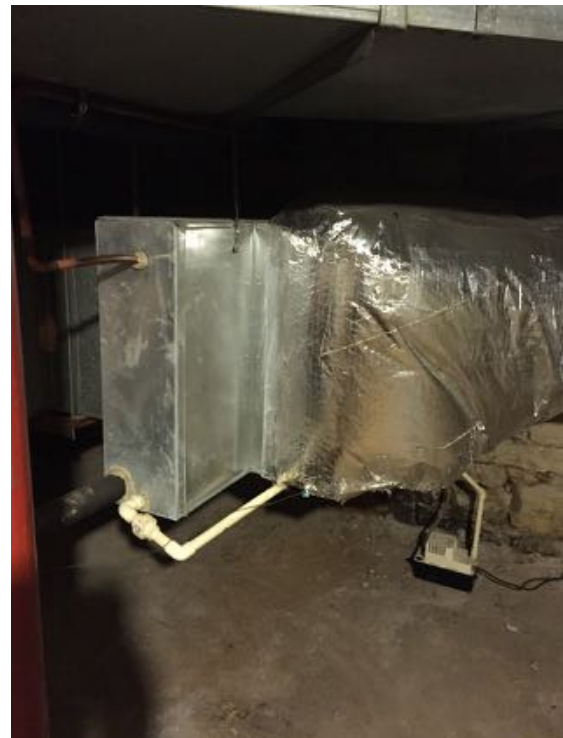
It appears that the cooling coil and condensing unit may be newer than the Reznor make-up air unit.

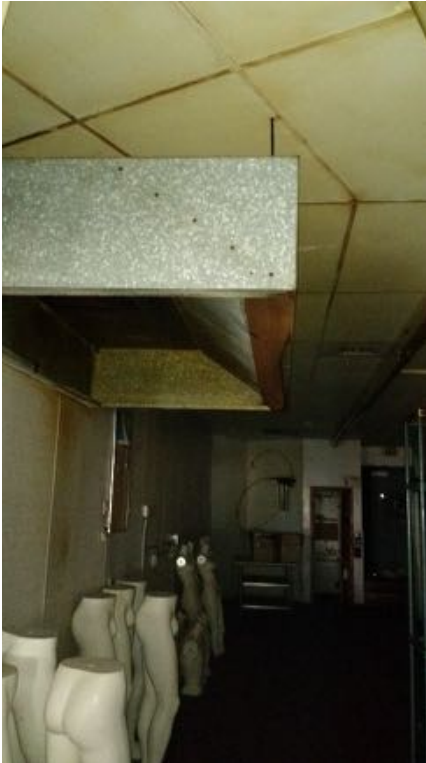
As a pizza oven hood, this hood was functional and relatively safe. This is not a cooking hood and cannot be used for common commercial cooking equipment. We would recommend removal and disposal of this hood, but as a “heat relief” hood, it could remain for some use.

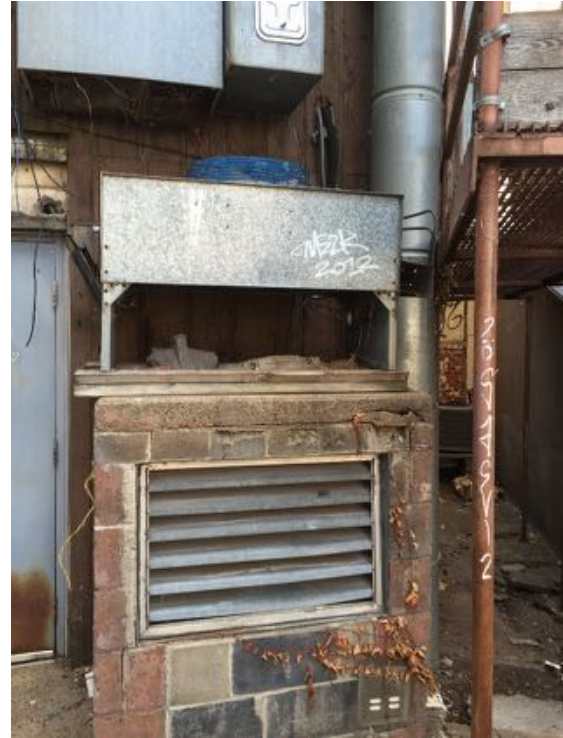
In the above photograph, the louver is the outside air intake connected to the Reznor heater. This louver is located approximately 30 inches above grade in the alley. This is a legal installation, but also susceptible to plenty of debris, dirt, etc. If this duct system is re-used, the louver should be removed and cleaned and the outside air path should be inspected and cleaned as necessary.

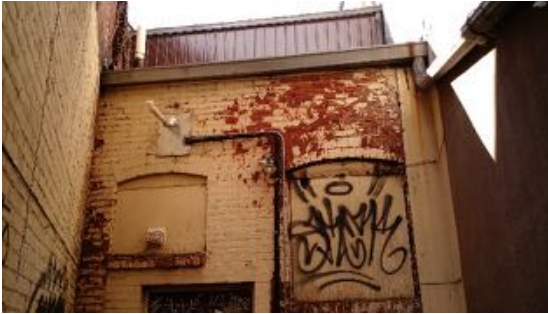
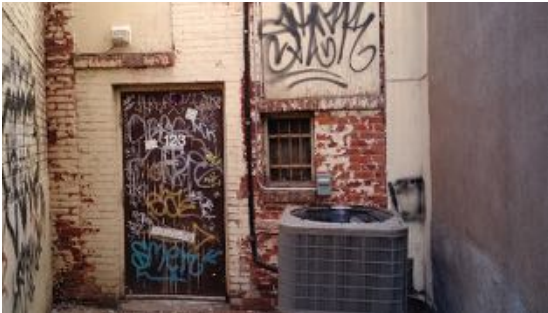
The following exterior photographs show a classic residential furnace vent termination and refrigerant piping to a residential condensing unit. The white louvered device above the entrance door may be an outside air ventilation opening.

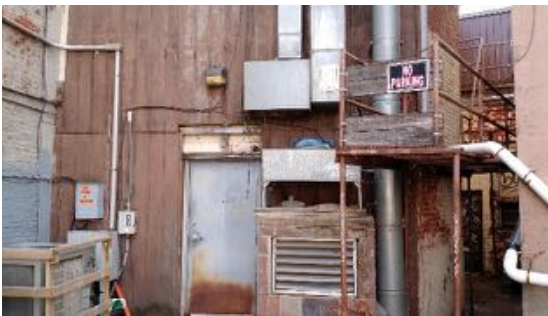
Power to Rocky's goes into the basement from this pull box. You can see another service tapped from this pull box and running up and then along the building to an adjacent building. This seems to be a secondary service without any disconnecting means or over-current protection. On face value, this would appear to be a significant code violation, but additional investigation is warranted.

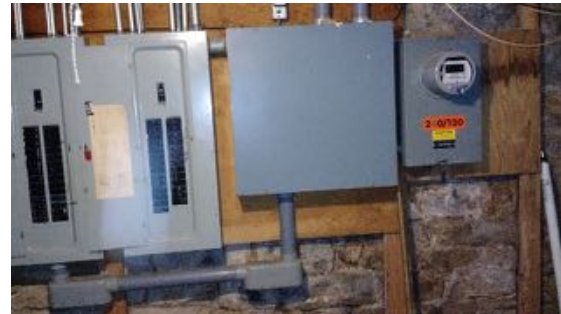
This is a 240/120 VAC, three phase, four wire "Delta" service and comes from a different source than the typical power supply from the 208/120 VAC network running in tunnels throughout downtown La Crosse. This alternative source of power presumably does not require the fuse protection of the downtown network 208/120 VAC power supply.

It is unclear why this building is served with power from a separate source and why the supplied power is of a different voltage. There is no code violation to this discrepancy, but it does seem strange. Most of the older downtown La Crosse buildings are supplied with 208/120 VAC three phase power from the underground network.

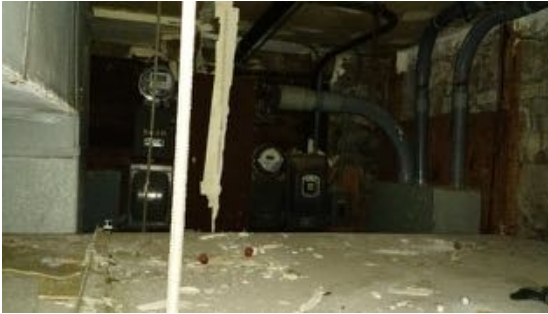
To reach this equipment, one has to crawl on hands and knees under a large duct. Once behind the duct, there may be enough physical space to be code compliant, but this would be a very liberal interpretation of the code. There is no functioning lighting in this area.

There are, at least, two relatively new utility meters and two old fused disconnect switches in this area. In our opinion, this access is a significant safety hazard, if not a code violation. If the Reznor heating unit and all related ductwork is removed, then access to this equipment would be better.

The old electrical distribution equipment in the basement of the Rocky Rococo suite should be moved, replaced, or otherwise improved to be easily accessible and safe. Most likely this will result in replacement perform in partnership with the HVAC renovations.

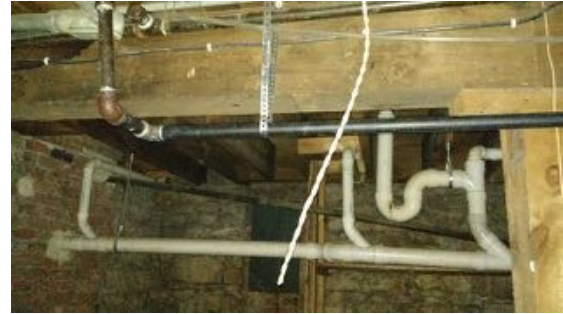
A very few non-code complying circuits were found. The photograph below shows an NM cable stapled to the wood joists below the Rocky Rococo tenant suite. *(Not the white spiral wire hanging vertically, but the gray wire running horizontally near the top of the beam.)*

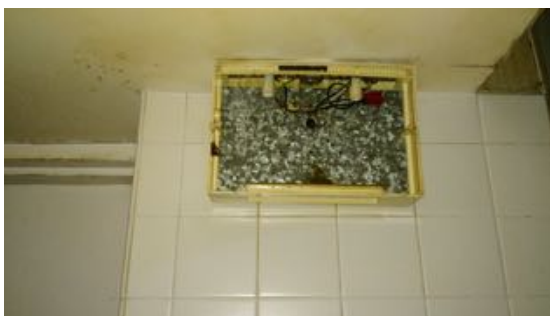
The above photograph shows an Exit light in the Rocky Rococo tenant suite that is

clearly not functional any more. There are minimal Exit lights on the upper floor levels and emergency lighting is generally absent in the spaces not normally used or occupied.
