# **THE CITY OF LA CROSSE**

## **Neighborhood/Community/Seniors Centers**

### **Facility and Programs Report**

December 2013

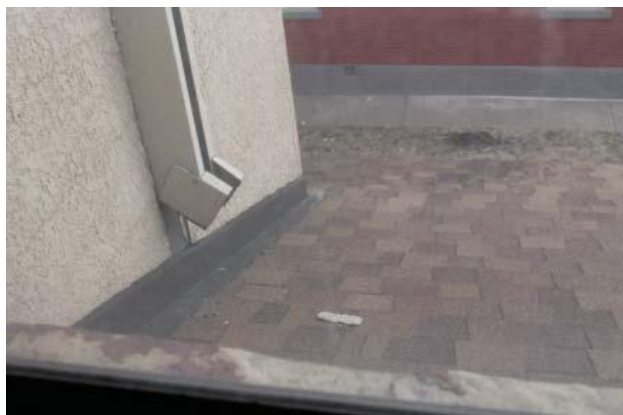
Roof over storage addition (damaged sill in foreground). (2012)

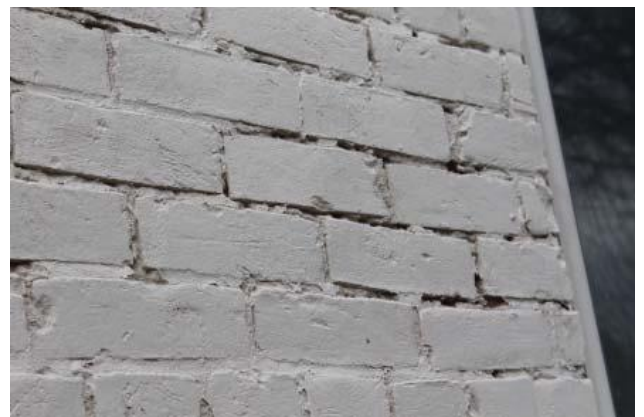
Typical painted brick condition. (2012)

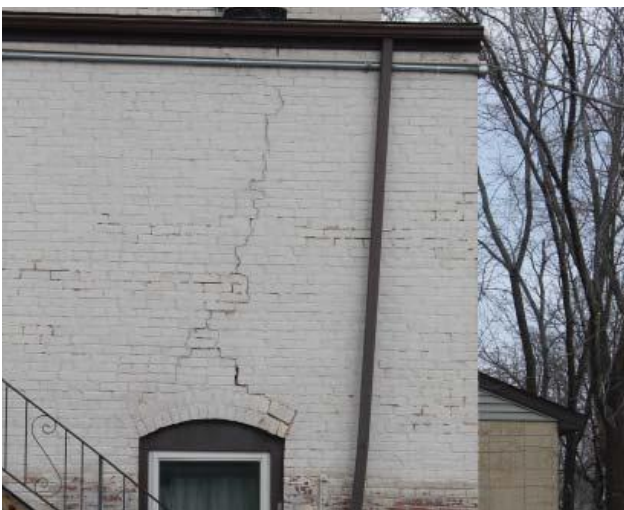
Condition of brick above south east window. (2012)

The exterior brick walls of the original building are showing their age and need maintenance. All four sides of the original structure exhibit deterioration of the brick, limestone, and mortar due to weathering, water infiltration, and age. At some point in the history of the building the exterior brick has been painted and this paint is now chipped and peeling. The lower portion of the west wall has had tuckpointing and paint removal work attempted, however, in the process the cleaning has marred the surface of the brick face. Many of the lower level limestone sills have been correctly replaced. Our recommendation

is to replace the rest of the excessively deteriorated limestone sills, the spalled and damaged bricks, and be even more careful with the paint removal process to clean and tuckpoint the grout joints on all the affected walls. The lower level of the north facade of the building has an applied stucco ashlar pattern faux stone. This is severely stained, cracking, and starting to fall off of the building. Its removal to return the building to its original appearance should be investigated. The concrete masonry unit walls of the 1977 addition have an applied EFIS coating. This surface is severely cracked and separating from the substructure, and there are no signs of expansion control. It is our recommendation to install movement control joints as required then affix expanded metal lath with anchors back to the CMU substrate and cover with a stucco system with an acrylic topcoat. It was not pos-

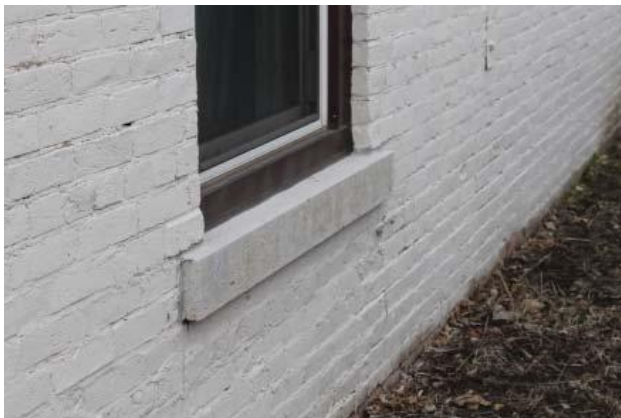
New stone sill in painted brick wall. (2012)

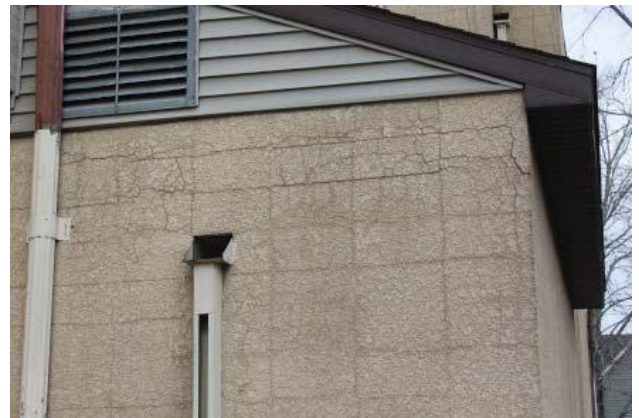
Cracked EFIS walls of 1977 addition. (2012)

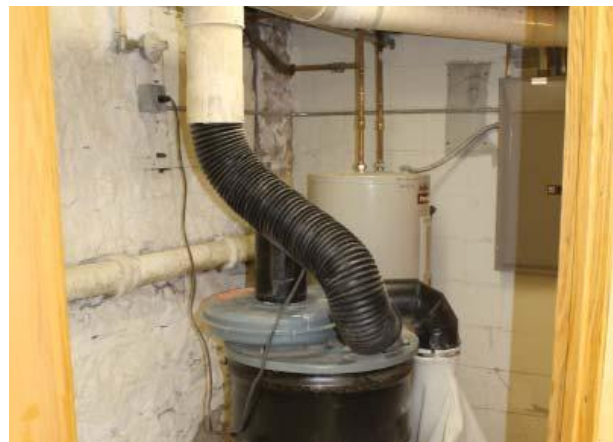
Mechanical room located under central egress stair. (2012)

Under the central stair a mechanical room is located. This space should be separated from the stair and adjoining spaces by a minimum one hour fire resistant barrier, including a rated door, as it contains electrical panels, a water heater, and a dust collection system terminus. The walls of this room are comprised of three different systems; concrete masonry units (CMU), the original stone exterior foundation

wall, and a gypsum board wall. Penetrations through these walls are also unprotected. The frame on the door to this room is split at the head and should be repaired.

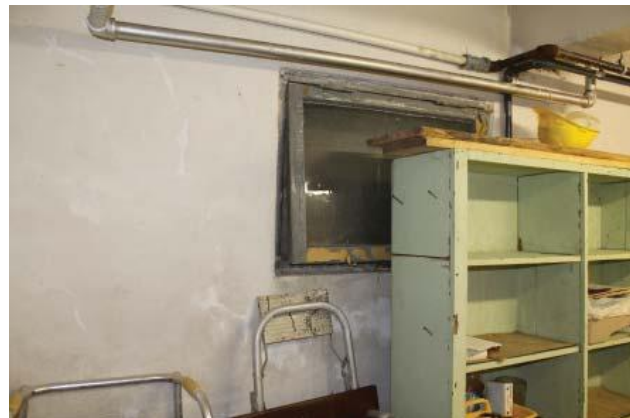
South west storage room, exterior window. (2012)

The storage room in the south-west corner of the basement still has one of the exterior windows intact along the west wall. This opening has been infilled to the exterior and the window glazing should be removed. The door frame trim is almost completely missing in this room.

This minor repair should be completed. There is also unenclosed pipework and valves within this space. Exposed ductwork, piping, and conduits throughout this level should be considered for enclosure as they are run along the open ceiling structure. Infilled windows in this space are not visible but presumably the original window fenestration has been removed.

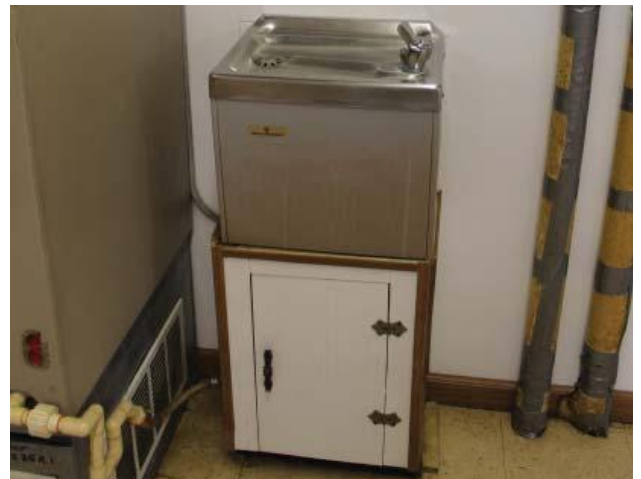
Inaccessible drinking fountain. (2012)

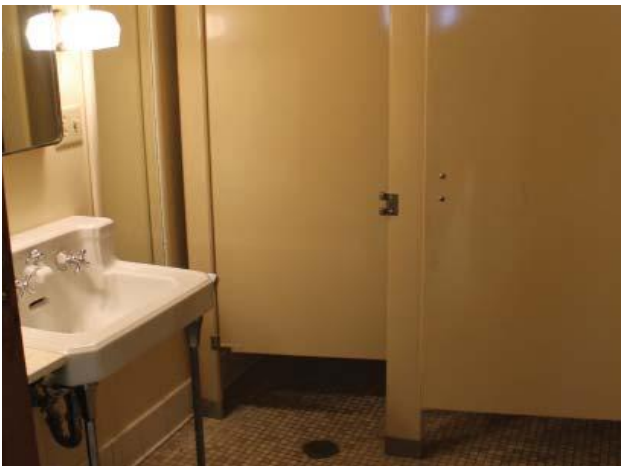
Out-dated and inaccessible first floor restrooms. (2012)

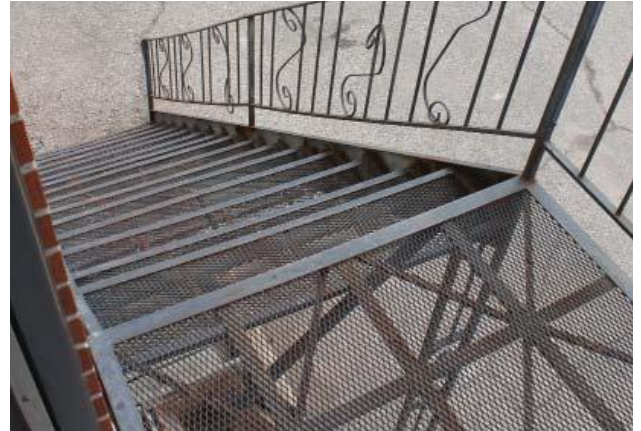
Fire escape stair at south end of building. (2012)

The fire escape (exterior stair) is in fair to poor condition. The handrail requires replacement or repair. The bottom tread is not evenly spaced with the others posing a possible tripping hazard. The treads are all

showing rust at the stringers. The exterior door at the top of these stairs is in need of repair/replacement as well. The bottom of the door has rusted through and prevents proper closure posing a security issue as well.

| ITEM | PRIORITY | ESTIMATED COST |
|--|---|---|
| Replace South Fire Escape and Exit Door | High | \$ 10,500 |

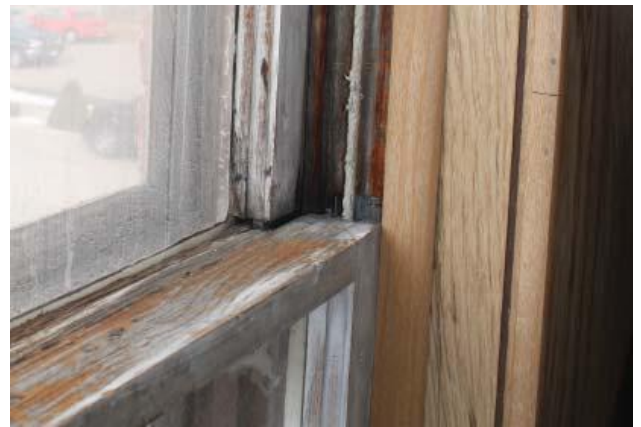
Typical window condition on second floor. (2012)

The window in this room, as with those throughout the rest of the floor, as discussed in the envelope section, are original and in need of repair or replacement due to lack of maintenance.

| ITEM | PRIORITY | ESTIMATED COST |
|--|---|---|
| Replace 2 <sup>nd</sup> Floor Windows | Medium | \$ 25,000 |

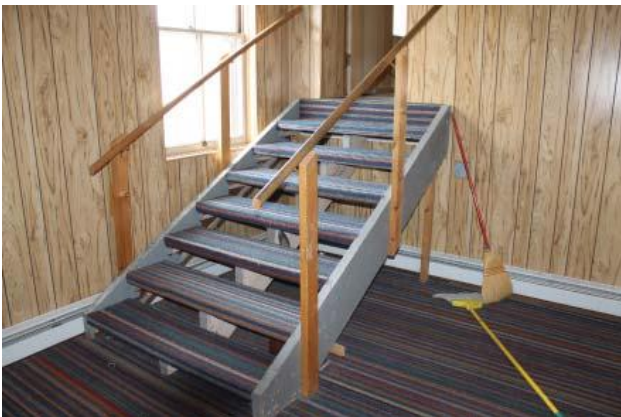
Stair from south meeting room to second floor hall. (2012)

The stair from this lowered meeting room floor to the main second floor hall is also not code compliant in its open risers, tread finish, or railings. This stair should be completely reconstructed to meet code

| ITEM | PRIORITY | ESTIMATED COST |
|--|---|---|
| Replace South Meeting Room Stair | High | \$ 5,000 |

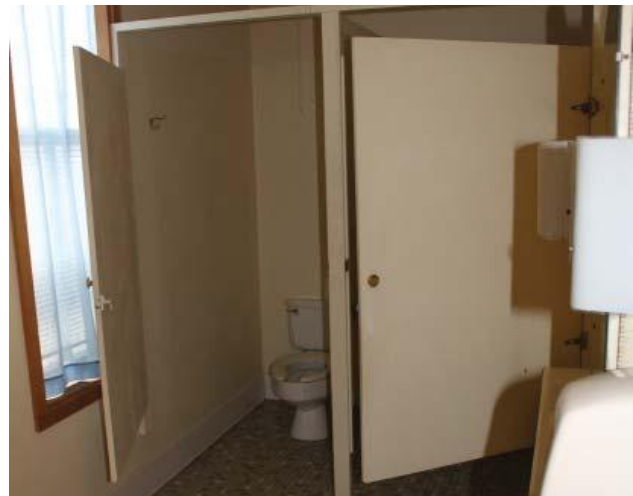
Partition obscuring restroom window. (2012)

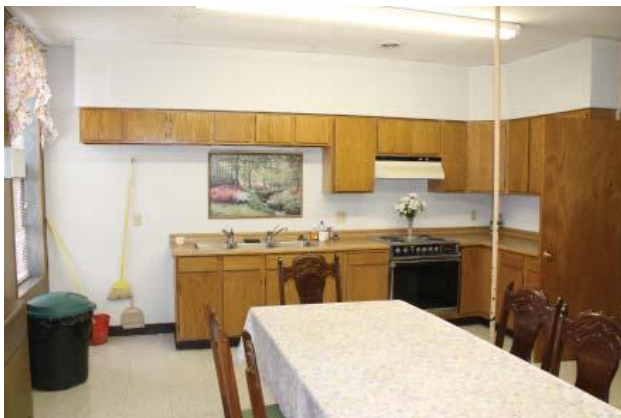
Second floor kitchen with vertical tie rod. (2012)

Across the hall on the eastern half of the central section of the building is a second kitchen. The paint on this structural element is chipped and should be repainted. The entire length of the north wall of the kitchen has built in storage cabinets constructed of wood frame and paneling. The rest of the room is in good condition with dated fixtures, appliances, and finishes.

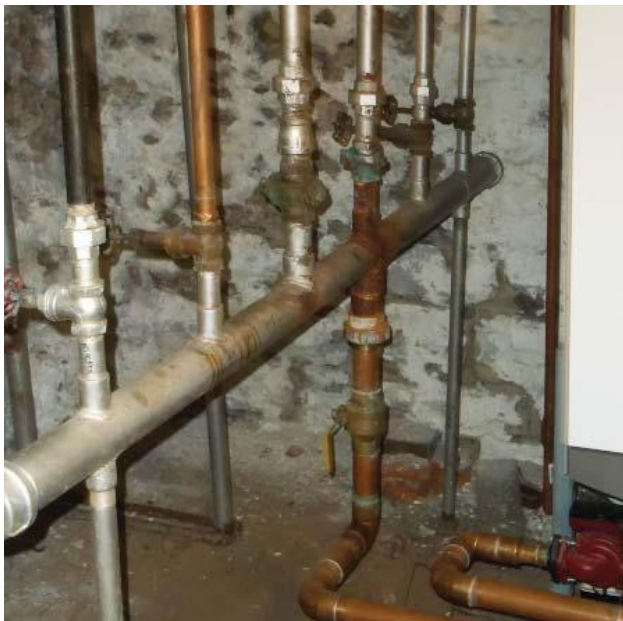
- C. Although the boiler is new, most of the existing piping, valves, and heating specialties were left in place. Many of the isolation valves are old gate valves, which likely do not seal water-tight anymore. A conventional expansion tank, without a gauge glass, was retained. The original water specialties were left in place. It would have been better to update these devices when the boiler was replaced, but they are easy to replace in the future if they fail.

Older piping and valves for heating system. (2012)

| ITEM | PRIORITY | ESTIMATED COST |
|---|---|---|
| Gate Valve Replacement | Low | \$ 1,000 |

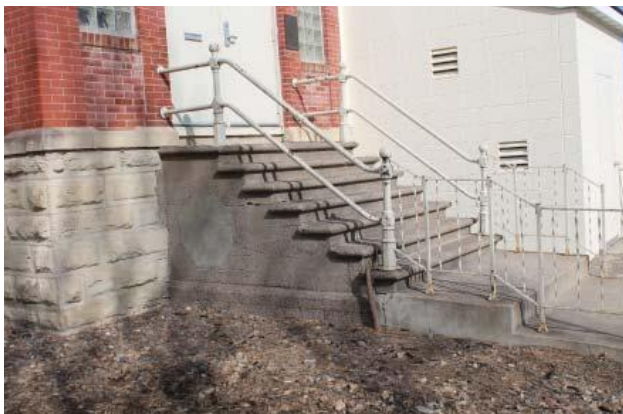
Brick and Foundation condition at south elevation (2012)

The exterior brick and limestone walls of the 125 year old original building are showing their age and need maintenance. All four sides of the original structure exhibit deterioration of the brick, limestone, and mortar due to weathering, water infiltration, and age. Our recommendation is to replace the excessively deteriorated limestone blocks and sills, the spalled and damaged bricks, and to tuckpoint the grout joints on all the affected walls. The concrete masonry unit walls of the 1975-80 additions have been properly maintained, painted, and appear to be in satisfactory condition. Our recommendation is to continue moni-

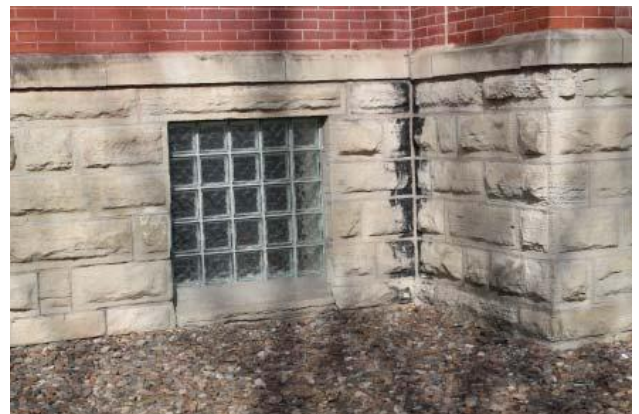
Foundation and Sill condition at south elevation (2012)

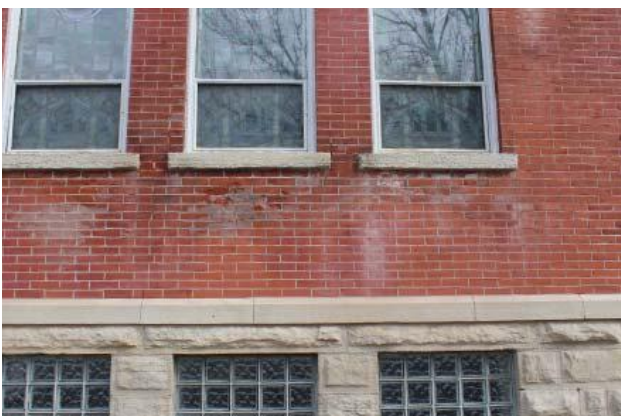
Sill and window condition at west elevation (2012)

| ITEM | PRIORITY | ESTIMATED COST |
|--|---|---|
| Replace Windows in Original Building | Medium | \$ 40,500 |

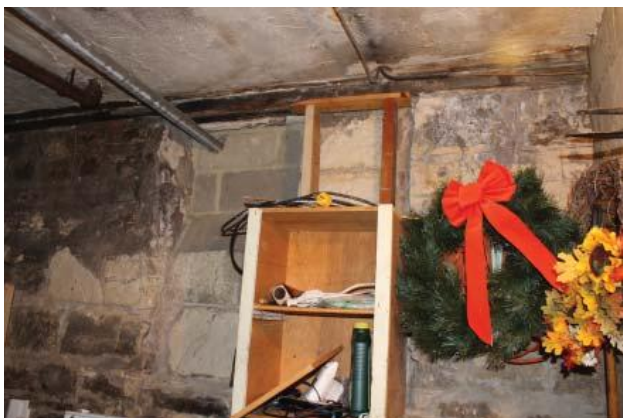
Foundation condition in lower level storage area. (2012)

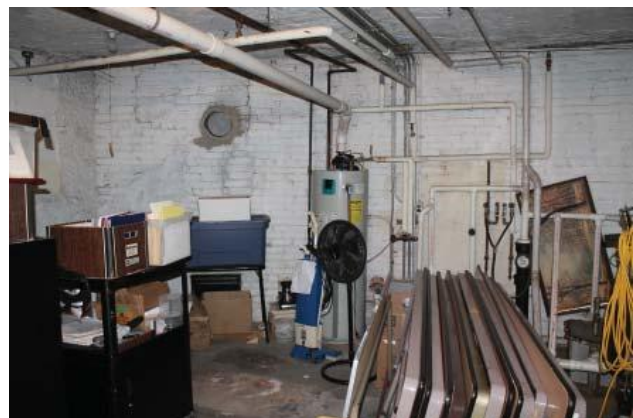
Interior wall condition in lower level storage area. (2012)

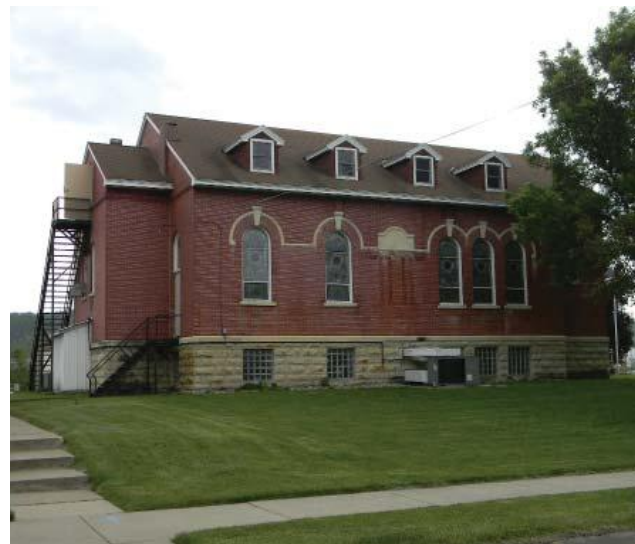
West wall of original building showing masonry and stone deterioration.

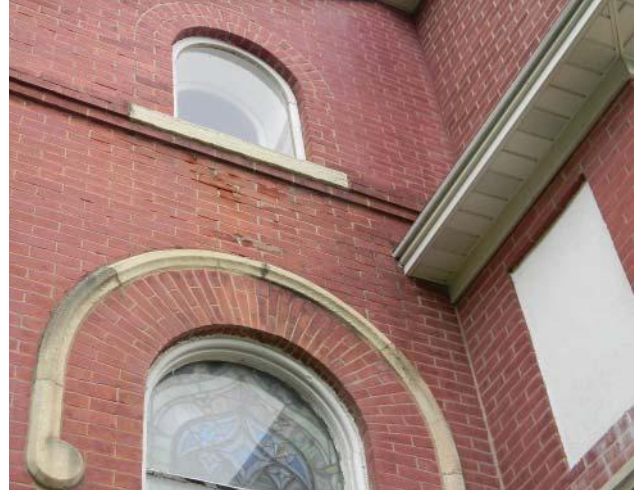
South wall of original building showing masonry deterioration.

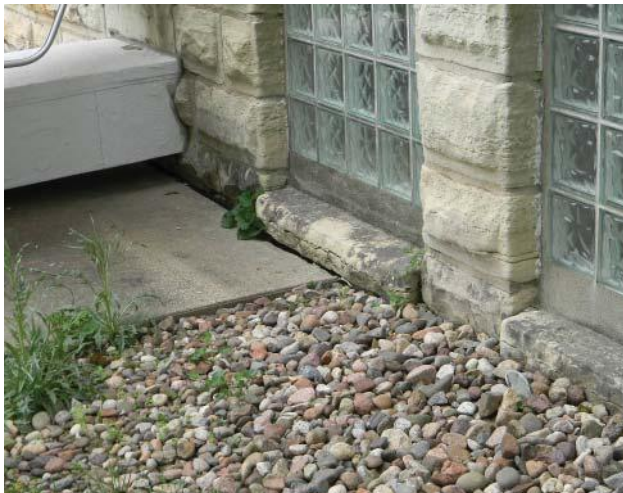
West wall of original building showing limestone deterioration.

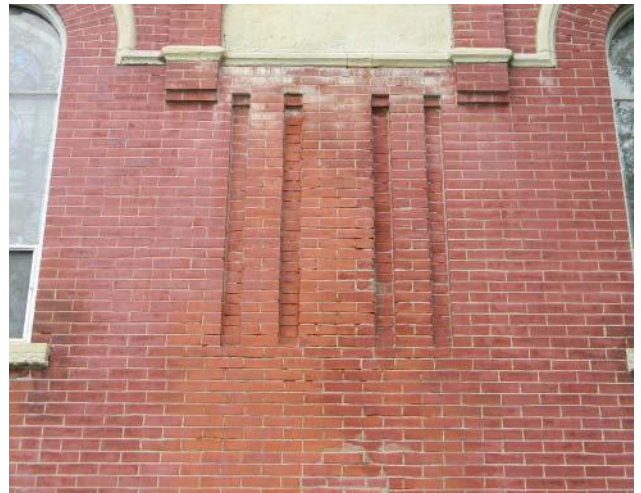
West wall of original building showing masonry deterioration.

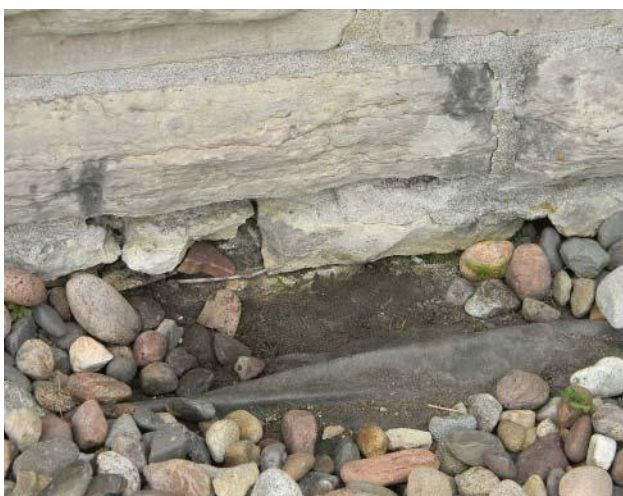
Close-up of limestone wall foundation at grade on the west elevation.

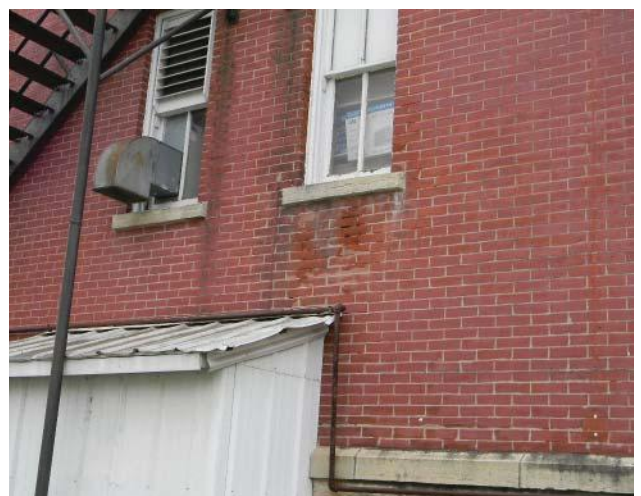
North wall of original building showing masonry deterioration.

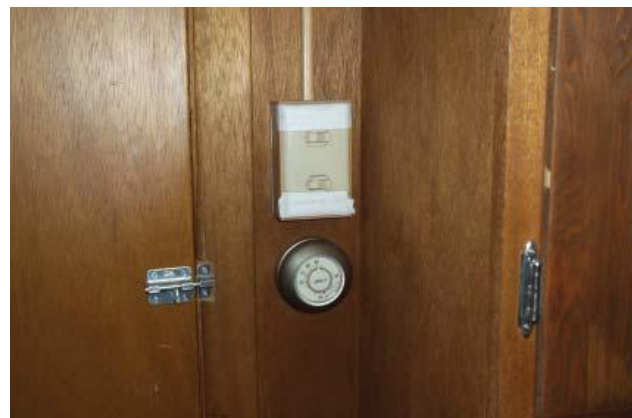
Typical light switches. (2012)

- D. We would also recommend that most of the lighting switches be replaced. Lighting switches

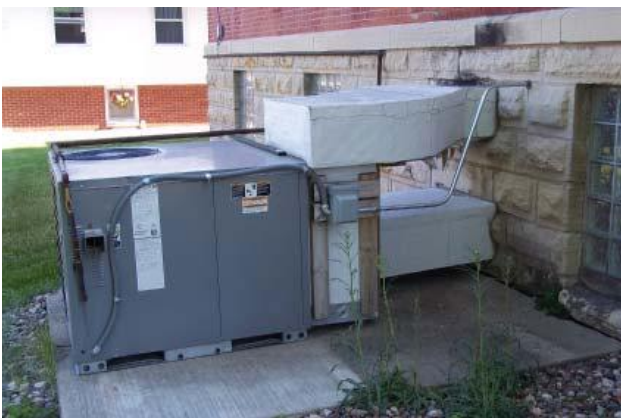
- C. The Basement Level of the original building, including the kitchen, is served by a rooftop unit located on grade on the west side of the building. This unit was installed in 2008 and appears to be in very good condition. The air is ducted through the sidewall of the original building and ductwork is generally exposed at the ceiling of the basement. This unit provides heat from a natural gas supply and air conditioning. This unit is not equipped with an “economizer” and does not appear to have any outside ventilation air capabilities. This would be a Code violation for the commercial occupancy of this space. The unit/system should be fitted with a means to introduce tempered outside air into the building during occupied periods. At present, this seems to be more of a “residential” installation.

Rooftop heating unit located at west side on grade. (2012)

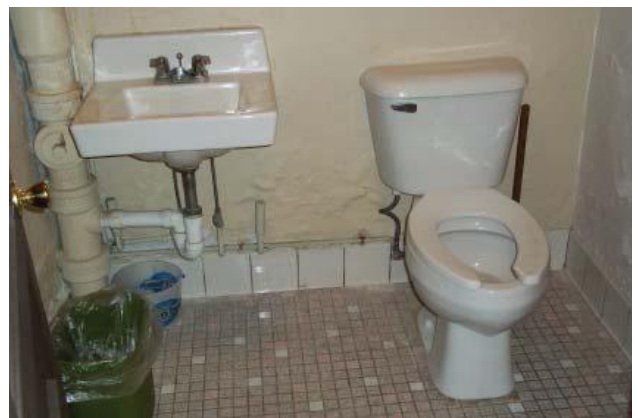
7. Plumbing Fixtures and Primary Equipment
- A. Plumbing fixtures in the original building are in generally good condition and operational. The plumbing fixtures in the building addition are commercial-quality and in good condition. Toilets are tank-style and do not typically meet current ADA requirements. Lavatories are typically wall-hung, but again do not meet any current ADA requirements.

Lower level women's room in original building. (2012)

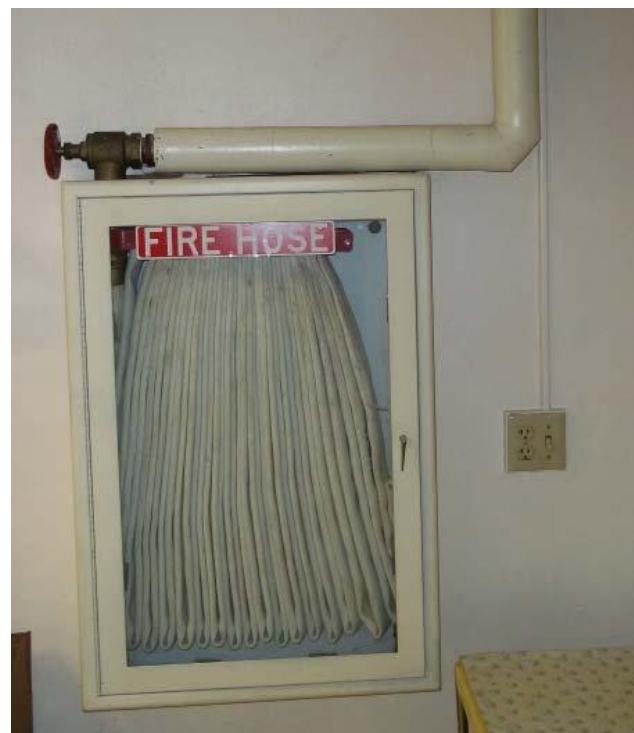
- A. This building has a single 1-1/2 inch branch water supply from the domestic water service that serves a single fire hose located in the Basement Floor Level near the Kitchen in the original building. Although the hose and cabinet appear to be in good condition, we do not know the actual age and condition of this hose. Typically, these hose cabinets are no longer used by fire fighting

Lower level fire hose. (2012)
