Harry J. Olson Senior Center
La Crosse, Wisconsin

6 September 2012 ARCHITECTURAL AND ENGINEERING ANALYSIS

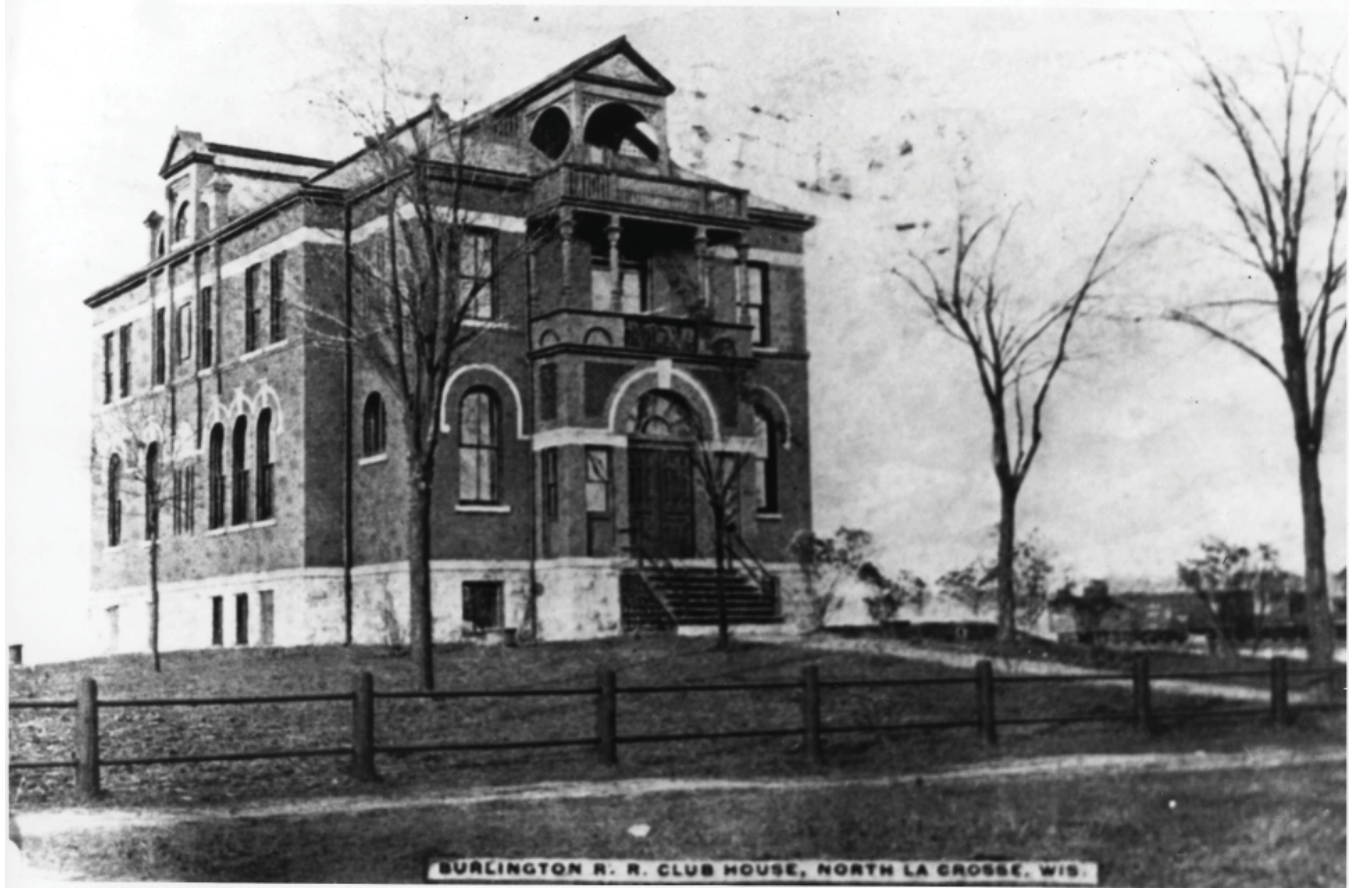
Burlington R.R. Club House, North La Crosse, WI (c. 1900)

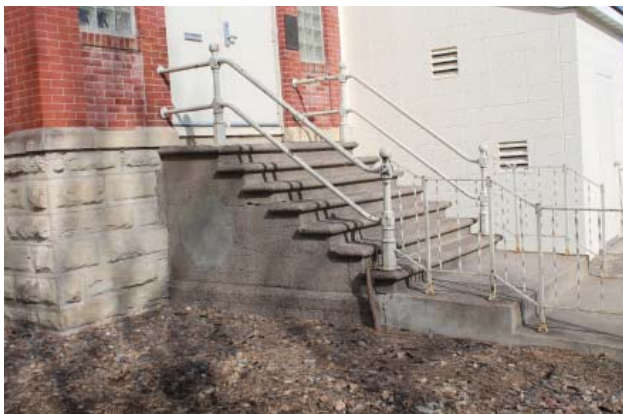
Brick and Foundation condition at south elevation (2012)

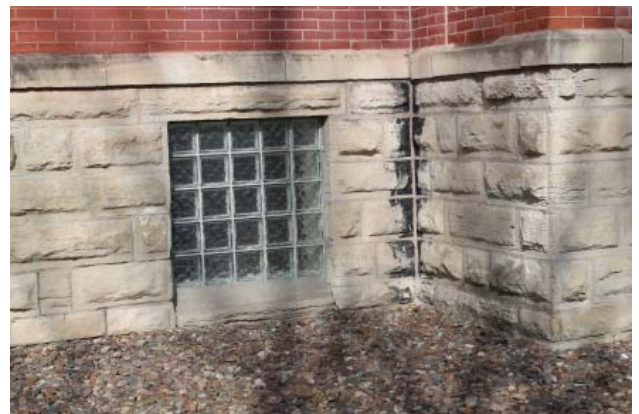
Foundation and Sill condition at south elevation (2012)

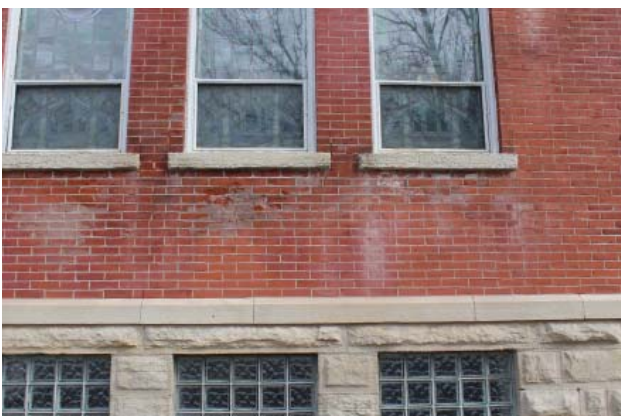
Sill and window condition at west elevation (2012)

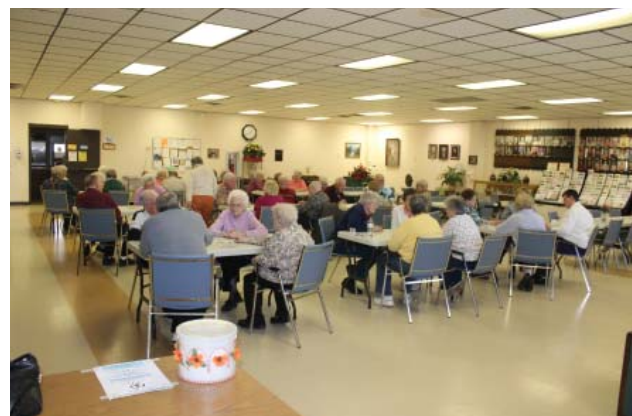
Multi-purpose room in 1975 addition (2012)

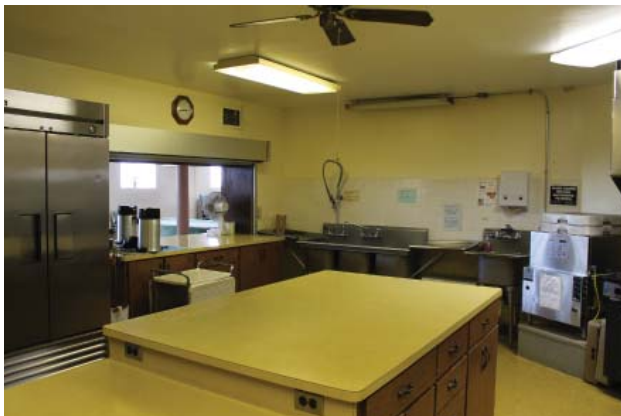
Kitchen in lower level. (2012)

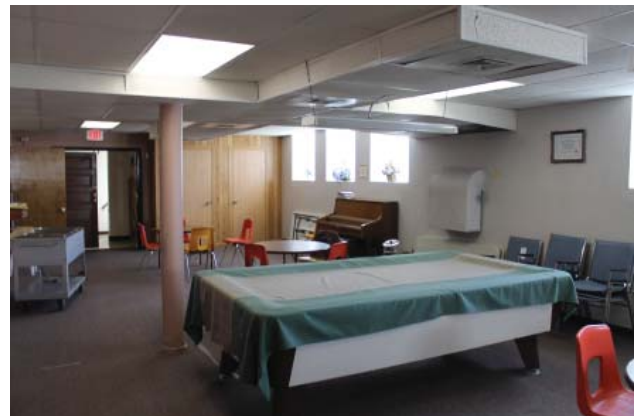
Multi-purpose room in original building lower level. (2012)

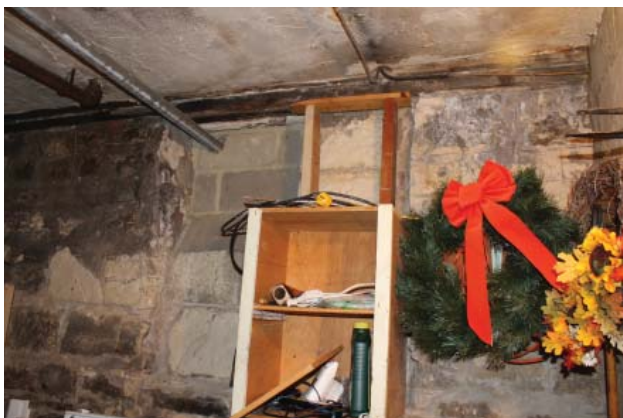
Foundation condition in lower level storage area. (2012)

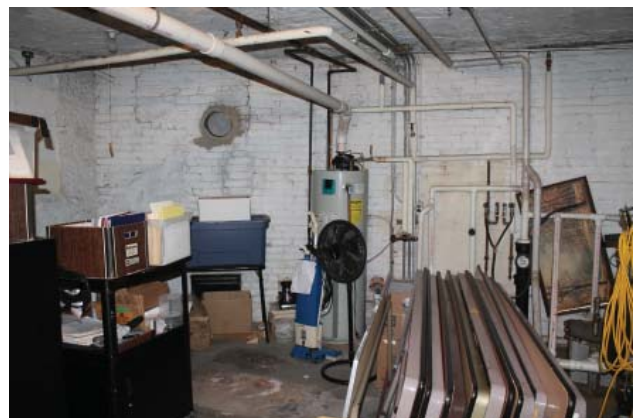
Interior wall condition in lower level storage area. (2012)

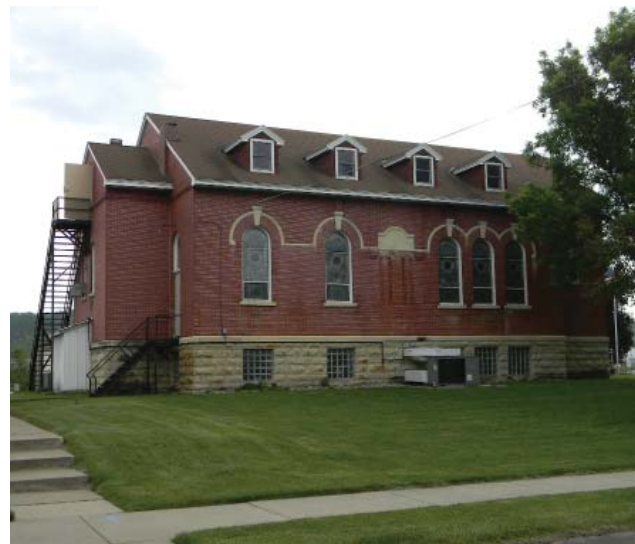
West wall of original building showing masonry and stone deterioration.

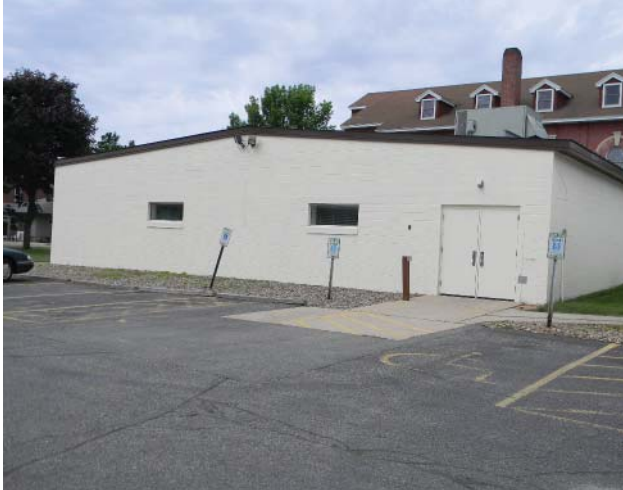
East wall of 1975 addition with original building behind.

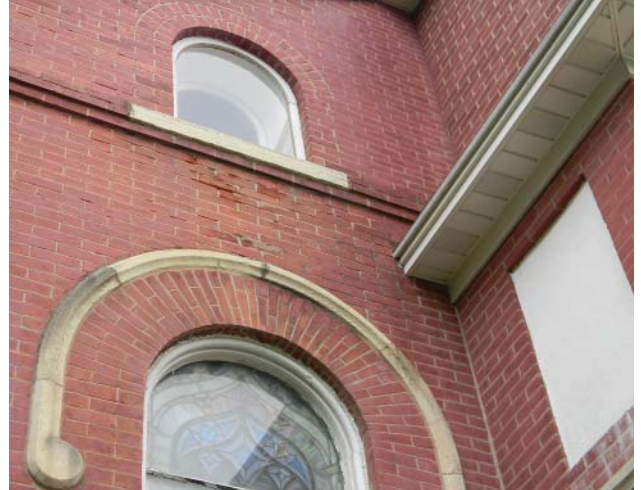
South wall of original building showing masonry deterioration.

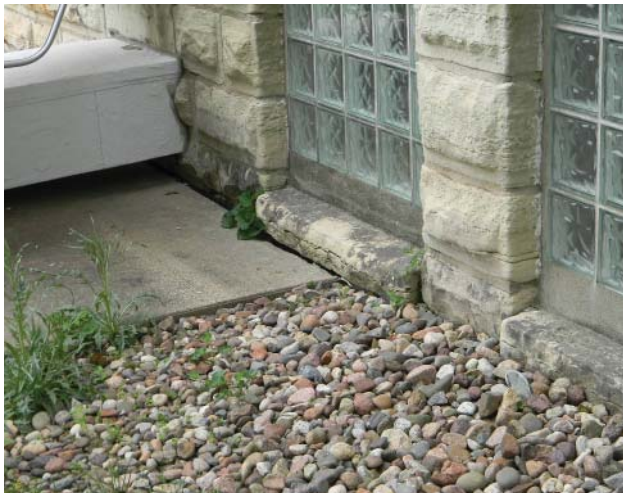
West wall of original building showing limestone deterioration.

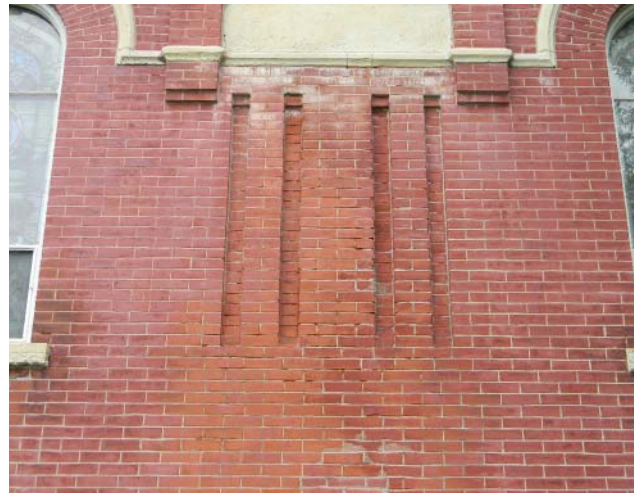
West wall of original building showing masonry deterioration.

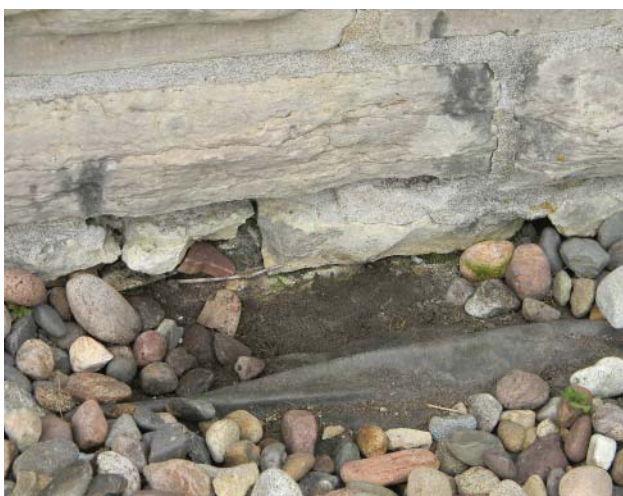
Close-up of limestone wall foundation at grade on the west elevation.

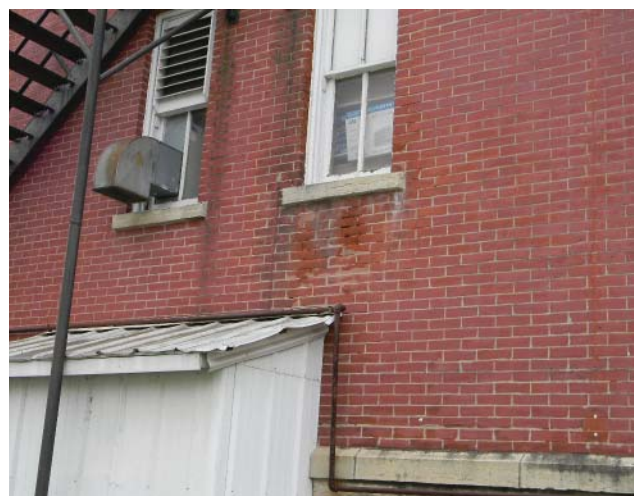
North wall of original building showing masonry deterioration.

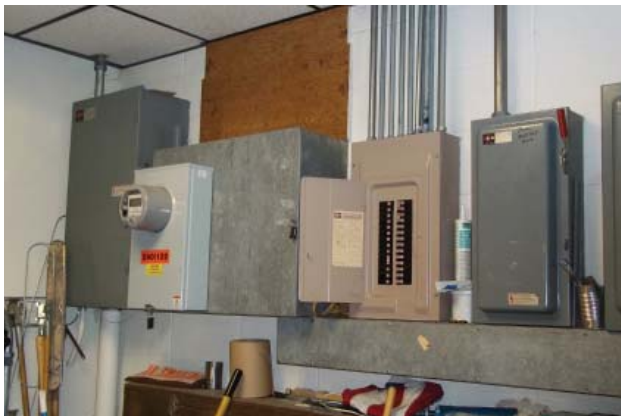
Multiple metering cabinets, load centers, and switches. (2012)

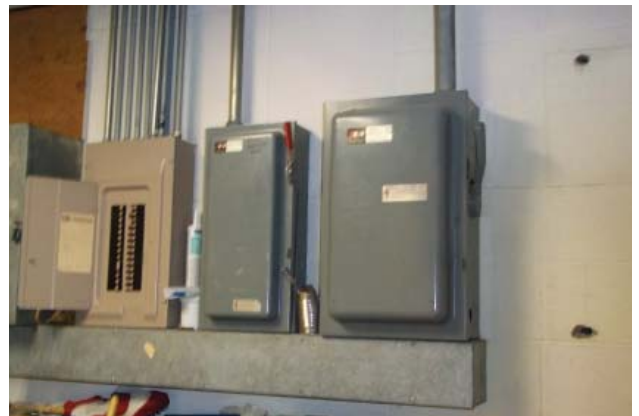
Multiple metering cabinets, load centers, and switches. (2012)

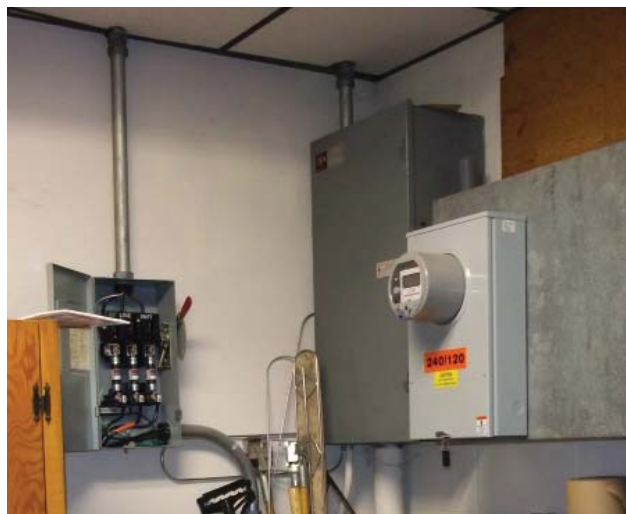
Multiple metering cabinets, load centers, and switches. (2012)

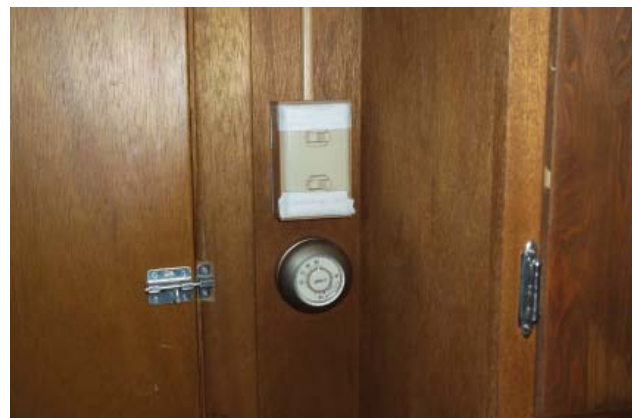
Typical light switches. (2012)

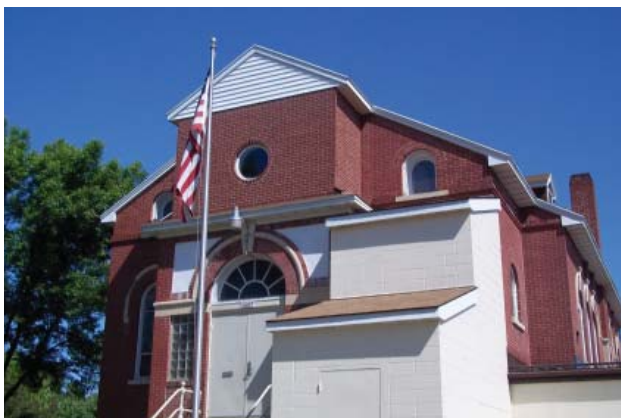
Exterior lighting fixtures. (2012)

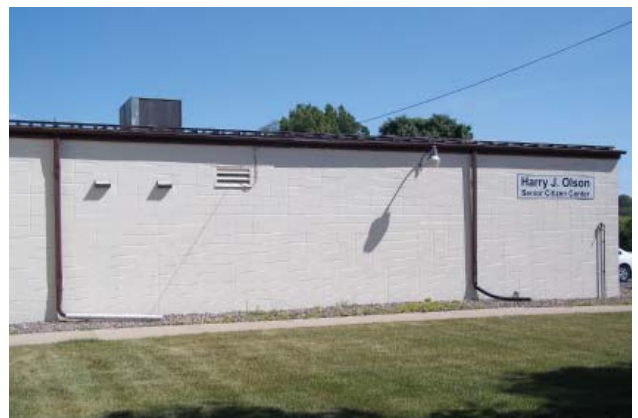
Exterior lighting fixtures. (2012)

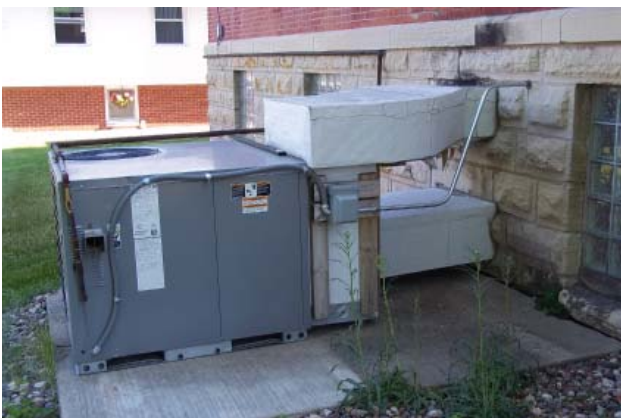
Rooftop heating unit located at west side on grade. (2012)

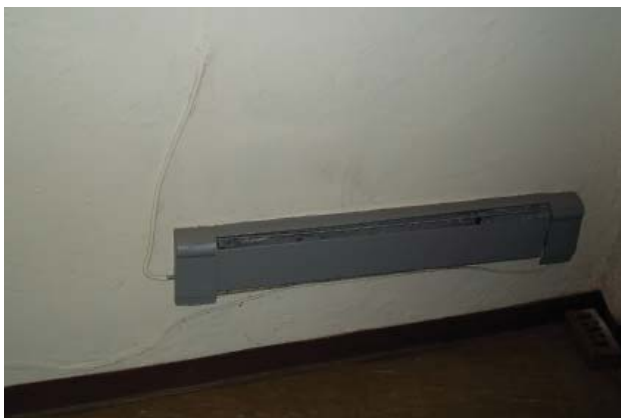
Supplemental electric heat. (2012)

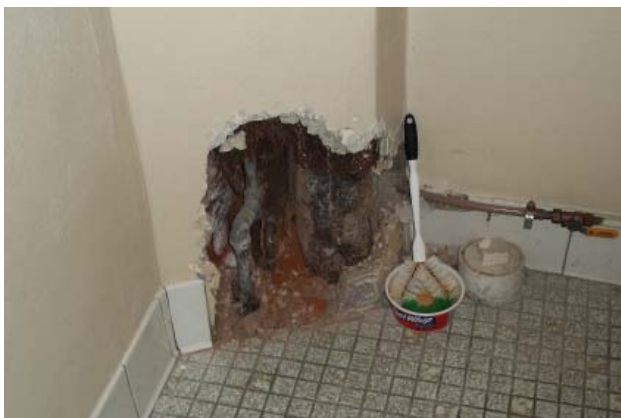
Opening in wall to access piping. (2012)

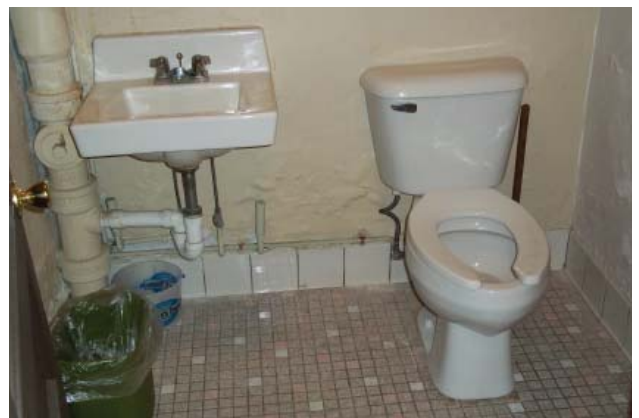
Lower level women's room in original building. (2012)

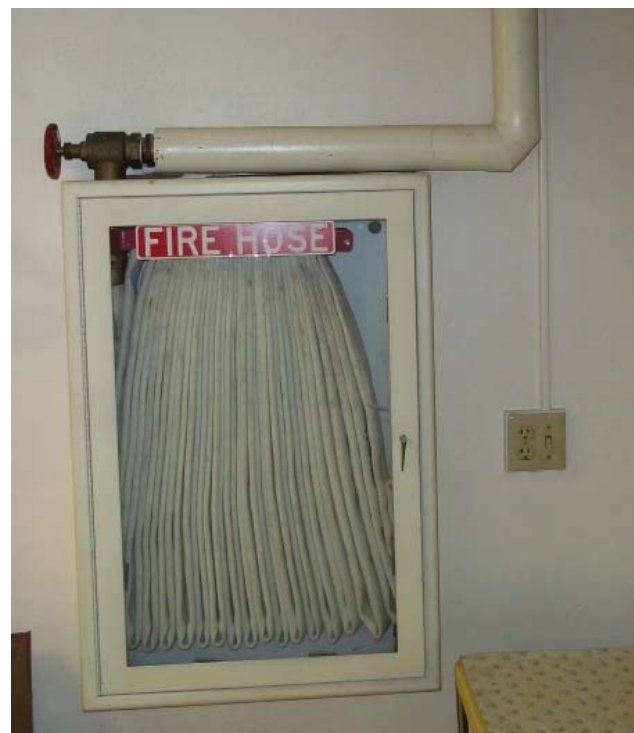
Lower level fire hose. (2012)
