Southside Senior Center
La Crosse, Wisconsin

6 September 2012 ARCHITECTURAL AND ENGINEERING ANALYSIS

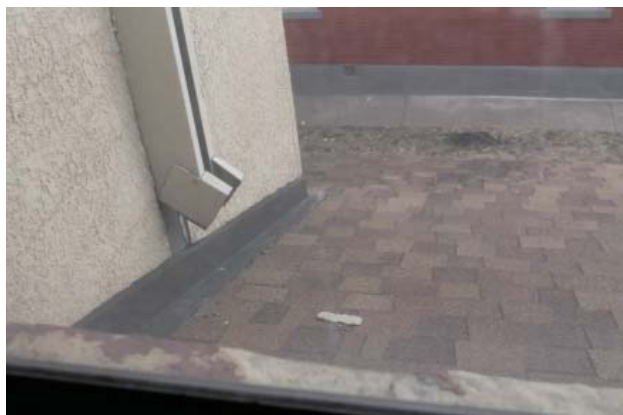
Roof over storage addition (damaged sill in foreground). (2012)

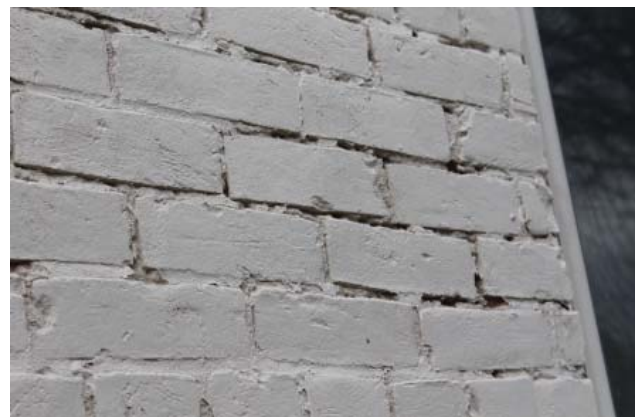
Typical painted brick condition. (2012)

The exterior brick walls of the original building are showing their age and need maintenance. All four sides of the original structure exhibit deterioration of the brick, limestone, and mortar due to weathering, water infiltration, and age. At some point in the history of the building the exterior brick has been painted and this paint is now chipped and peeling. The lower portion of the west wall has had tuckpointing and paint removal work attempted, however, in the process the cleaning has marred the surface of the brick face. Many of the lower level limestone sills have been correctly replaced. Our recommendation

is to replace the rest of the excessively deteriorated limestone sills, the spalled and damaged bricks, and be even more careful with the paint removal process to clean and tuckpoint the grout joints on all the affected walls. The lower level of the north facade of the building has an applied stucco ashlar pattern faux stone. This is severely stained, cracking, and starting to fall off of the building. Its removal to return the building to its original appearance should be investigated. The concrete masonry unit walls of the 1977 addition have an applied EFIS coating. This surface is severely cracked and separating from the substructure, and there are no signs of expansion control. It is our recommendation to install movement control joints as required then affix expanded metal lath with anchors back to the CMU substrate and cover with a stucco system with an acrylic topcoat. It was not pos-

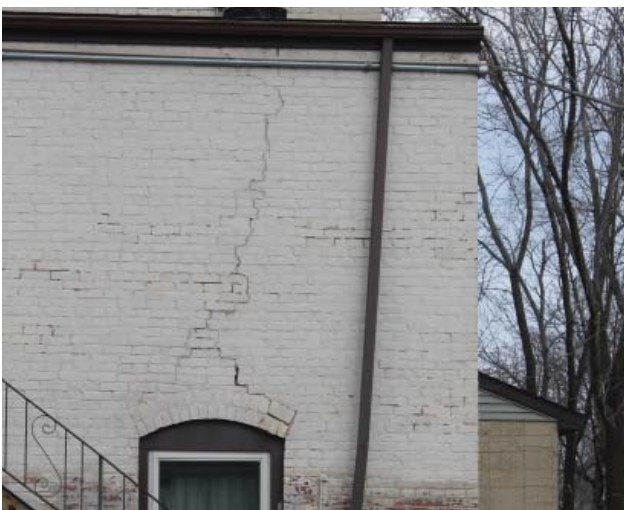
Condition of brick above south east window. (2012)

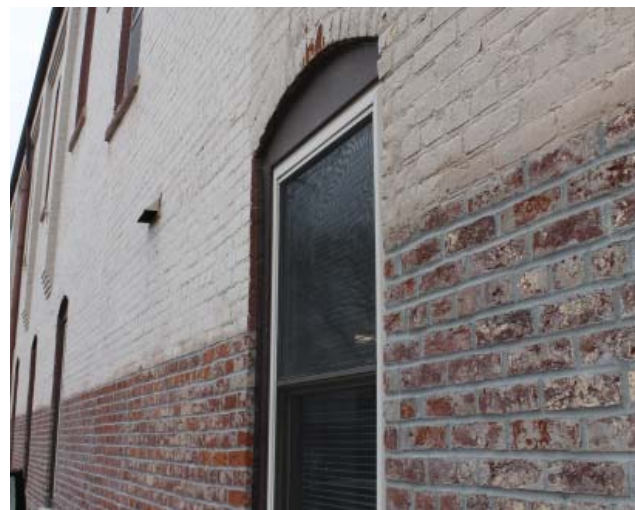
Cleaned and re-tuckpointed brick. (2012)

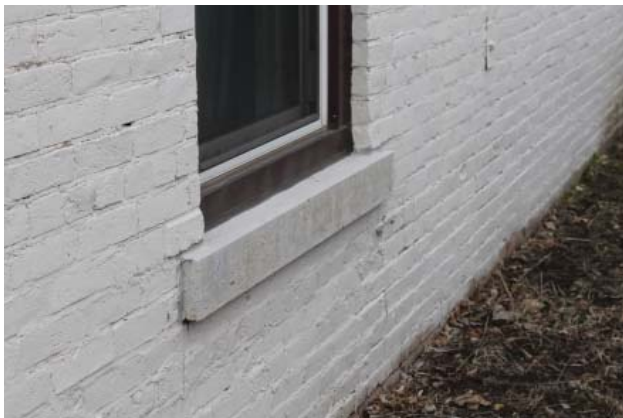
New stone sill in painted brick wall. (2012)

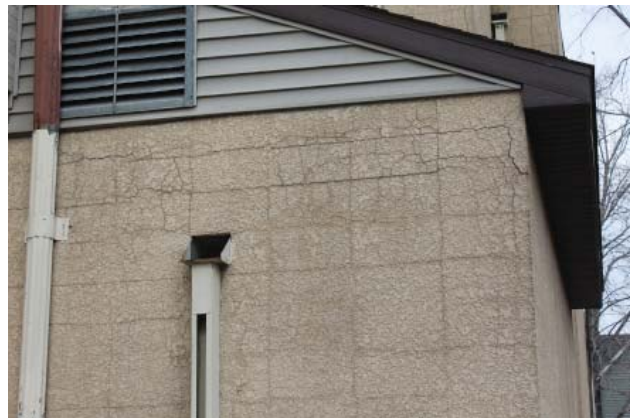
Cracked EFIS walls of 1977 addition. (2012)

- is deteriorated, which is visible by the accumulation of mortar dust pile up around the edge of the foundation.
5. The elevator, exit stair, and storage structure addition on the east side of the building are constructed of masonry bearing walls and cast in place concrete floor structure and steel bar joist roof. These are structurally appearing to be in good condition. The exterior stucco on these areas is in poor condition and requires repair.

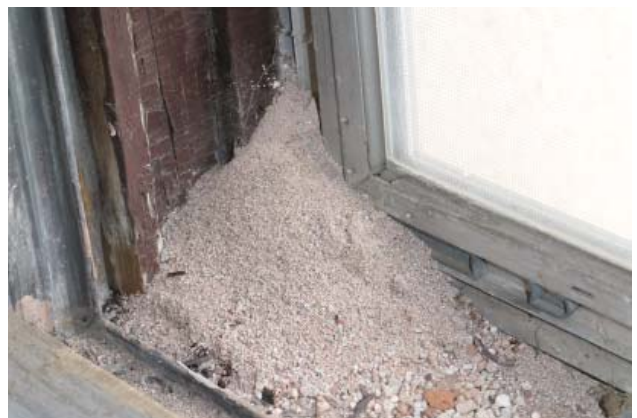
Brick debris at interior of second story window. (2012)

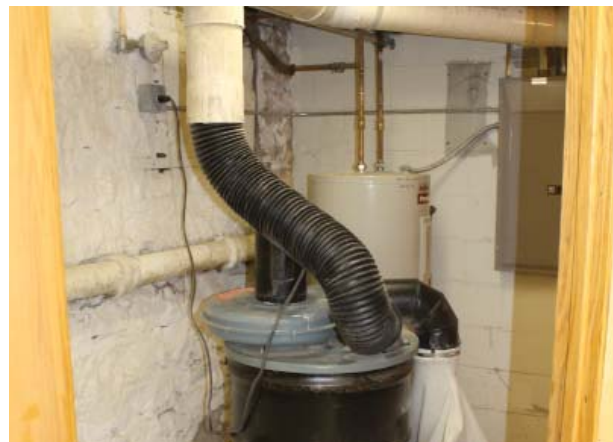
Mechanical room located under central egress stair. (2012)

Under the central stair a mechanical room is located. This space should be separated from the stair and adjoining spaces by a minimum one hour fire resistant barrier, including a rated door, as it contains electrical panels, a water heater, and a dust collection system terminus. The walls of this room are comprised of three different systems; concrete masonry units (CMU), the original stone exterior foundation

wall, and a gypsum board wall. Penetrations through these walls are also unprotected. The frame on the door to this room is split at the head and should be repaired.

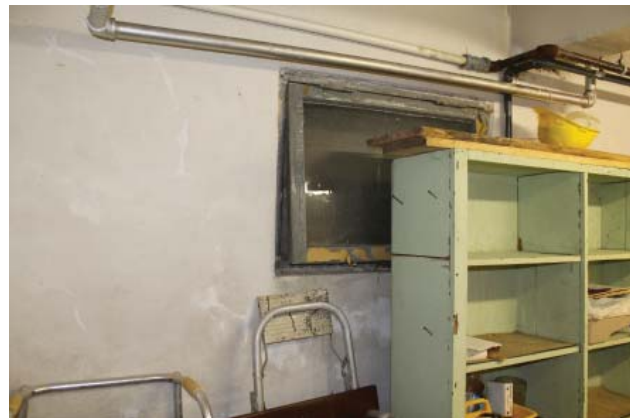
South west storage room, exterior window. (2012)

The storage room in the south-west corner of the basement still has one of the exterior windows intact along the west wall. This opening has been infilled to the exterior and the window glazing should be removed. The door frame trim is almost completely missing in this room.

This minor repair should be completed. There is also unenclosed pipework and valves within this space. Exposed ductwork, piping, and conduits throughout this level should be considered for enclosure as they are run along the open ceiling structure. Infilled windows in this space are not visible but presumably the original window fenestration has been removed.

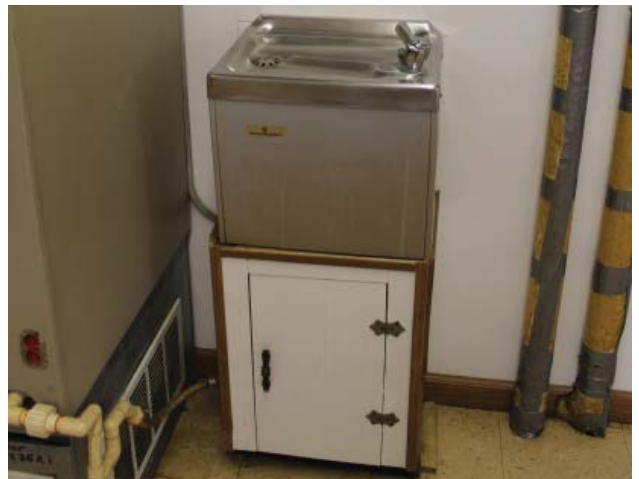
Inaccessible drinking fountain. (2012)

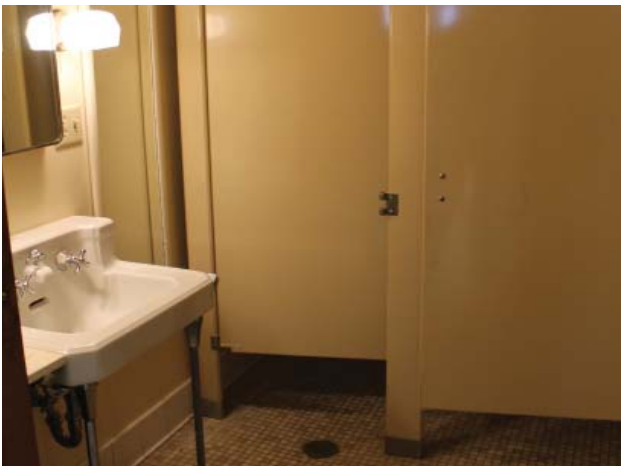
Out-dated and inaccessible first floor restrooms. (2012)

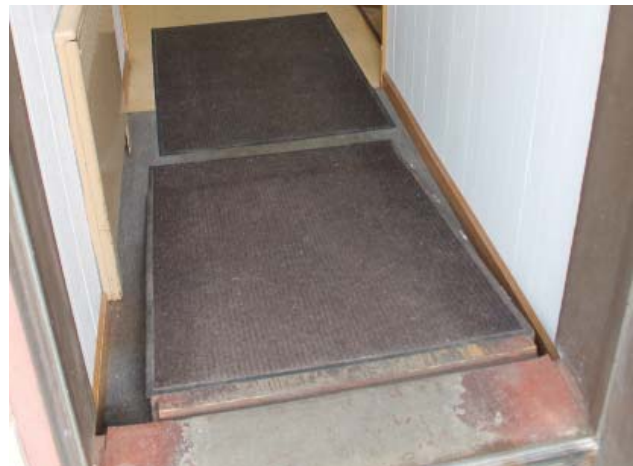
The corridor to the south exit is in fair condition generally. The exception to this is the temporary ramp that has been constructed to get through this required exit door. This ramp should be constructed

"Temporary" ramp at rear exit. (2012)

as a permanent part of the building meeting code requirements for such a ramp.

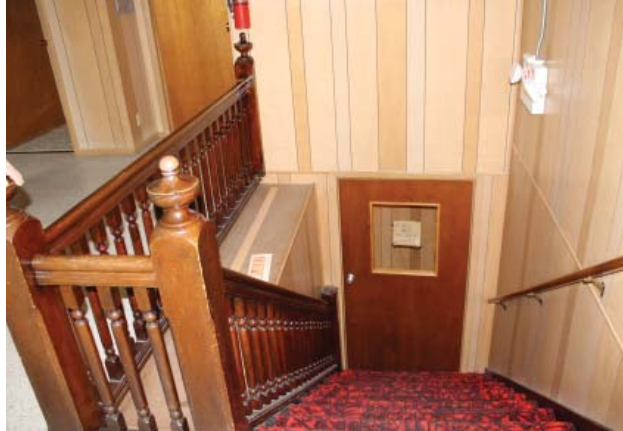
Added enclosure to central stair from second floor. (2012)

The original stair to the second floor is in good condition from the first floor to the first landing and overall has retained its historic integrity to this point. However, from this landing upward code violations and infill construction have altered this stairway. This stair is currently designated as the second means of egress from the second floor. The stair if not a required exit does not need to be enclosed. The enclosure that has been constructed violates code requirements for landings at stairs in the location of the door and is not a rated enclosure.

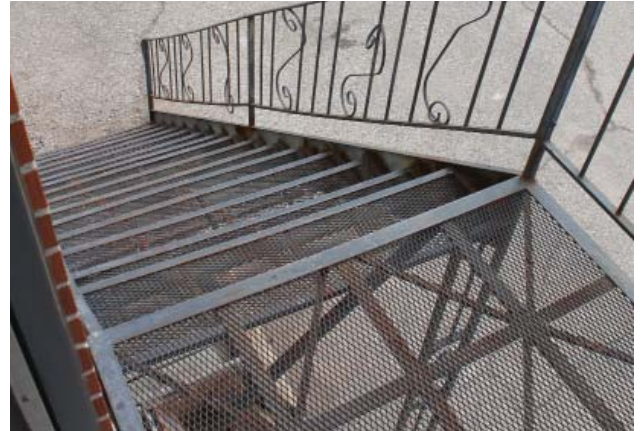
Fire escape stair at south end of building. (2012)

The fire escape (exterior stair) is in fair to poor condition. The handrail requires replacement or repair. The bottom tread is not evenly spaced with the others posing a possible tripping hazard. The treads are all

showing rust at the stringers. The exterior door at the top of these stairs is in need of repair/replacement as well. The bottom of the door has rusted through and prevents proper closure posing a security issue as well.

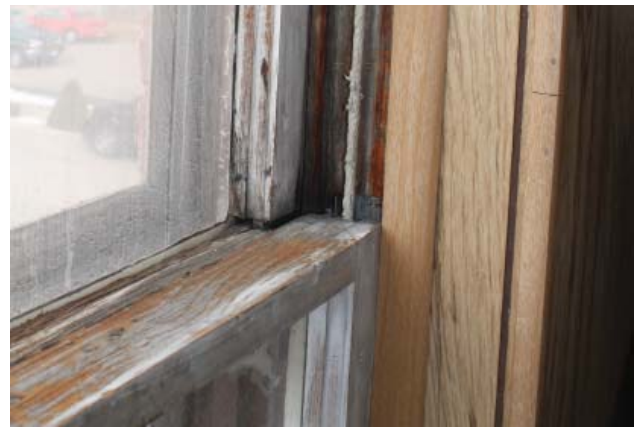
Typical window condition on second floor. (2012)

The window in this room, as with those throughout the rest of the floor, as discussed in the envelope section, are original and in need of repair or replacement due to lack of maintenance.

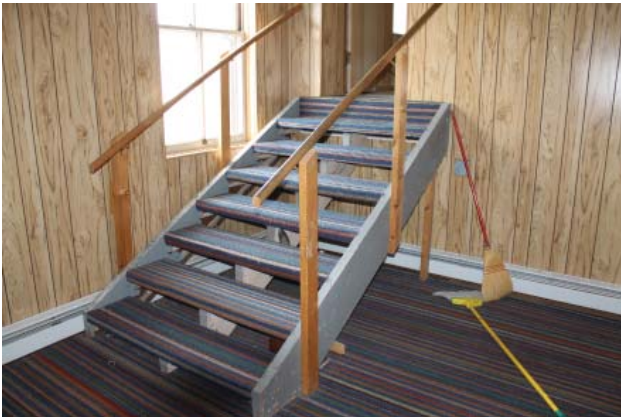
Stair from south meeting room to second floor hall. (2012)

The stair from this lowered meeting room floor to the main second floor hall is also not code compliant in its open risers, tread finish, or railings. This stair should be completely reconstructed to meet code

minimums. The entrance to this room from the hall has a low head height and a new door and frame should be installed.

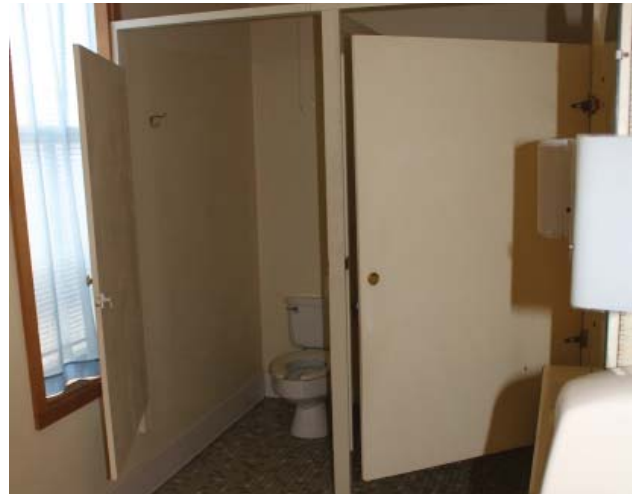
Partition obscuring restroom window. (2012)

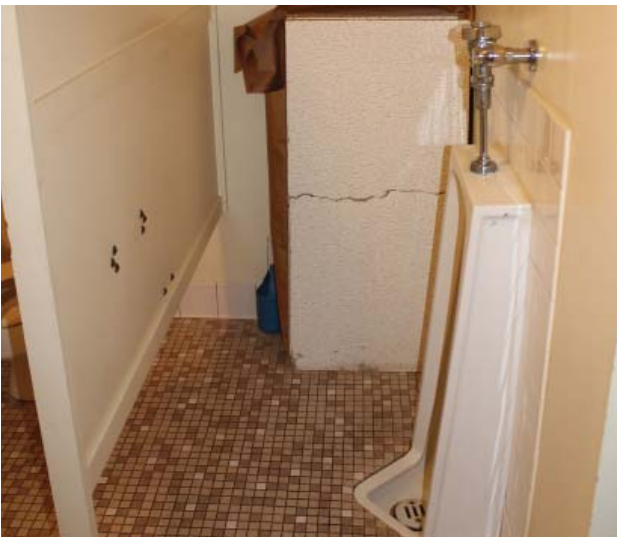
Men's room used for building material storage. (2012)

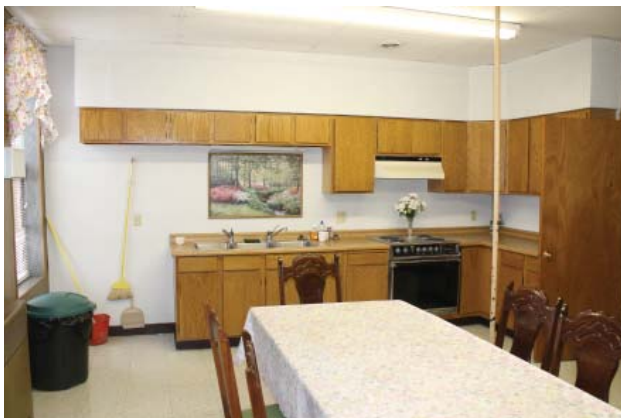
Second floor kitchen with vertical tie rod. (2012)

Across the hall on the eastern half of the central section of the building is a second kitchen. The paint on this structural element is chipped and should be repainted. The entire length of the north wall of the kitchen has built in storage cabinets constructed of wood frame and paneling. The rest of the room is in good condition with dated fixtures, appliances, and finishes.

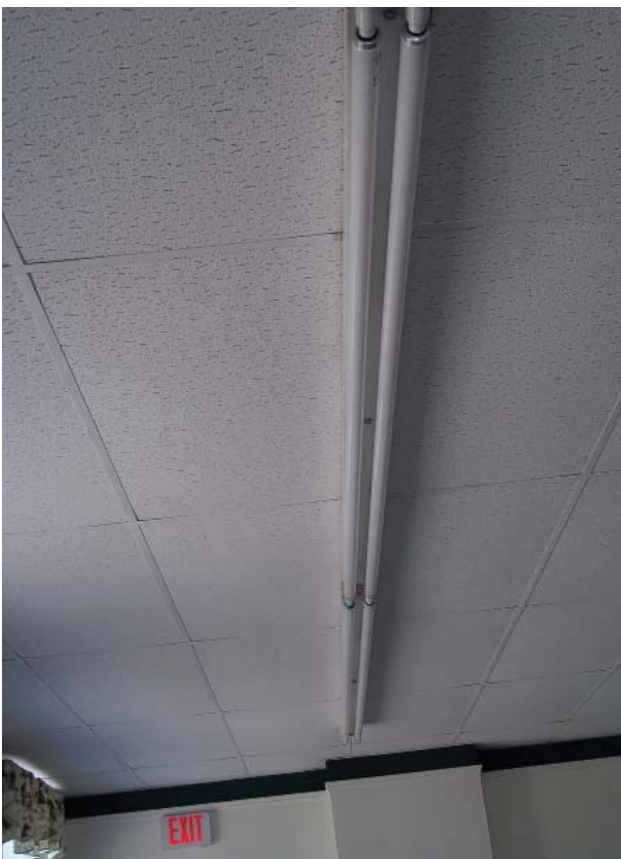
- A. Most of the lighting fixtures within this building are old and simple in form and construction. Fluorescent strip lighting using T12 lamps are the dominant lighting.
- B. Switching is entirely manual. Switching is simply – typically one switch per room. Switches are showing some age and probably should be replaced as time and budget permit.

Typical fluorescent strip lighting. (2012)

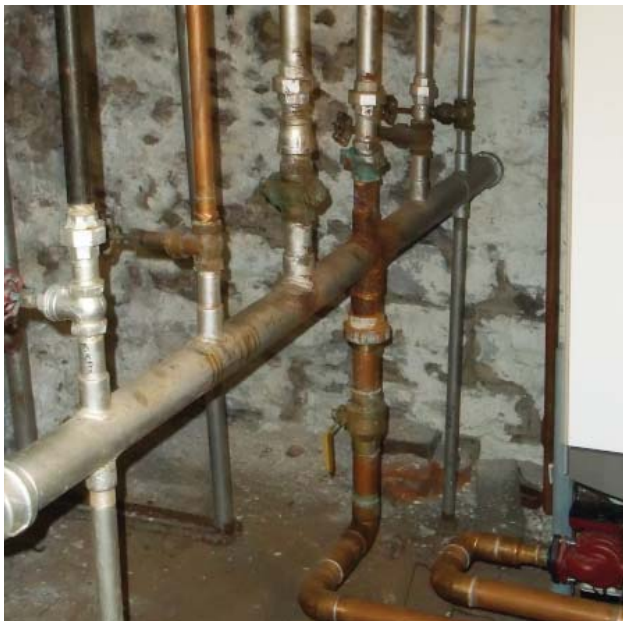
- C. Although the boiler is new, most of the existing piping, valves, and heating specialties were left in place. Many of the isolation valves are old gate valves, which likely do not seal water-tight anymore. A conventional expansion tank, without a gauge glass, was retained. The original water specialties were left in place. It would have been better to update these devices when the boiler was replaced, but they are easy to replace in the future if they fail.

Older piping and valves for heating system. (2012)
