# Assessment of Condition and Maintenance of Public Art La Crosse, WI 2021

On-site inspections completed by Luke Achterberg, Adam Oldre, and Michael Martino

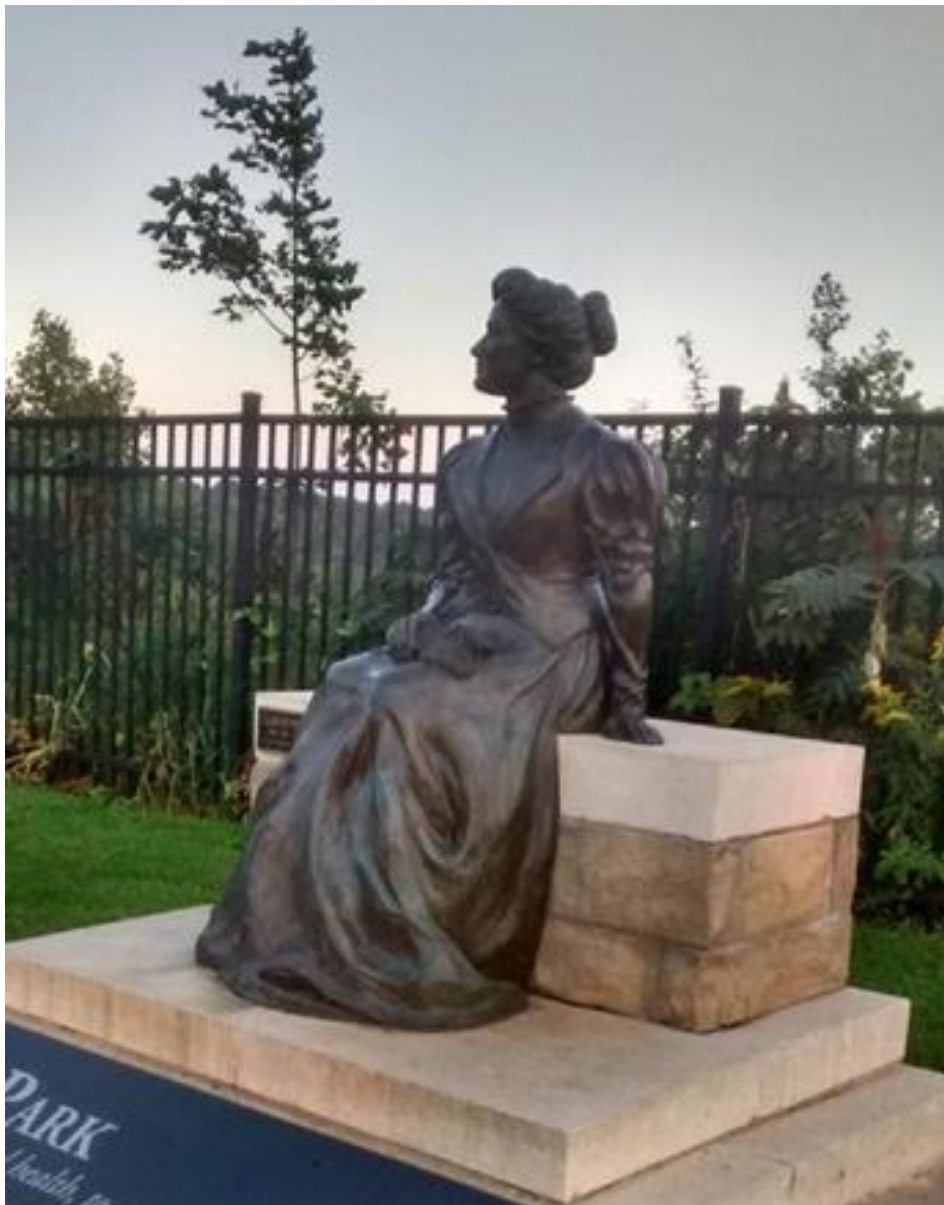
# ELLEN HIXON

- Condition – Good
- Some oxidation of the patina (green color).
- Lots of tourist activity with people sitting and taking pictures.

- Inspect once a week during peak tourism, (May through September), for any wear or damage from human interaction.

- Inspect, clean, and wax annually. On a hot day, clean with warm water and mild soap and wax with Renaissance Wax and buff. Estimated cost: \$140.

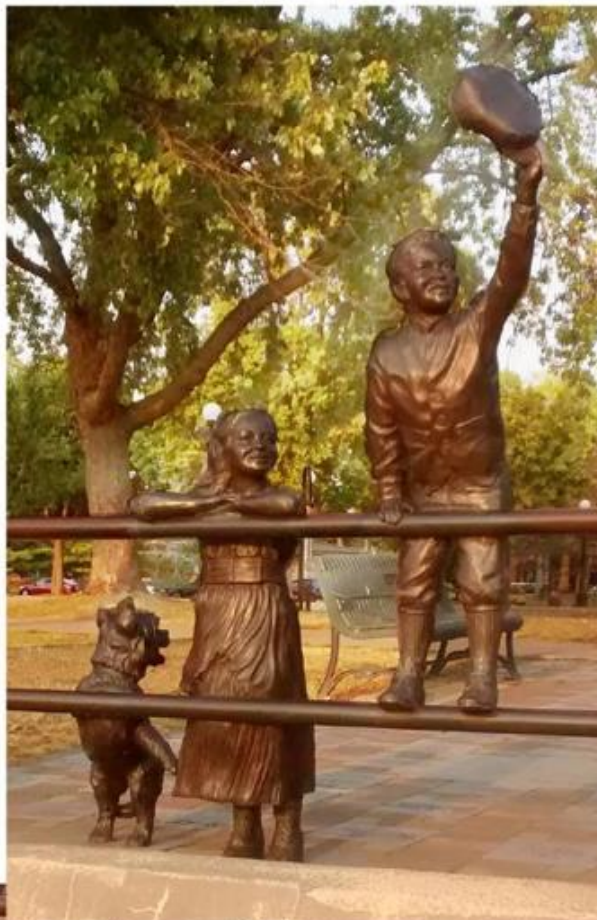
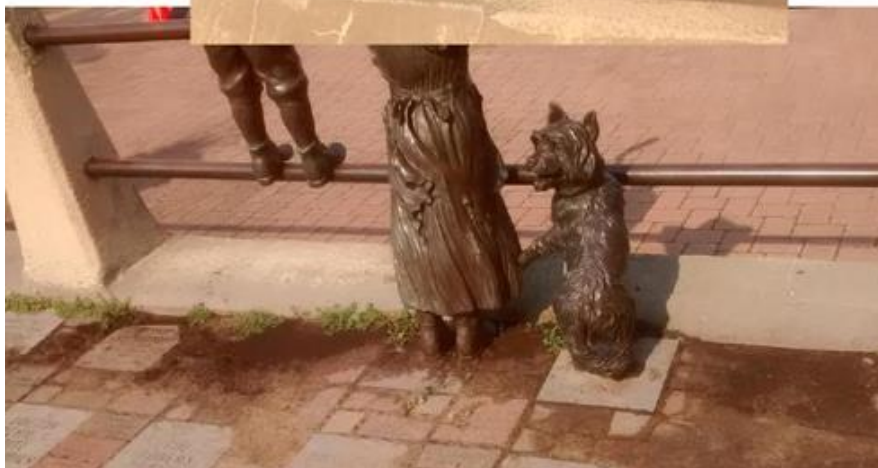
# A Simpler Time

- Water, dirt, and weeds at the base of sculpture.

- Remove weeds, clean around foot of sculpture.

- Inspect, clean, and wax annually. On a hot day, clean with warm water and mild soap and wax with Renaissance Wax and buff. Estimated cost: \$100.

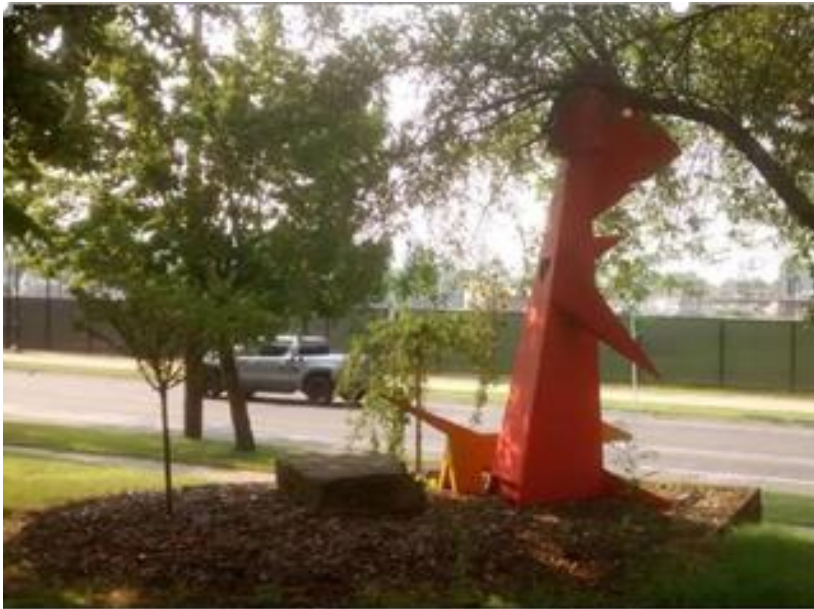
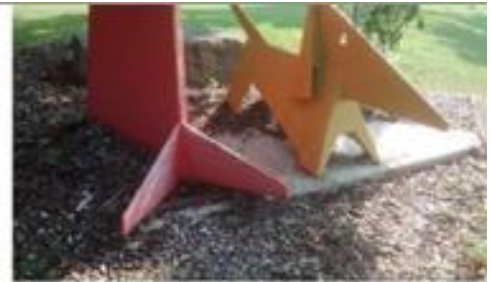
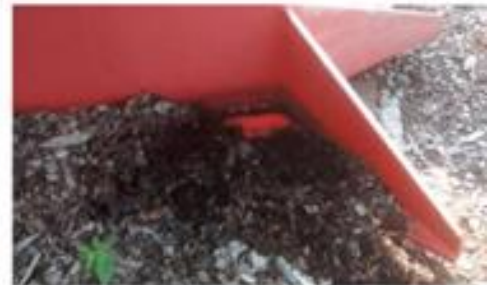
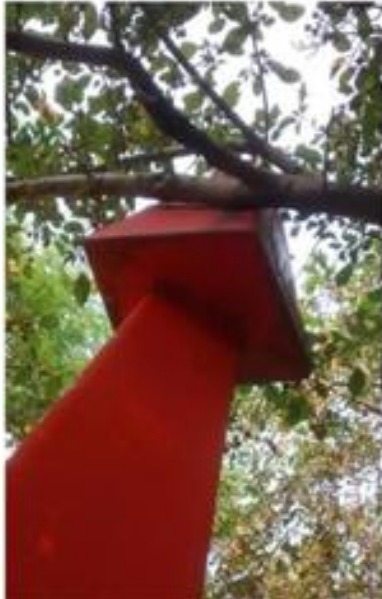
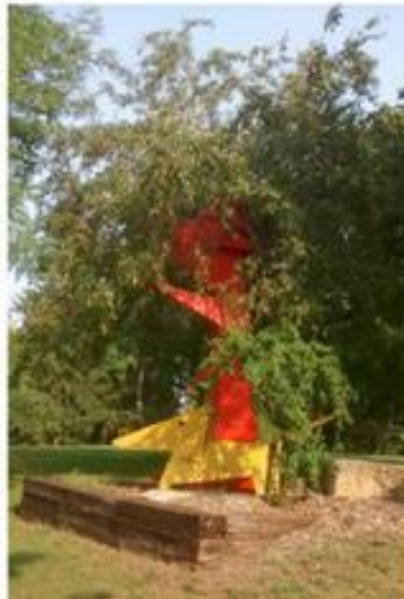
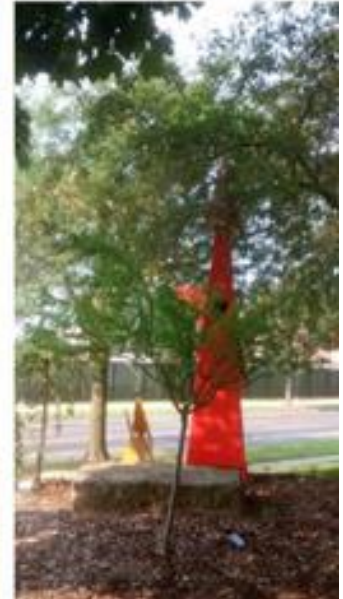
# ANIDONTS

- Paint Issue: Large branch rubbing on head of sculpture.
- Rust Issue: Mulch covering metal, some paint deterioration.
- Visual Issue: Two memorial trees planted too close to sculpture, blocking view.

- Prune tree, remove mulch from concrete pad, and move trees or remove sculpture, refinish and reinstall away from growing trees.

- Inspect, clean, and wax annually. Clean with soft cloth and check for rust and paint deterioration.
- In 2036, possible refinish and paint. Estimated cost: \$4,000.

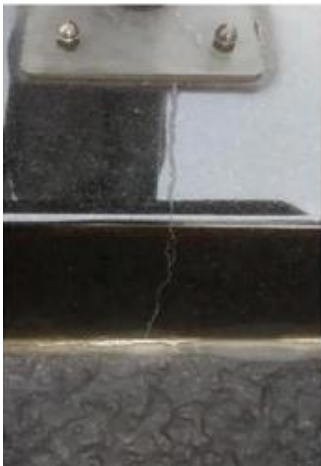
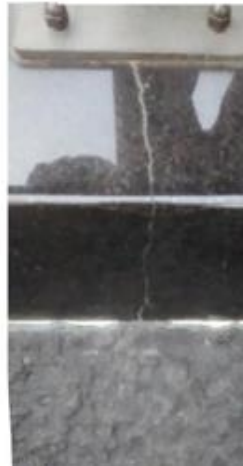
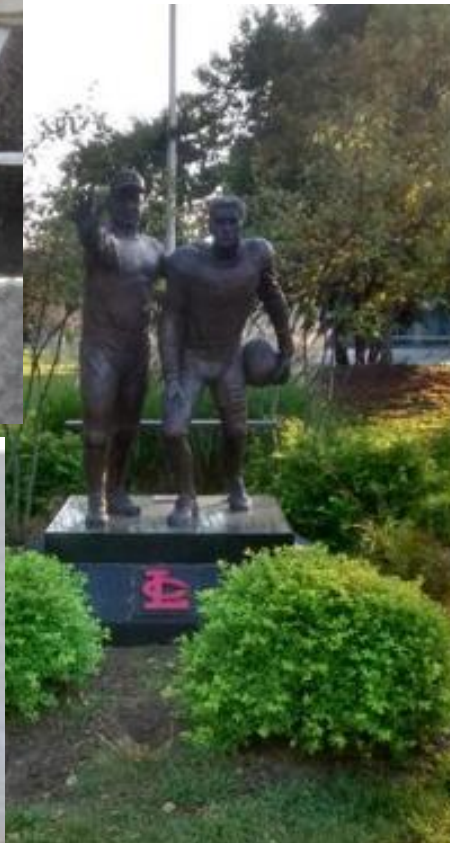
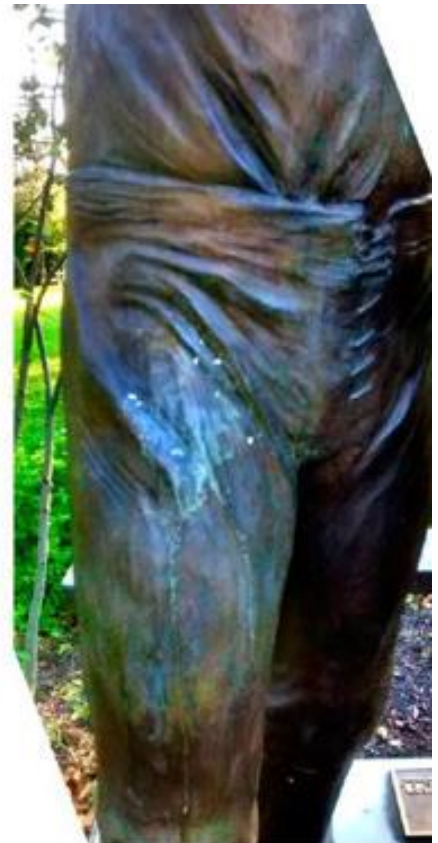
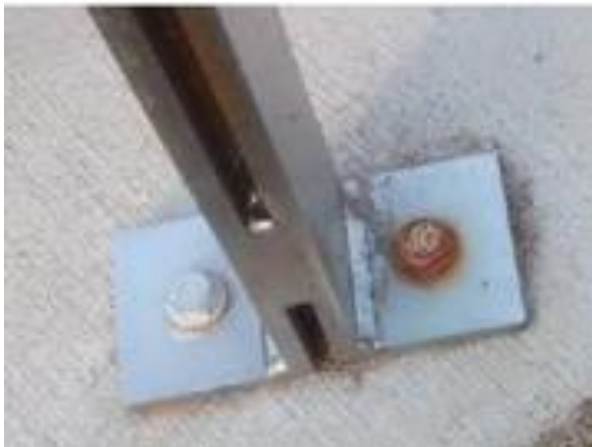
# Walter “Babe” Weigent

- The sculpture has been vandalized. It has been hit with eggs at least two times.
- Evidence of tampering with the bench which could have led to the two cracks on the back of the granite base.
- The two bushes in the front obscure the base.
- One of the bolts on one of the plaques is rusting.
- The sculpture cannot be seen at night.

- Lights need to be installed to discourage vandalism and enhance the view at night.
- La Crosse Memorial was consulted about the cracks in the granite and they recommend the cracks be filled with black epoxy.
- The bushes in front can be moved apart or more to the sides.

- Inspect, clean, and wax annually. On a hot day, clean with warm water and mild soap and wax with Renaissance Wax and buff.
- The rusting bolt needs to be cleaned and coated to slow the rusting process.
- In 2026, assess anchor rust issue. Replace with 5/5 hardware.

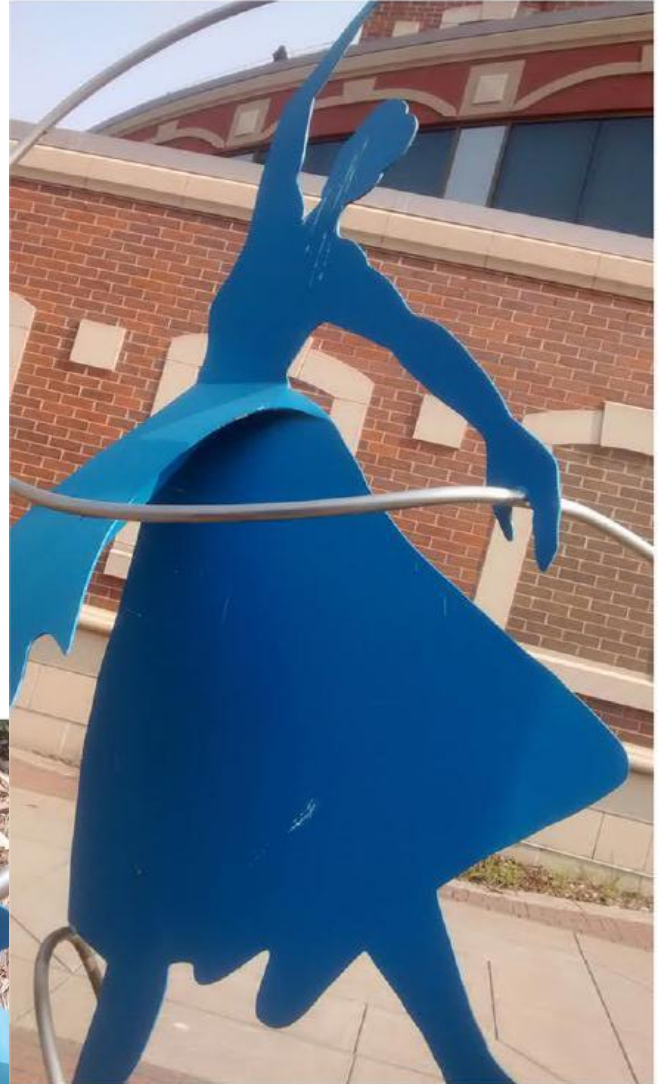
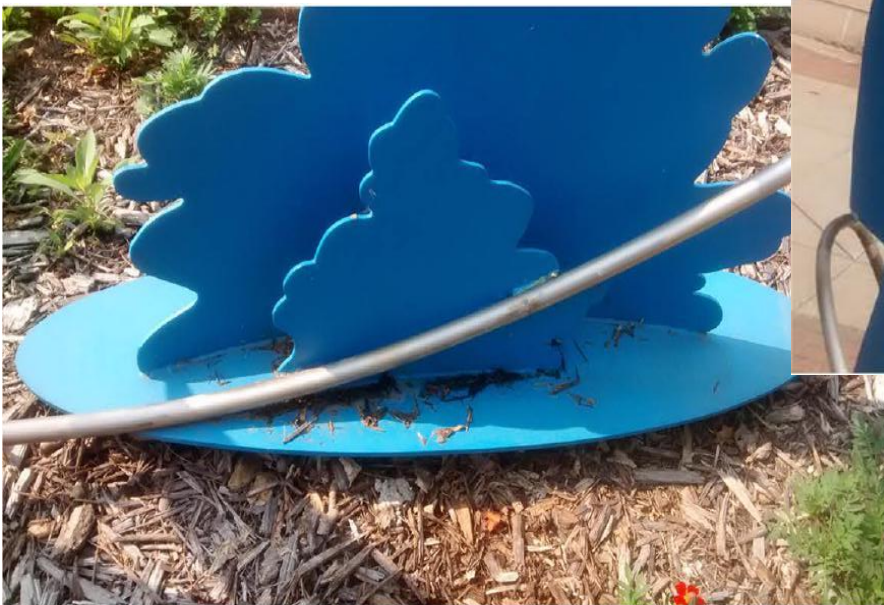
# Dancers

- Repainted in 2019.
- Estimated anchor of life 26-30 years.

- Clean and inspect annually.
- In 2046, inspect anchors and consider repainting. Estimated cost: \$15,000-\$25,000.

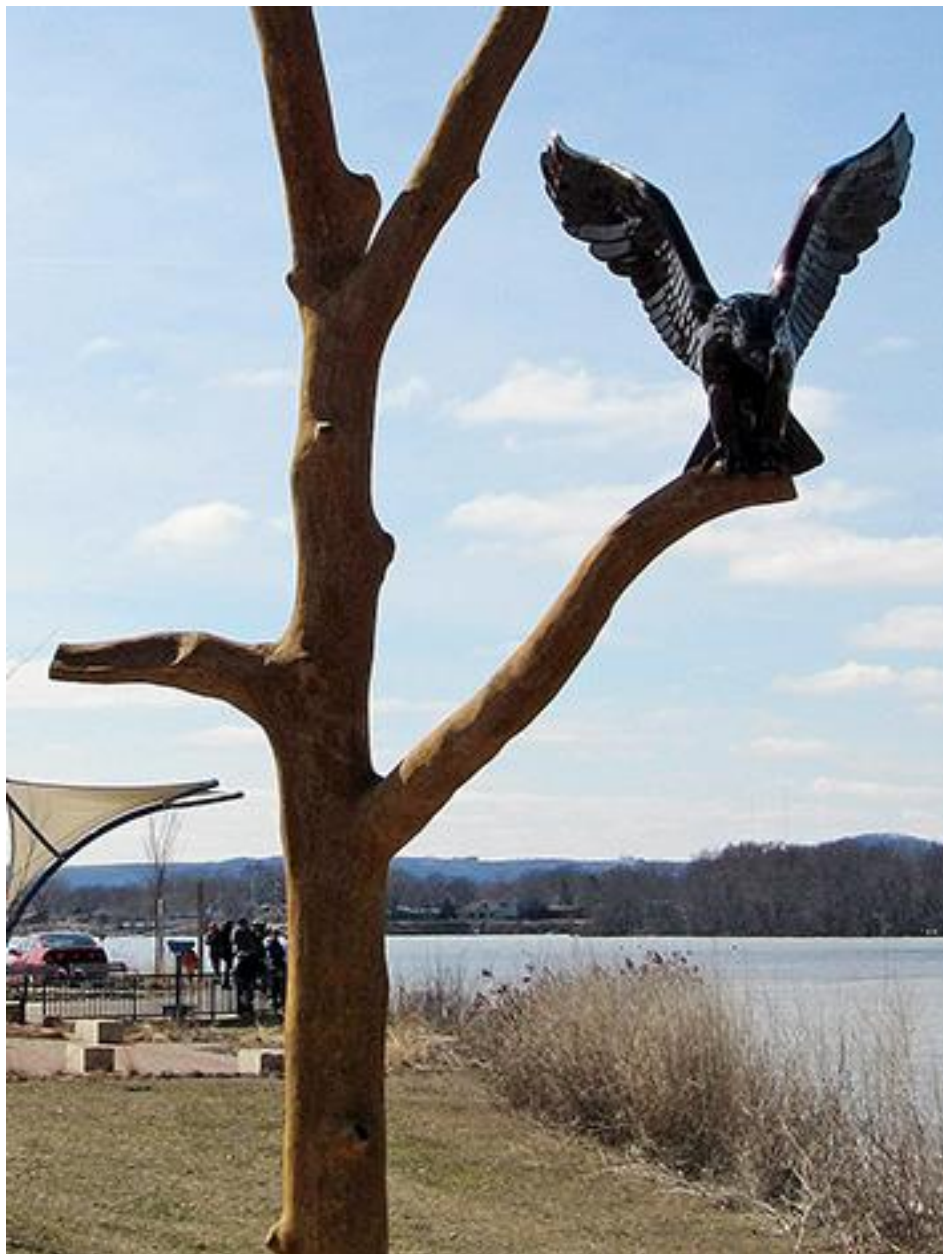
# Eagle Watch

- Condition-Good.
- Some natural cracking of the wood.

- Take note of the cracking in the tree to make sure it is not affecting the structural integrity of the branch on which the fiberglass eagle is bolted.

- Inspect annually.

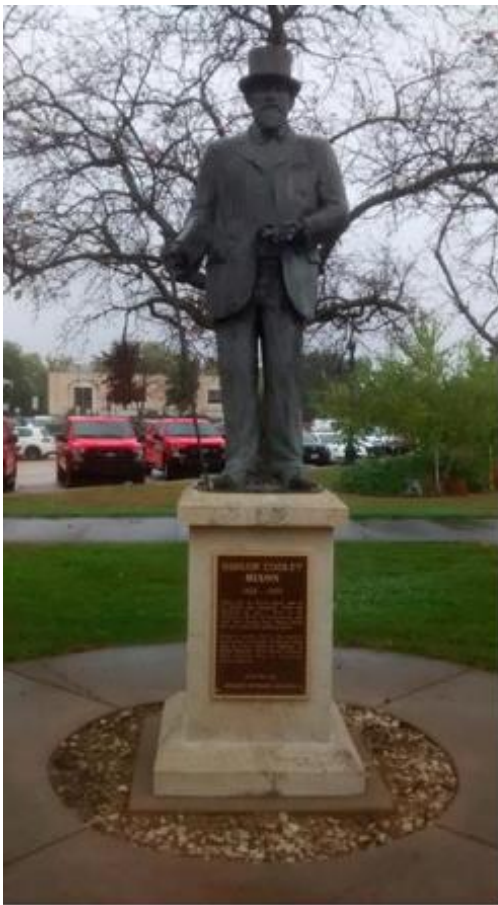
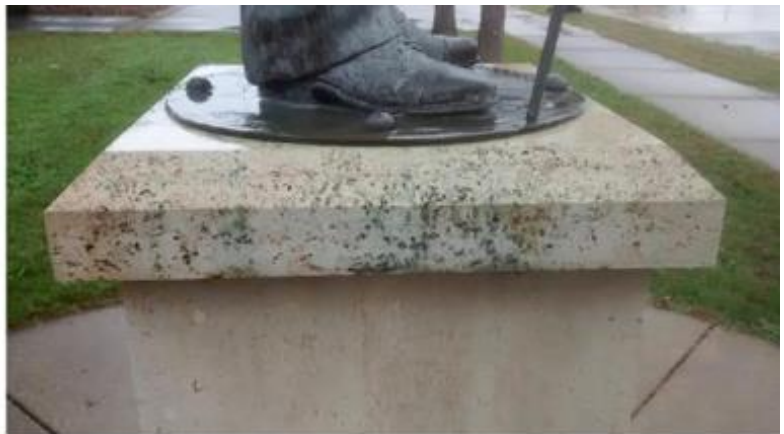
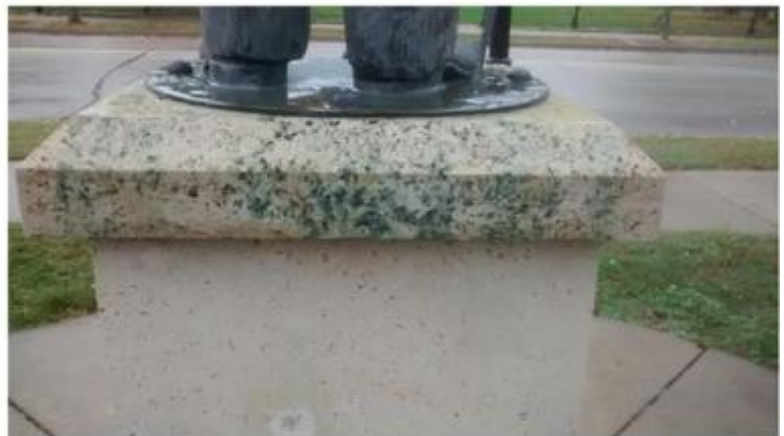
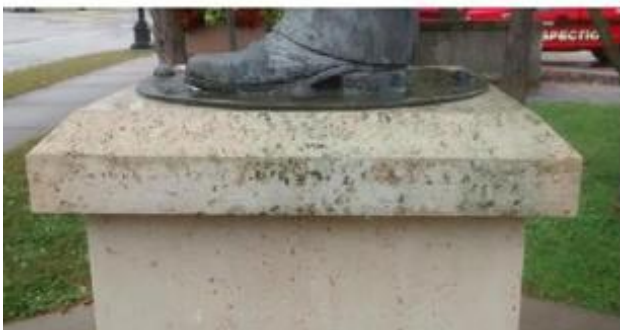
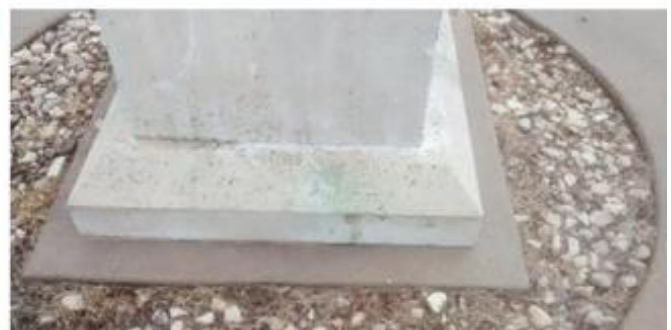
# Gideon Hixon

- Condition – Good.
- The top of the base is discolored.

- Base should be cleaned to remove discoloration.

- Inspect, clean, and wax annually. On a hot day, clean with warm water and mild soap and wax with Renaissance Wax and buff.

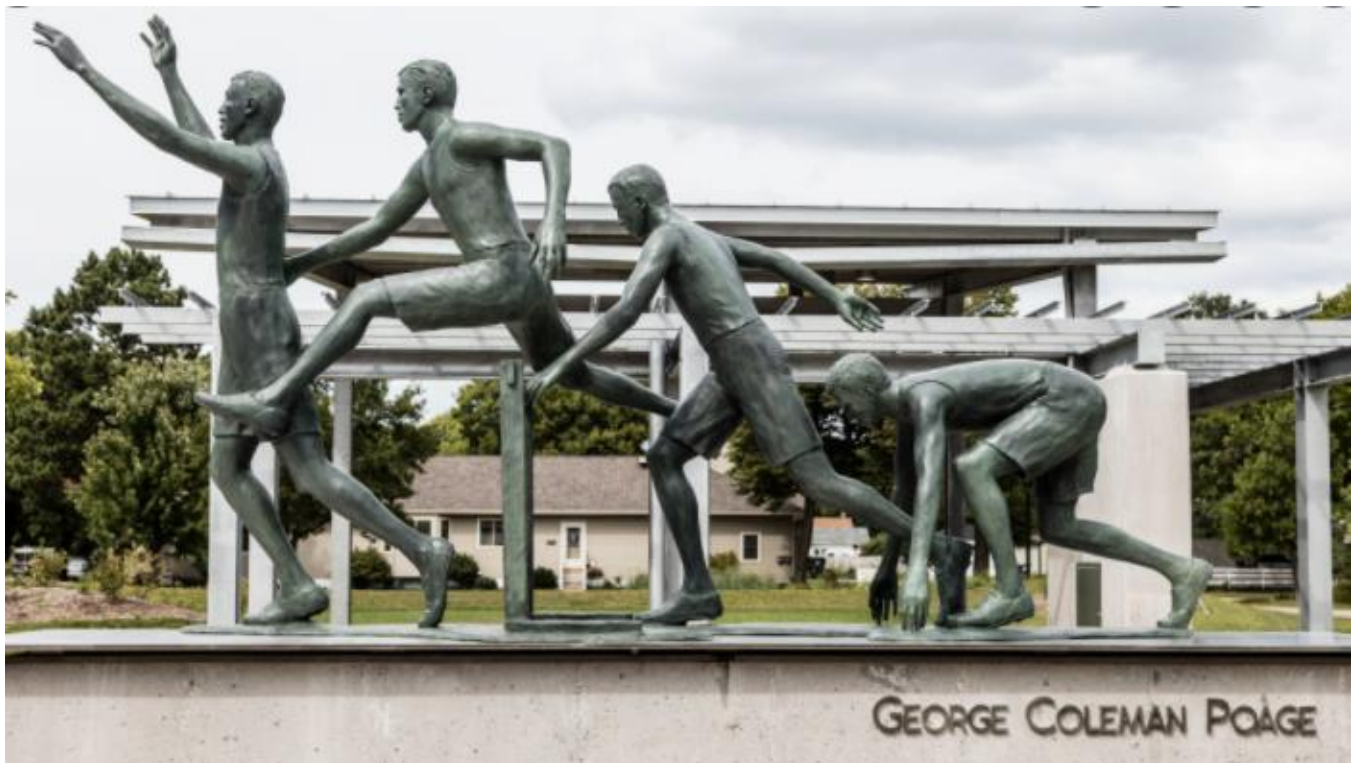
# George C. Poage

- Condition – Good.
- Bronze

- Inspect, clean, and wax annually. On a hot day, clean with warm water and mild soap and wax with Renaissance Wax and buff.
- Stainless-steel base cleaned with Weiman stainless steel cleaner. Estimated cost: \$400.
- In 2031, inspect base for cracks.

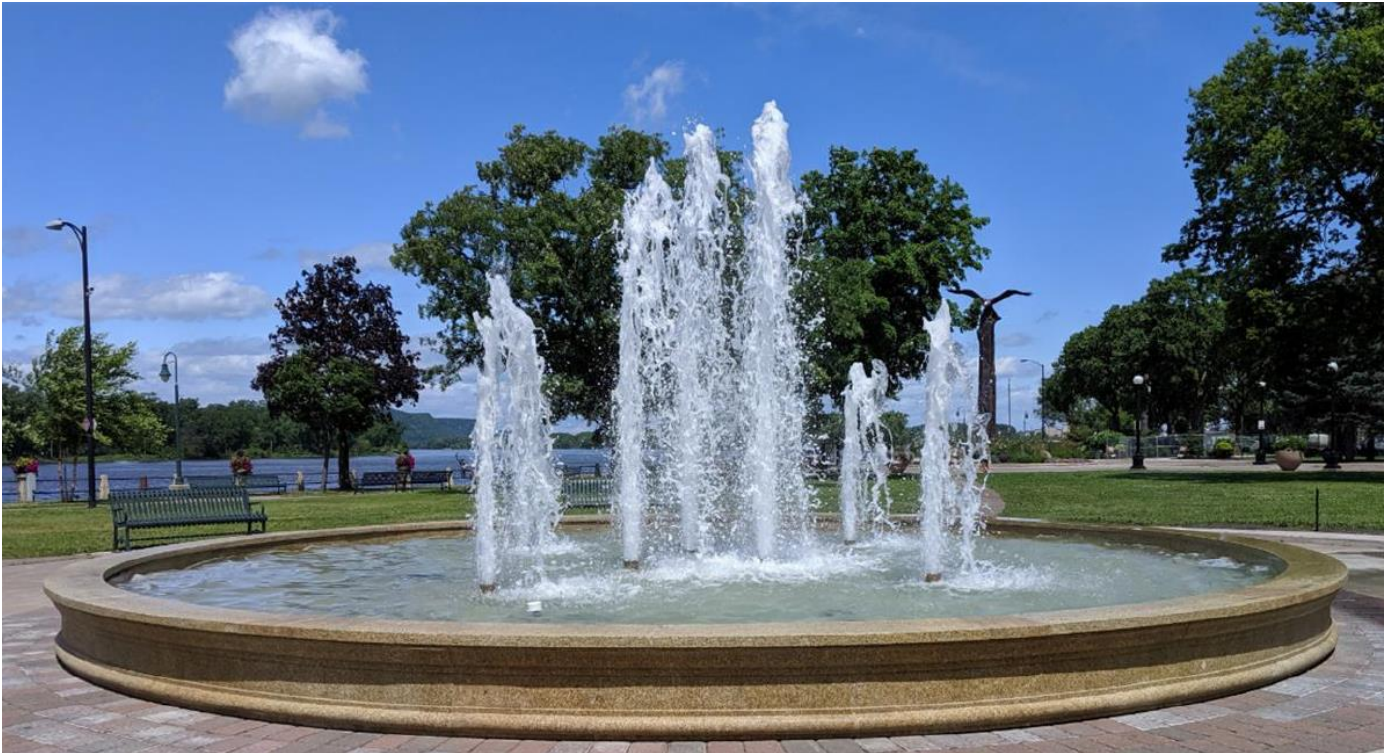
# Hoeschler Fountain

- Condition – Good.
- Bronze letters embedded in the concrete.

- Inspect annually. Consult a plumbing contractor for upkeep.

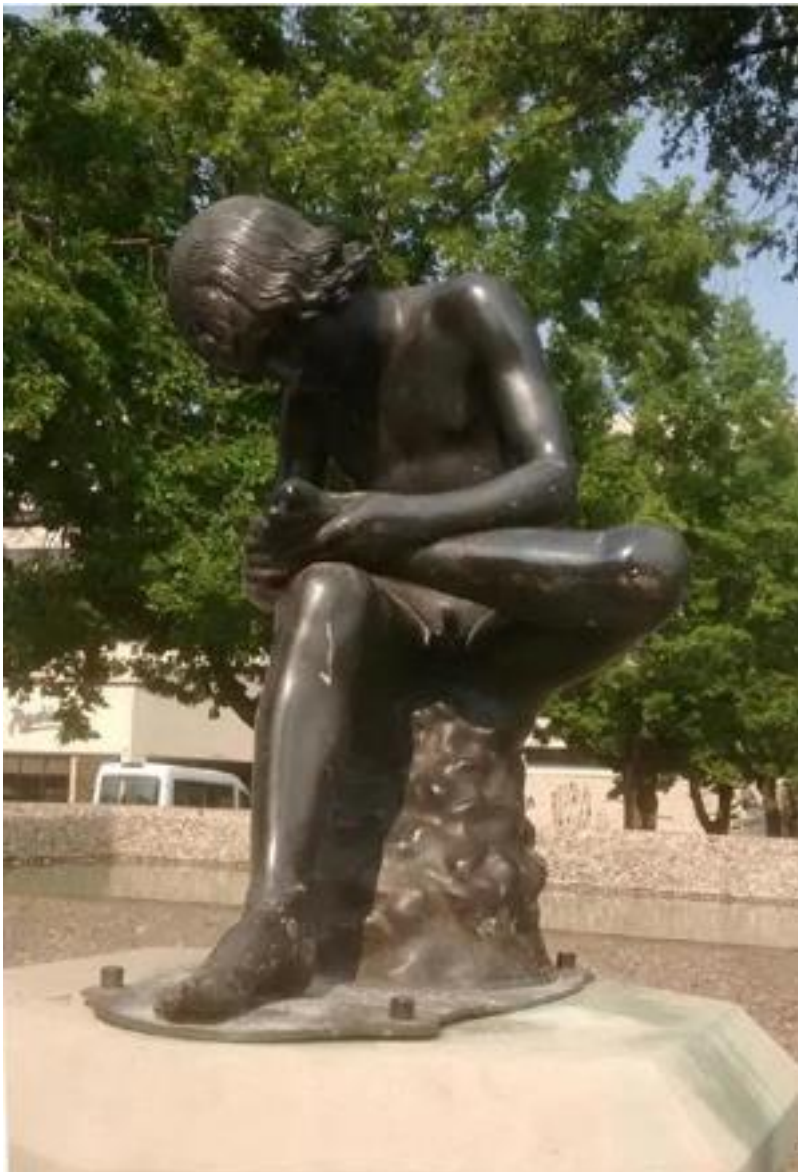
# Le Pineau

- Condition – Good.
- Some staining on the base due to run-off from the figure.

- The wax will seal the surface and reduce the run-off that stains the base.
- To clean the base, make a paste of one part by weight of dry powdered ammonium chloride and four parts by weight of a suitable filler such as diatomaceous earth. Form a smooth paste by adding ammonia water. Apply a layer of paste one eighth to one quarter inch thick over stained area: do not remove until dry. May take three applications. Base could also be sealed to help prevent further staining.

- Inspect, clean, and wax annually. On a hot day, clean with warm water and mild soap and wax with Renaissance Wax and buff. Estimated cost: \$50.

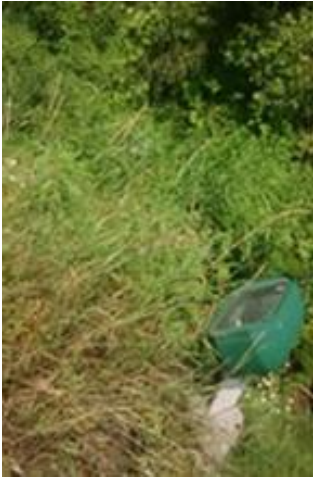
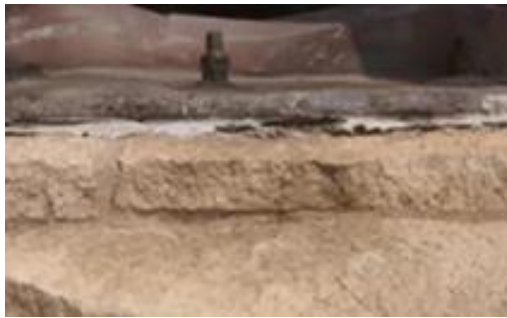
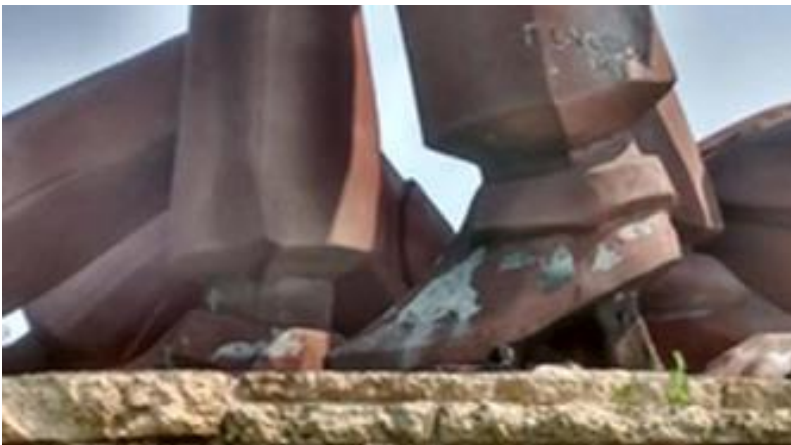
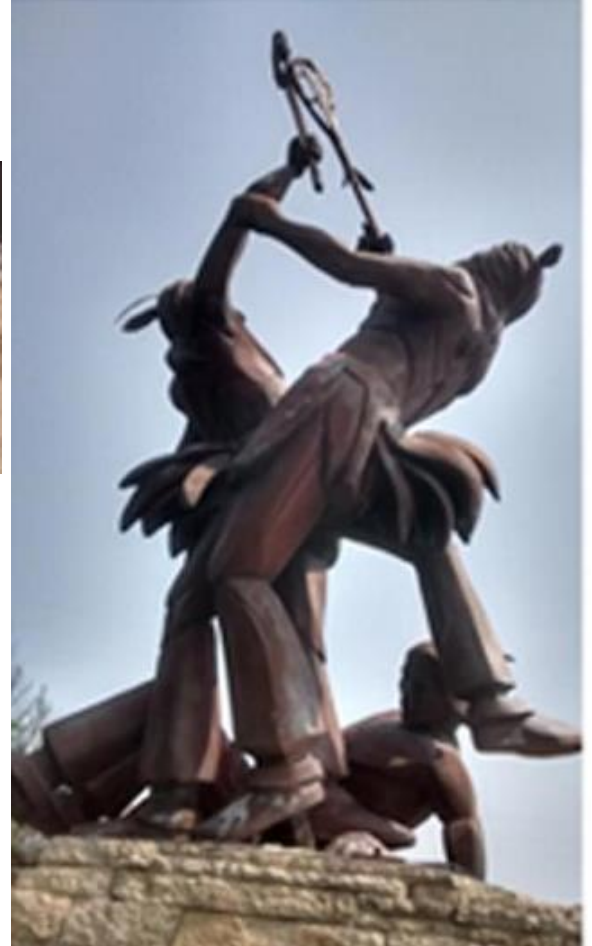
# La Crosse Players

- The paint on the sculpture is flaking in some areas; mostly the feet.
- Weeds are growing in front of the lights, blocking the light at night.
- Caulk on base is shrinking, leaving gaps.

- Clean and repaint structure.
- Remove weeds.
- Clean and re-caulk base plate.

1. Scrape and touch up flaking spots.
2. Polyurethane bronze paint. This would change the finish to a glossier metallic look.
3. Clean and repaint with Sherwin Williams dura-plate 235 Marine Paint. Life expectancy of Marine Paint is 15-20 years.

Because of the height and terrain around it, it is suggested to consult a company like La Crosse Sign Company for repainting.

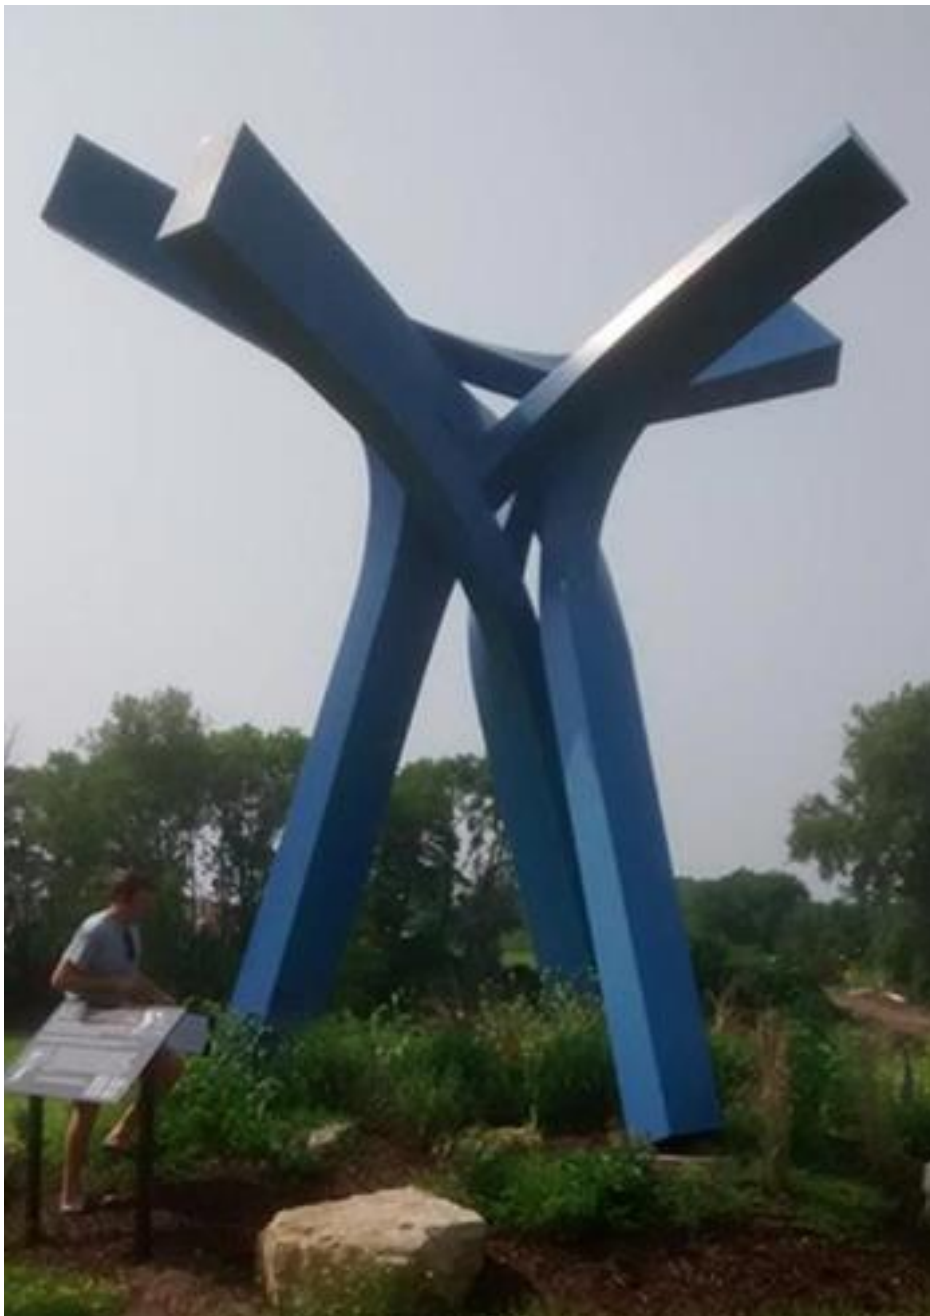
# Lyra

- Metal and paint condition-good.
- There is a visual issue with the plants obscuring the base of the sculpture.

- Remove plants or use a shorter ground cover that will not grow more than 3” high.

- Inspect annually and clean as needed.
- In 2041, repaint. Estimated cost: \$5,000.

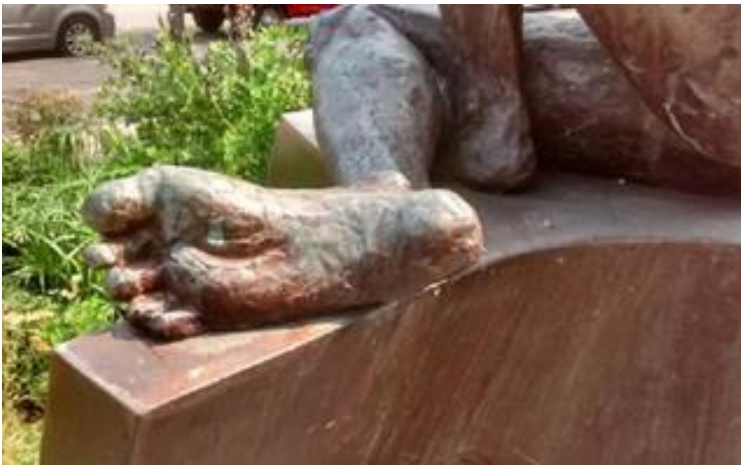
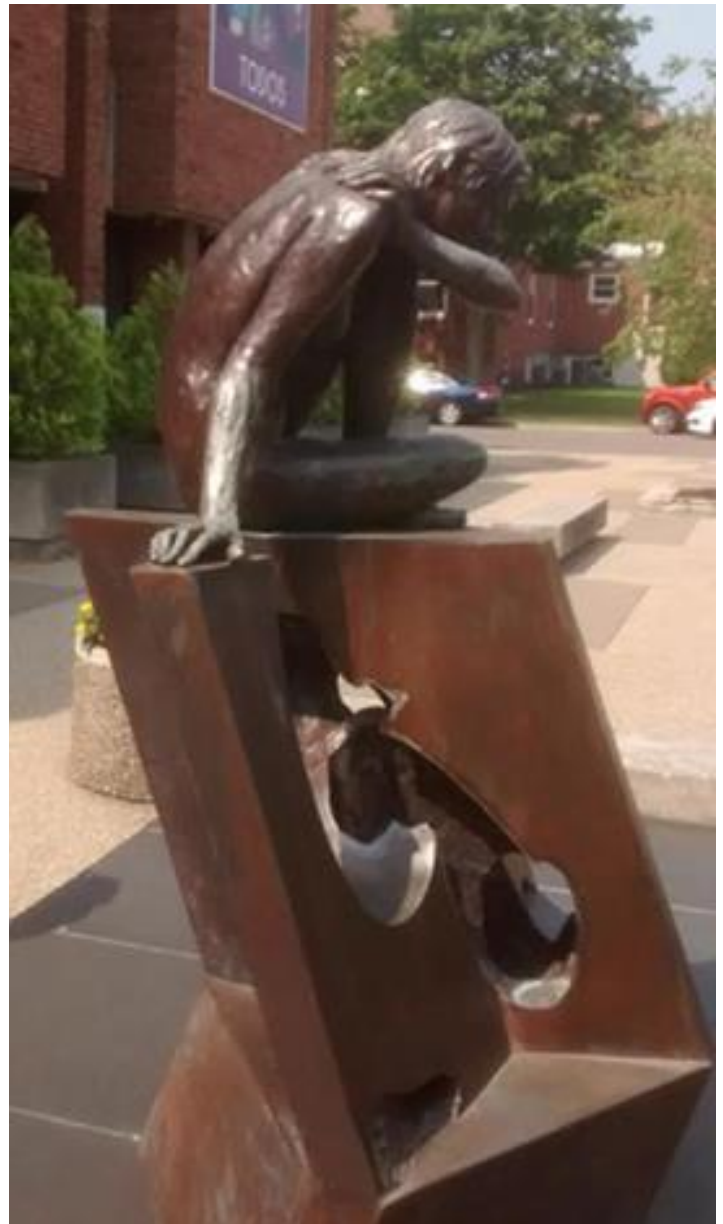
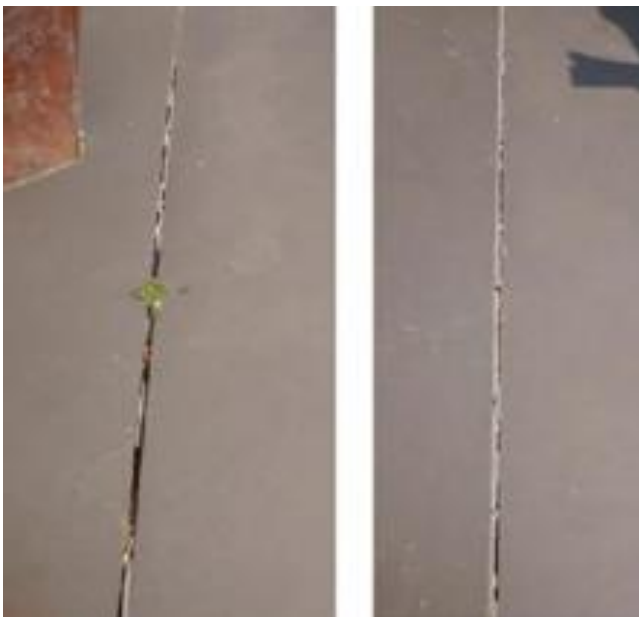
# Reflections

- The bronze figure is in good condition. It needs to be cleaned and waxed. There are gaps in the seams of the base panels. There are some areas under the base panels where the concrete is crumbling.

- Re-caulk the seams between the vase panels, estimated cost: \$50
- Repair concrete. Although the damage seems to be minimal, we recommend consulting concrete expert to determine extent of damage and best way to fix it.

- Inspect, clean, and wax annually. On a hot day, clean with warm water and mild soap and wax with Renaissance Wax and buff. Estimated cost: \$250.

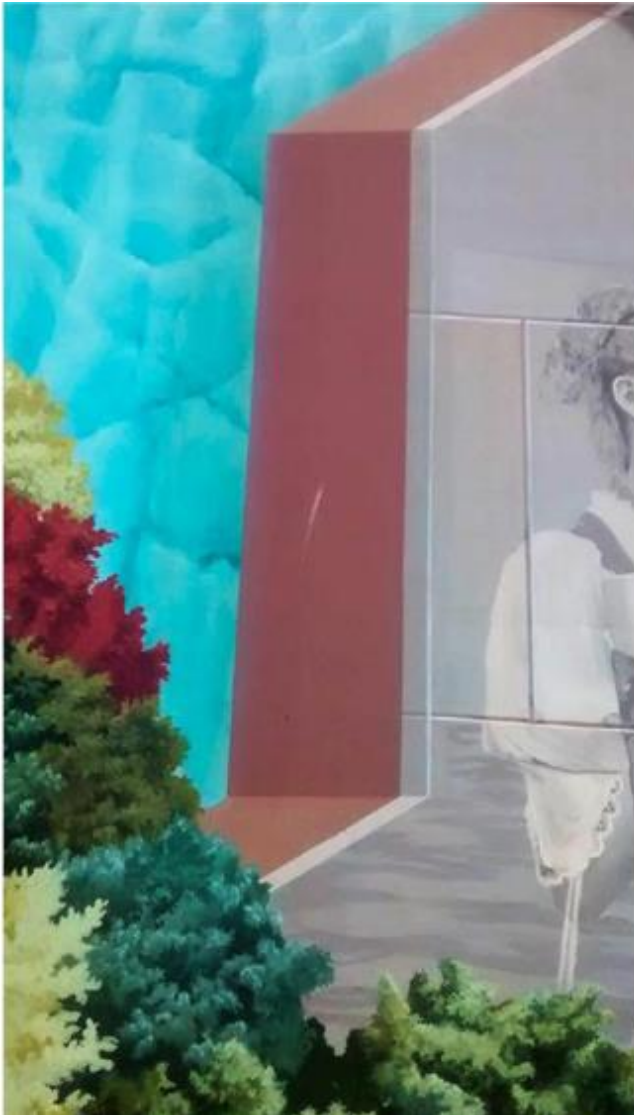
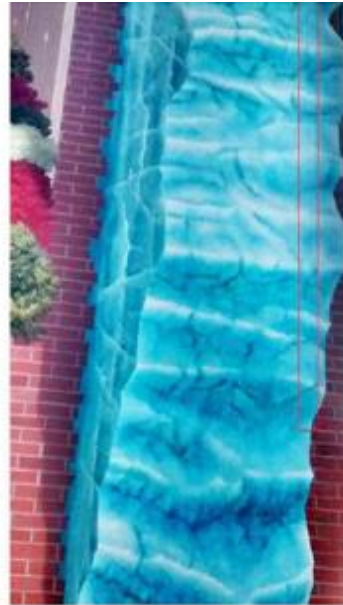
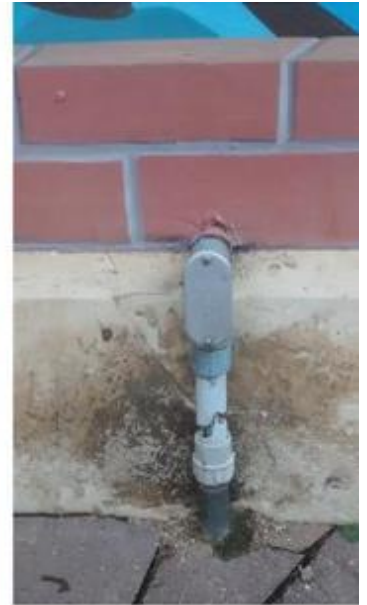
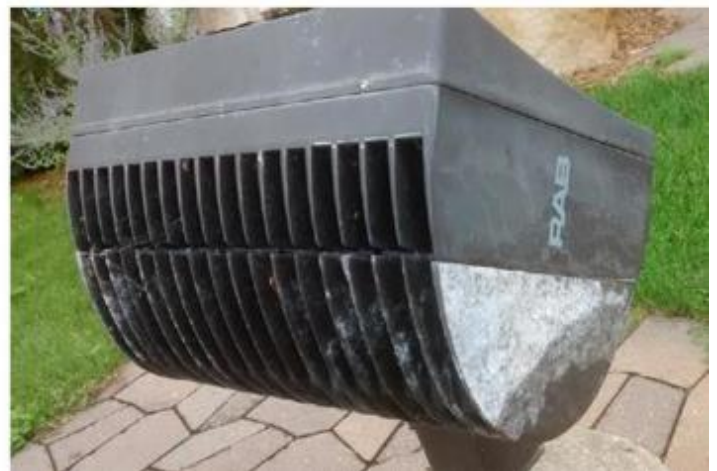
# Confluence

- Condition – Good.
- There is a small white streak on the left side.
- On the ice image on the right side, there is a very slight vertical crack.
- There is a broken conduit pipe in the center at the base on the wall.
- One of the lights is showing signs of corrosion on the outside of the metal box.

- Contact the artist, John Pugh, about proper cleaning procedure.
- Keep an eye on slight crack to see if it gets larger.
- Contact an electrician to fix broken conduit.
- Clean the corrosion on the light box.
- Inspect and clean every five years.

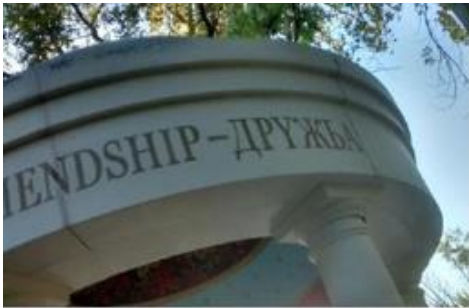
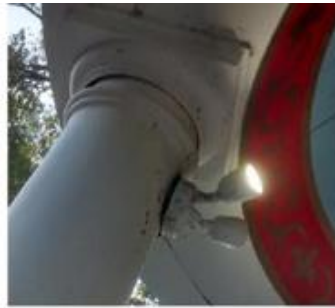
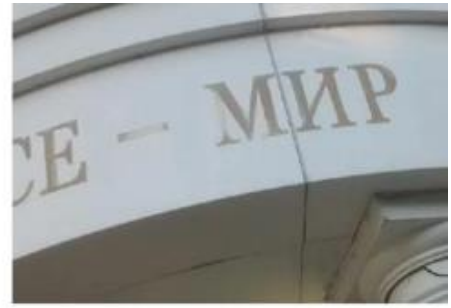
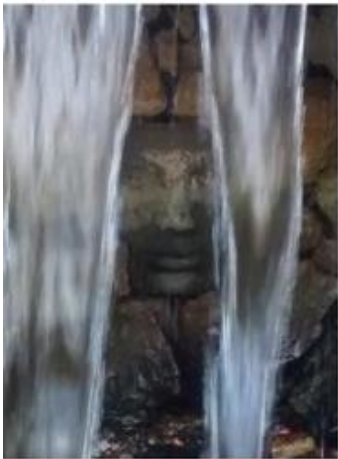
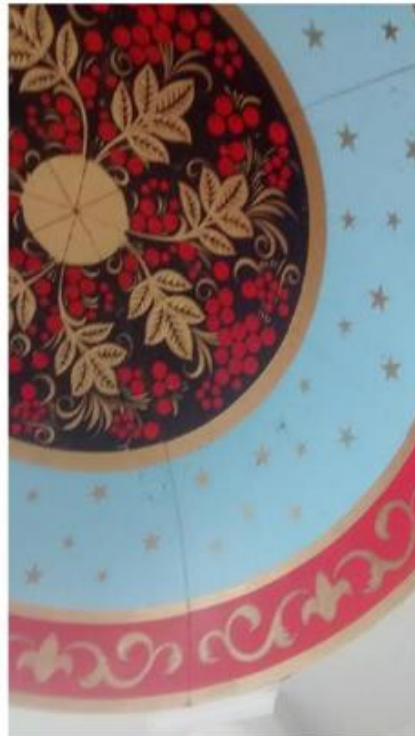
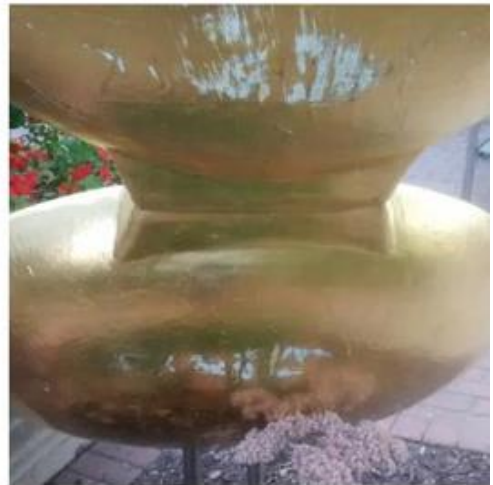
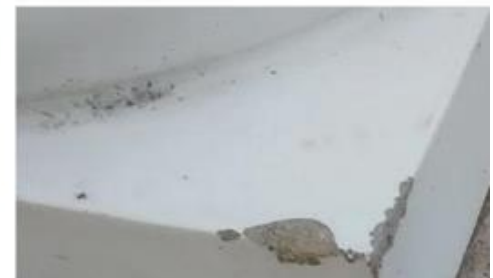
# International Friendship Gardens

- The Bezedka structure lettering is faded in some places.
- Folk art image on the underside of the roof is in good shape and just needs to be cleaned.
- Some planters are cracked.
- The German Garden sculpture has some of the metal leaf rubbed off.

- The Bezedka should be cleaned with warm water and mild soap and the lettering should be repainted with metallic gold sign painter's enamel. Estimated cost: \$200.
- The leaf that is rubbed off on the German sculpture can be replaced with imitation gold and silver leaf. Estimated cost: \$100.
- The cracked planters can be patched with epoxy putty or fiberglass patch.
- Inspect and clean annually.
- In 2036, possibly repaint.

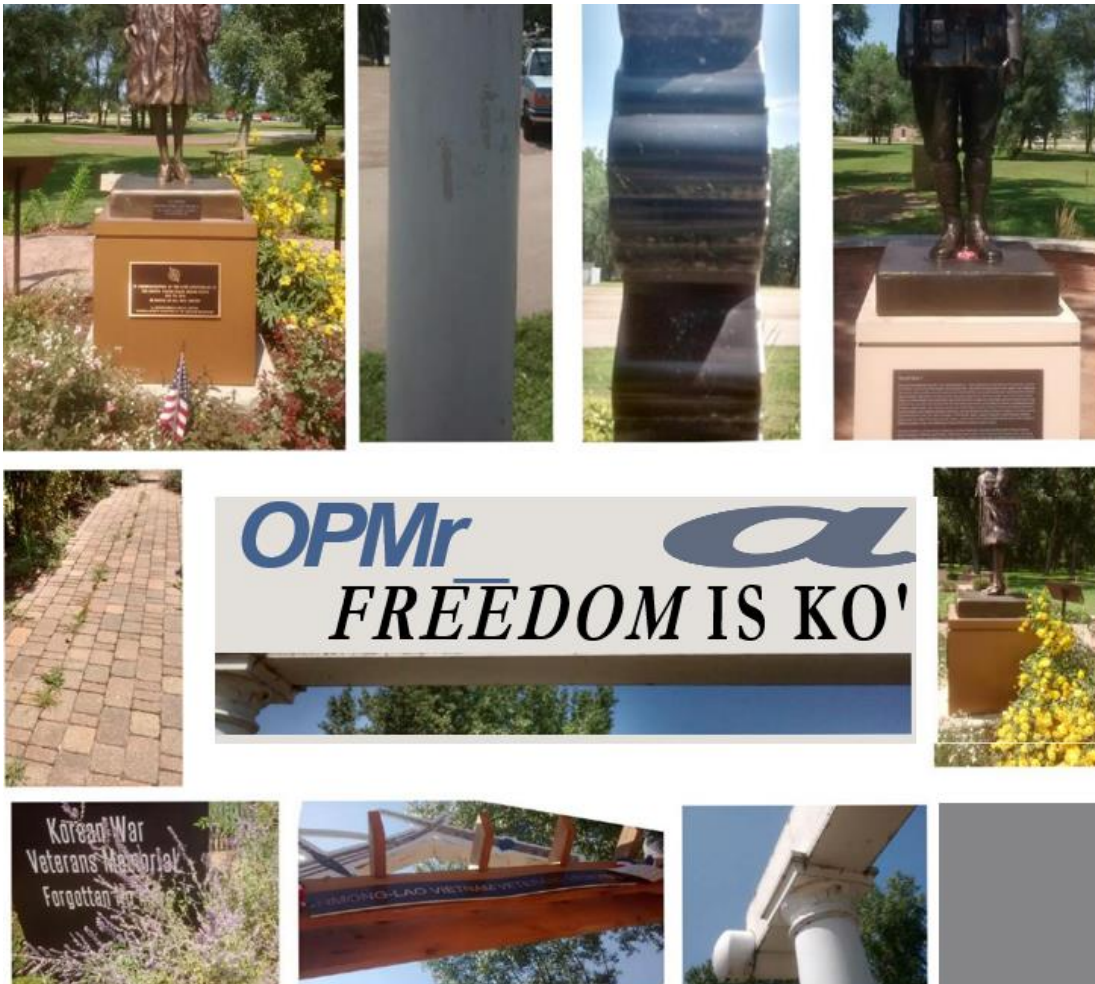
# Veteran Memorials

- Condition – Good.
- The fiberglass memorials have some small bare spots in deep areas.
- There are a few cut lines on the base of one figure.
- The wood arches have some mold on them. Some have paint chipping off.
- There are weeds in-between the bricks on the walkway.
- Foliage is obstructing some of the bases and lettering.

- The mold can be removed with mold cleaning solution.
- Some of the structures need to have the paint touched up or repainted, estimated: \$350. Another option is to ask volunteers to maintain the memorials.
- Prune or remove plants obscuring the base and lettering.
- Contact DWO company to patch fiberglass.

- Inspect and clean figures with mild soap annually.
- Every five years, possibly repaint structures.
- In 2036, possibly repaint structures and fiberglass figures.
