# Assessment of Condition and Maintenance of Public Art La Crosse, WI 2021

On-site inspections completed by Luke Achterberg, Adam Oldre, and Michael Martino

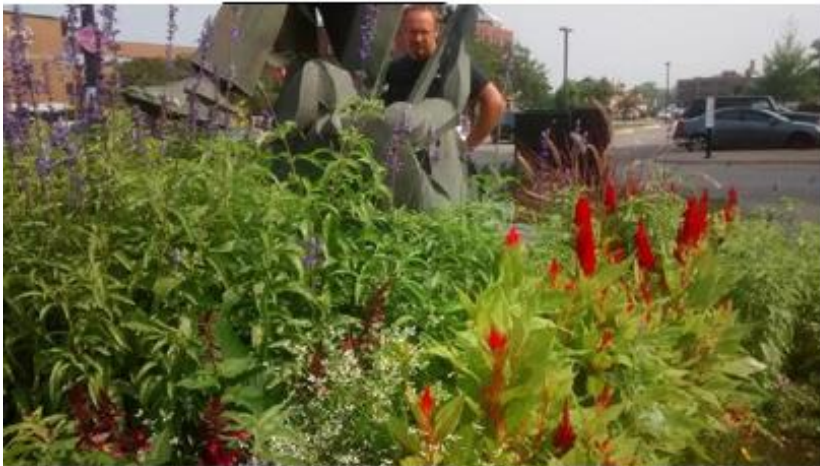
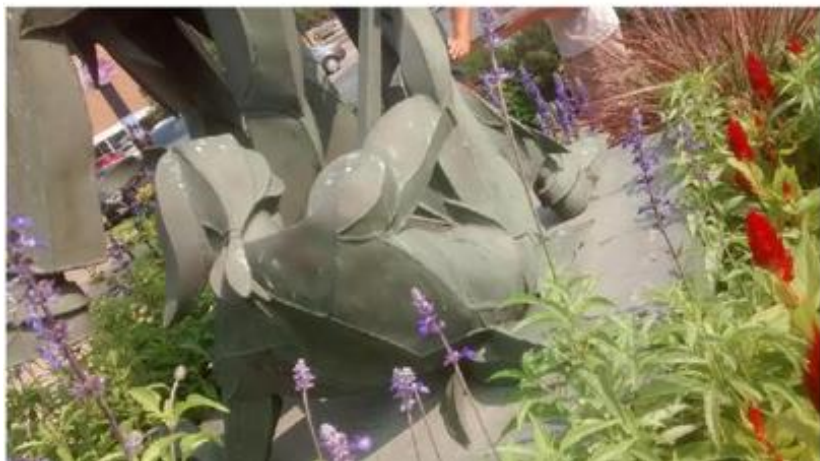
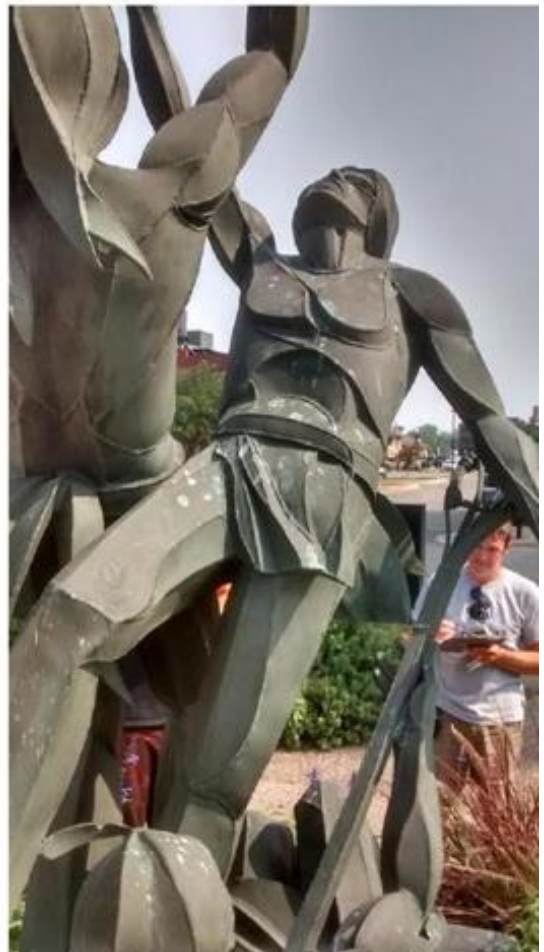
# La Crosse Players

- Condition – Good.
- The bronze sculpture, the patina is turning slightly green due to oxidation.
- The plants and flowers around the base are obscuring the view of the whole sculpture.

- The foliage needs to be pruned or removed so the full view of the sculpture can be seen from all sides.

- Inspect, clean, and wax annually. On a hot day, clean with warm water and mild soap and wax with Renaissance Wax and buff. Estimated cost: \$450. The wax will help prevent further oxidation.

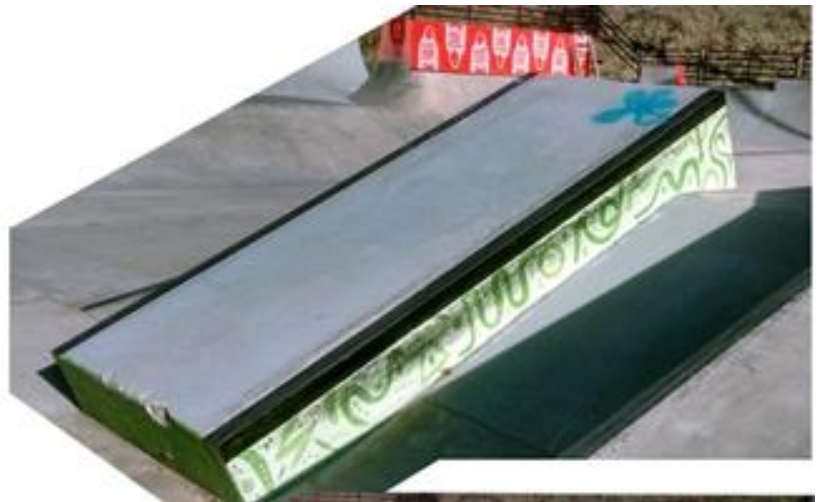
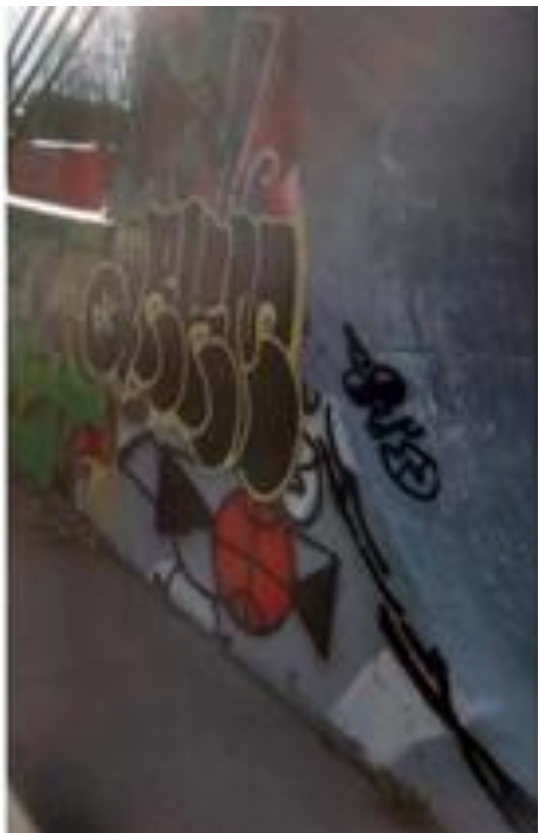
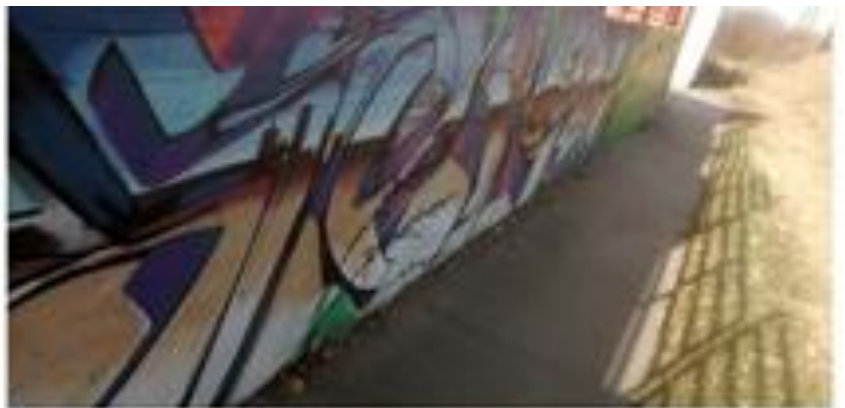
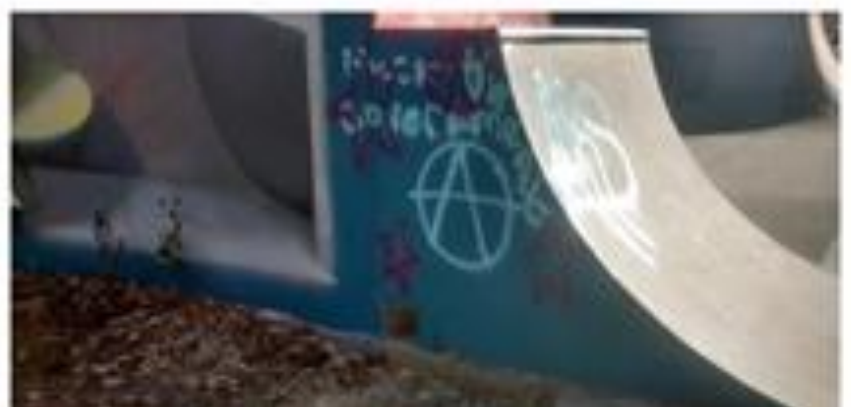
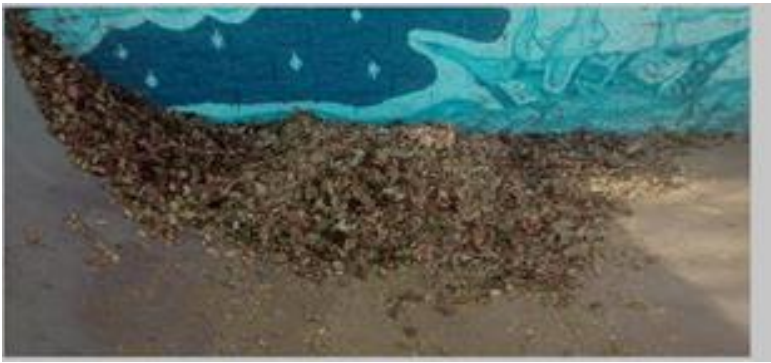
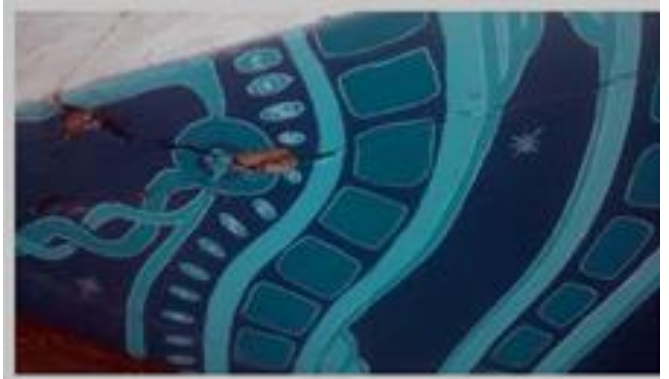
# Lueth Park Memorials

- Condition – Good.
- Some murals have abrasions due to activity.
- Tall weeds obscuring mural on the north wall.
- “Tagging” in several locations, unclear if it was allowed or vandalism.

- Remove leaves and weeds.

- Inspect and clean annually.
- Touch up paint in high activity areas every five years.

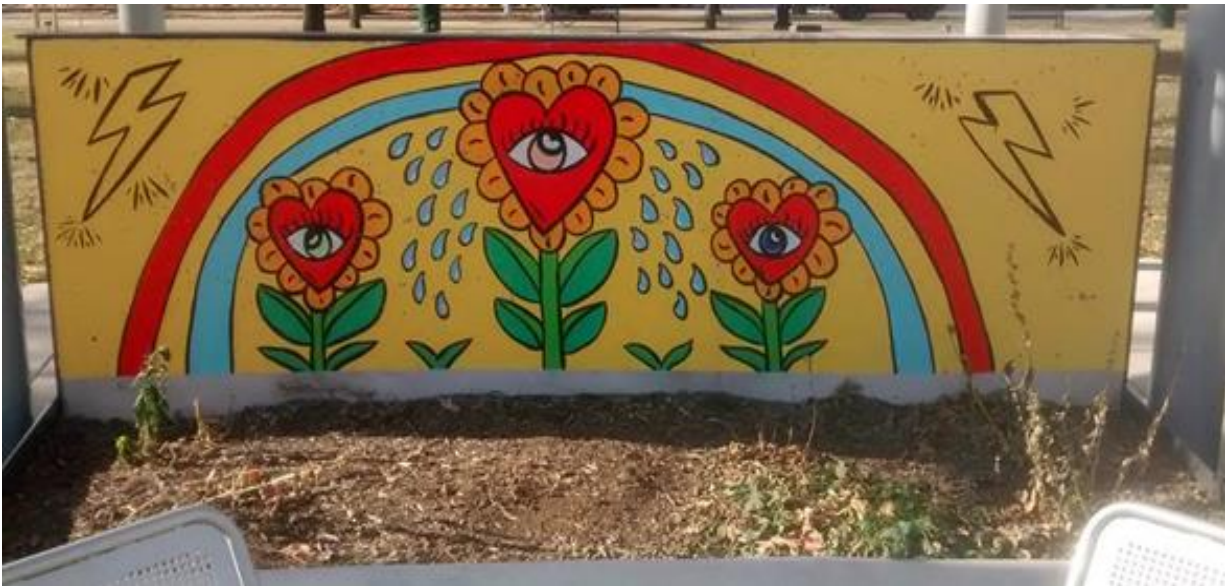
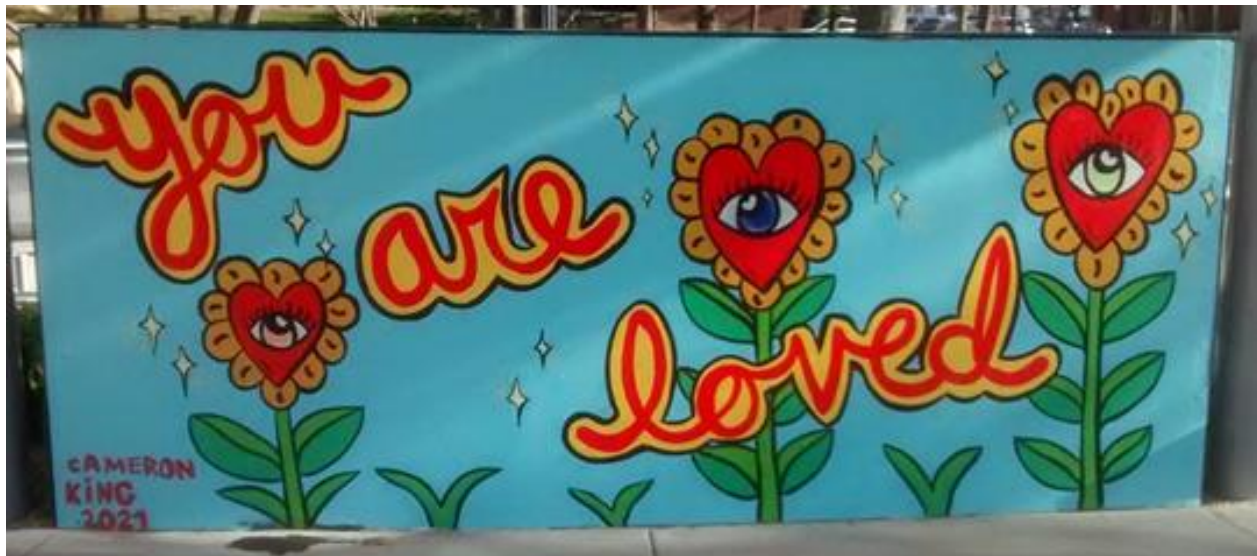
# Burns Park Memorial

- Condition – Good.
- Recently done.
- Flower beds should protect mural from damage.

- Make sure flowers on the east side are not too tall so they do not obstruct the mural.

- Inspect and clean annually.
- In 2026 and 2036, touch up paint. In 2031 and 2041, possibly repaint.

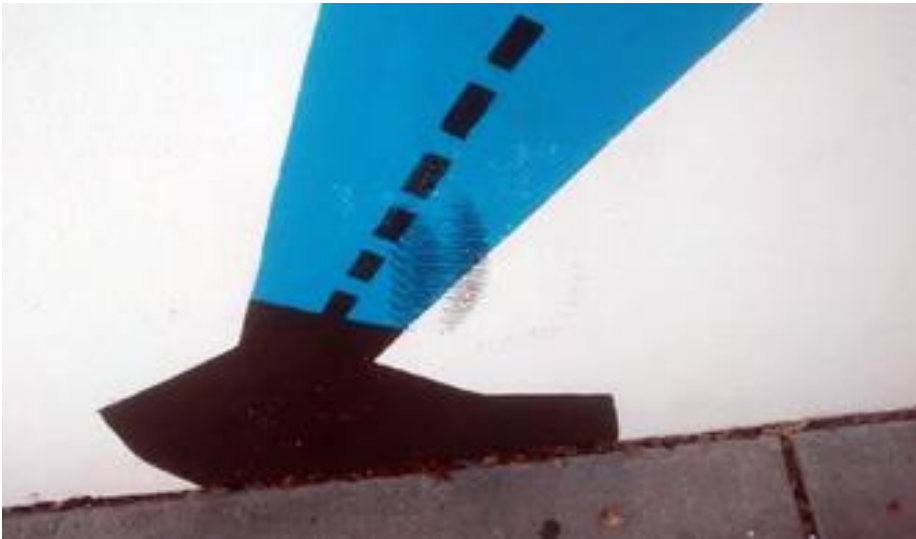
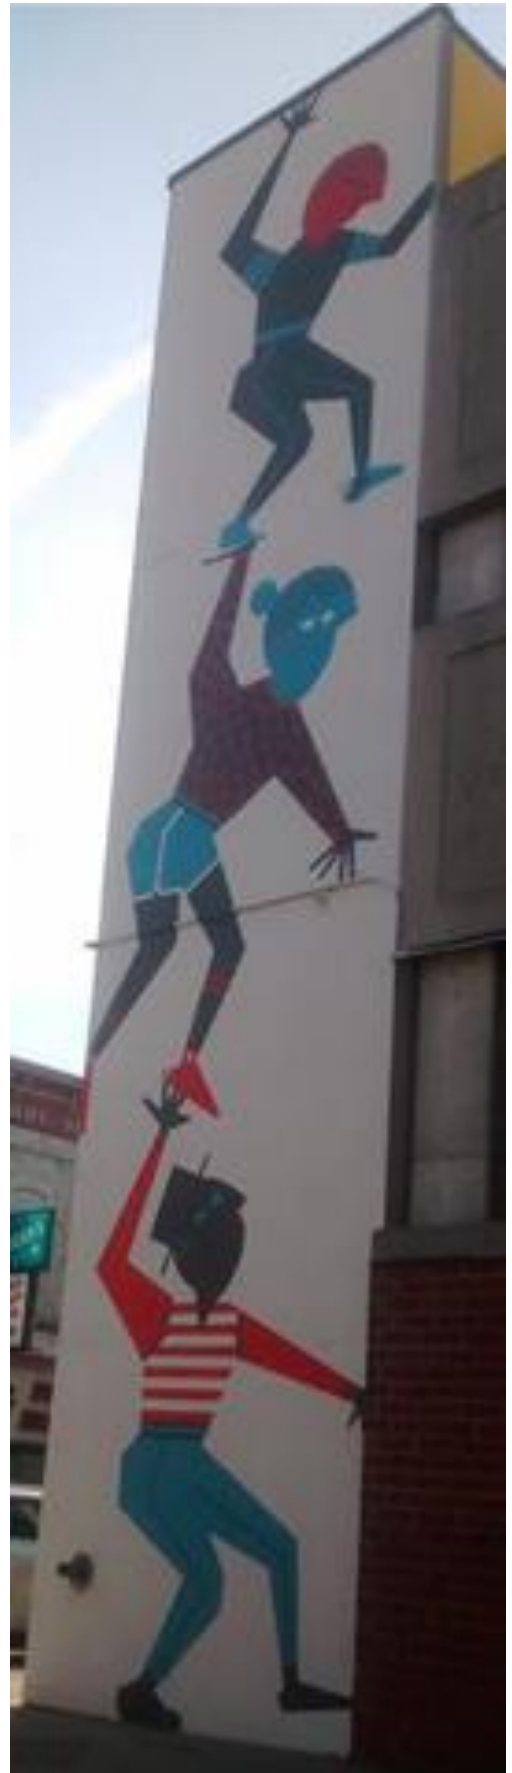
# Helping Hands

- Condition – Good.
- Dark marks at the bottom.

- Clean black marks.

- Inspect and clean annually.
- In 2031 and 2041, possibly touch up.
