# GRAND RIVER STATION

## Structural Assessment

October 2021

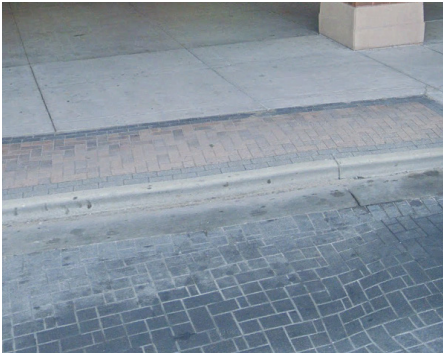
| Sub Category | Element | Condition | Priority | Details | Recommendation | Cost Estimate |
|---|---|---|---|---|---|---|
| Grounds + Turf | Pavers | Fair | I | Various pavers have sunk due to lack of compaction below. | Remove pavers and add compacted sand. | \$3,400 |

Pavers

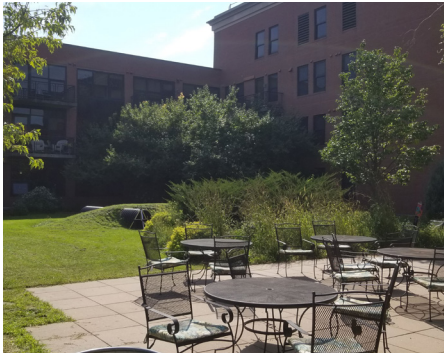
Topside of green roof

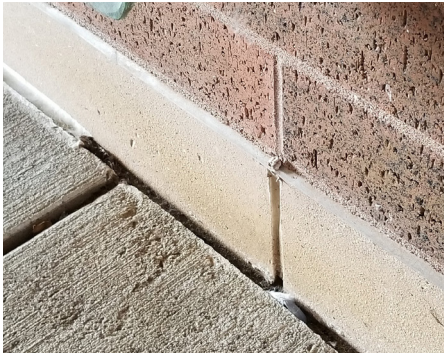
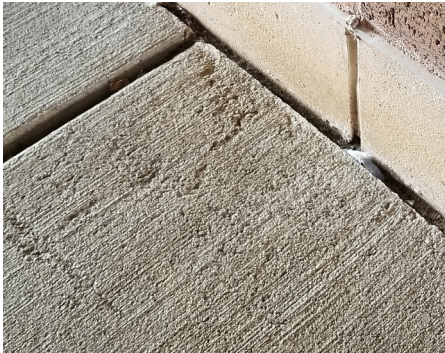
| Sub Category | Element | Condition | Priority | Details | Recommendation | Cost Estimate |
|---|---|---|---|---|---|---|
| Exterior Walls | Exterior Wall Base Joint | Fair | I | Caulk joint around the base of building is degraded, cracked, and shrinking from masonry. | Replace damaged caulk joints. | \$8,400 |

Caulk joint at building base

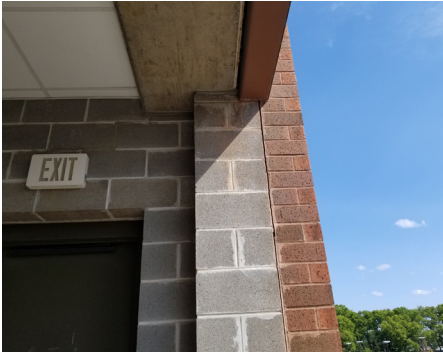
| Sub Category | Element | Condition | Priority | Details | Recommendation | Cost Estimate |
|---|---|---|---|---|---|---|
| Exterior Walls | Exterior Brick Façade | Poor | I | The brick façade appears to be pulled away from south face of parking level. | Verify brick ties are sound. Repair joint as needed. | \$2,700 |

Exterior brick facade

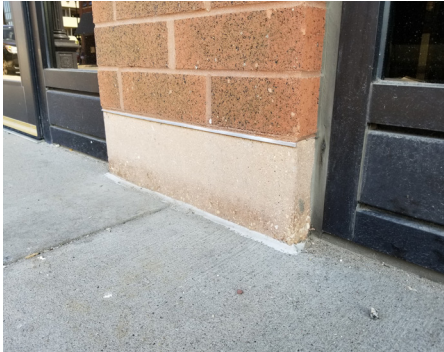
| Sub Category | Element | Condition | Priority | Details | Recommendation | Cost Estimate |
|---|---|---|---|---|---|---|
| Exterior Walls | Exterior Base Façade | Fair | 2 | Due to assumed winter salt and snow removal, the base of exterior walls are damaged. | Patch and seal walls as part of an annual maintenance plan. | \$53,200 |

Exterior facade baser

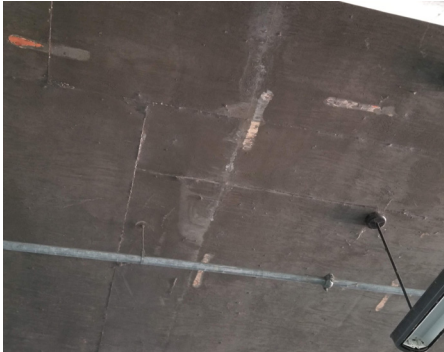
| Sub Category | Element | Condition | Priority | Details | Recommendation | Cost Estimate |
|---|---|---|---|---|---|---|
| Interior Ceiling | Underside of Green Roof | Poor | I | There is efflorescence on the underside of the green roof as seen from a parking space. | Further investigate green roof assembly. Verify waterproofing and the total applied loading. While further investigation is needed, this task is outside the scope of work for this project. Therefore, no costs are associated with the recommendation. | — |

Underside of green roof

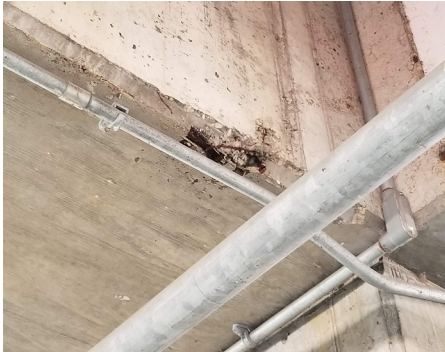
| Sub Category | Element | Condition | Priority | Details | Recommendation | Cost Estimate |
|---|---|---|---|---|---|---|
| Interior Ceiling | Parking Level Structure | Fair | I | Multiple locations of parking precast structure appeared to have exposed reinforcing. | Patch and repair all concrete beams and columns with exposed reinforcing. | \$3,400 |

Parking level structure

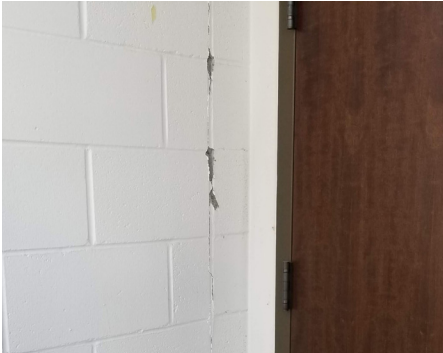
| Sub Category | Element | Condition | Priority | Details | Recommendation | Cost Estimate |
|---|---|---|---|---|---|---|
| Interior Walls | Northeast Stairwell | Poor | I | A vertical expansion joint appears to be filled with non-compressible material. | Clean joint and revise to backer rod and sealant. | \$2,700 |

Northeast stairwell vertical expansion joint

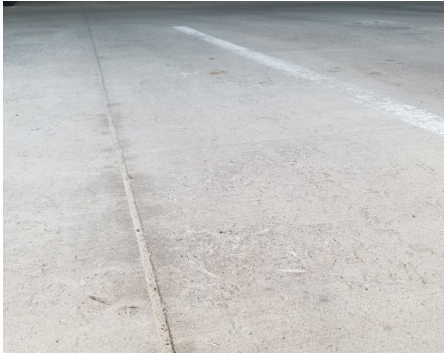
| Sub Category | Element | Condition | Priority | Details | Recommendation | Cost Estimate |
|---|---|---|---|---|---|---|
| Interior Floors | Parking Level Floor | Poor | I | Multiple locations appear to have surface wear and exposed reinforcing. | Clean and apply sealant to parking surface as part of an annual maintenance plan. | \$300,000 |

Parking level floor
