Architectural & Engineering Analysis

North Community Library

1552 Kane Street
La Crosse, Wisconsin

April 2026

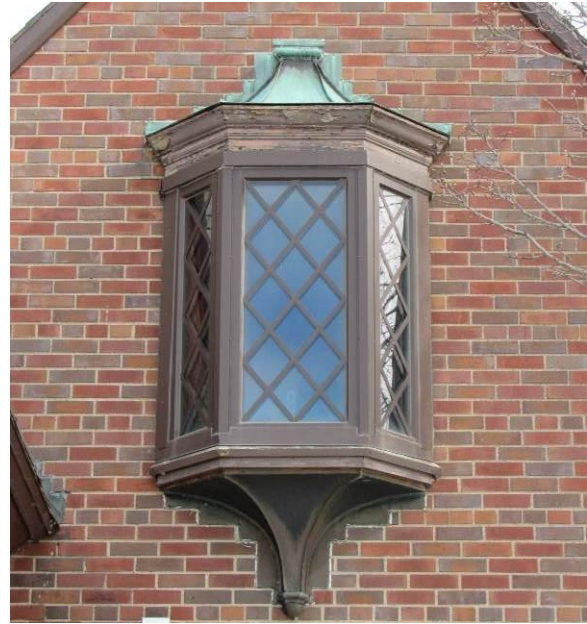
The windows have wood trim that is in fair-to-poor condition, especially on the faux half-timbered gable and the oriel window above the entry. Paint is flaking and there are early signs of rot starting on some of the members. If repairs are done in the next year or two, the damage will be minimal, but if it is ignored, the repair costs will grow significantly. The stucco appears to be in fair condition, but if the adjacent wood rots, water will penetrate behind the stucco and cause problems. At a minimum the trim should be restored and a new bead of sealant installed at all joints between the stucco and wood. It should also be noted that the nails holding the wood trim have significantly rusted and will need to be replaced. This is evident by the rust stains on the face of the wood trim.

Figure 13 – Oriel window has peeling paint and modern replacement windows (2026).

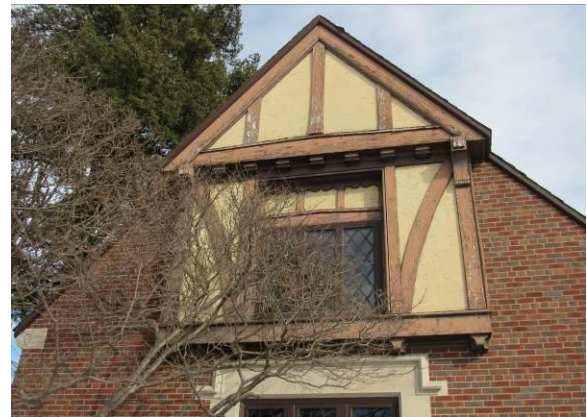
Figure 14 – Peeling paint and rusted nails are evident on the trim at the gable (2026).

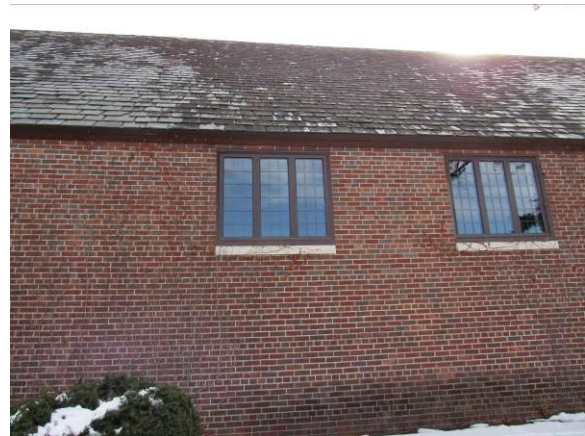
The north wall of the library is in fair condition. There were dark spots near grade indicating moisture infiltration. There is also ivy growing on this wall. As long as it is the type of ivy that attaches to the surface of the masonry it is of little concern; however, if it is the aggressive type of ivy that sends tendrils into the wall, it should be removed. This wall is very utilitarian and only has five punched openings. The rear part of the building has a lower wall with two courses of slightly corbelled brick. The brick bonding pattern is the same as the west facade.

Figure 17 – The darker masonry near grade has been saturated with moisture (2026).

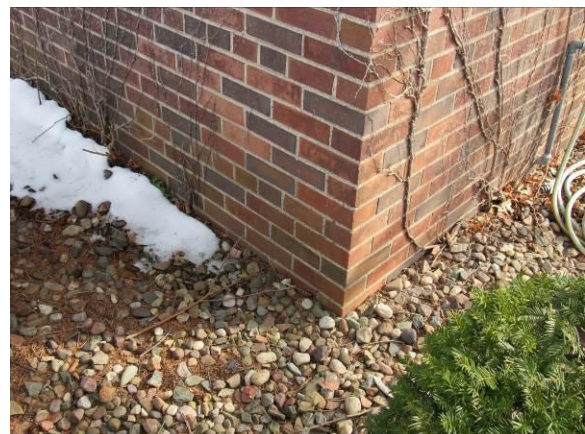
Figure 18 – The face brick runs below grade, notice the ivy (2026).

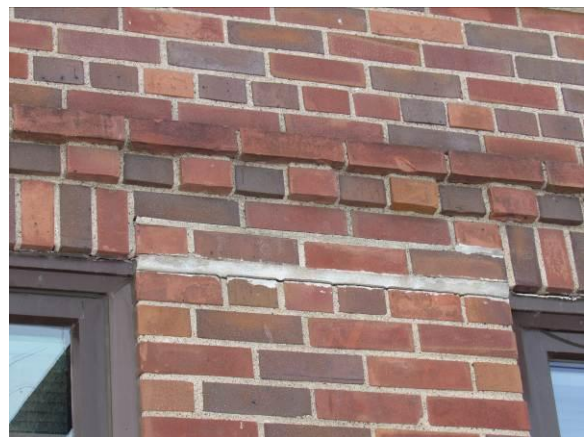
The east walls are mostly in fair condition with isolated areas in poor condition. These walls have the same brick configuration as the other facades. It looks like there may have been some water infiltration in the past just below the line of the flat roof. The mortar joints have been repointed with a lighter mortar and there is a slight bulge in the masonry. This is indicative of either water freezing and pushing the bricks out, or water rusting steel in the wall causing it to push the bricks out. The repairs do not look recent, so the problem may have been corrected. The electrical service drop is just north of the back doors. If possible, it would be better to convert the service to underground. The high walls behind the flat roof were not accessible and could not be fully evaluated for this study.

Figure 21 – Previous water infiltration may have rusted the steel lintel, pushing the bricks out of alignment(2026).

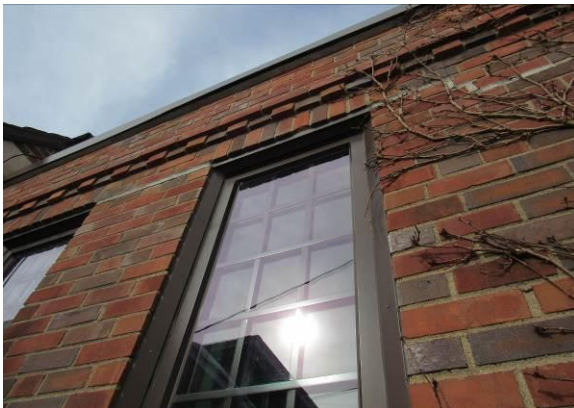
For the most part, the brick is in fair condition. There is a slight displacement of brick at the window heads/roof line. This area was repaired and is in a similar condition to the east facade. The chimney shows signs of mortar erosion and should have some minor tuckpointing done. The type of ivy on this wall should be verified to see if it is the surface attaching type or the penetrating type.

Figure 22 – Previous masonry repairs are evident at the window heads (2026).

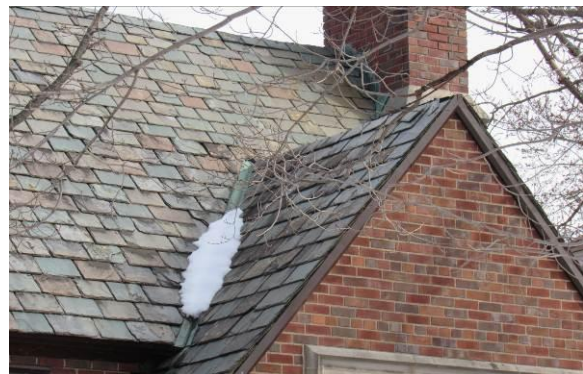
Figure 26 – The ridge on the dormer is damaged, possibly letting in water (2026).

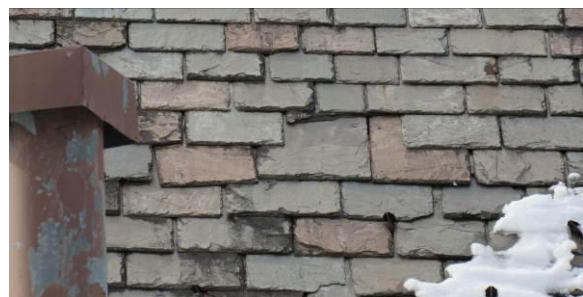
Figure 27 – Damaged and missing slate shingle should be replaced (2026).

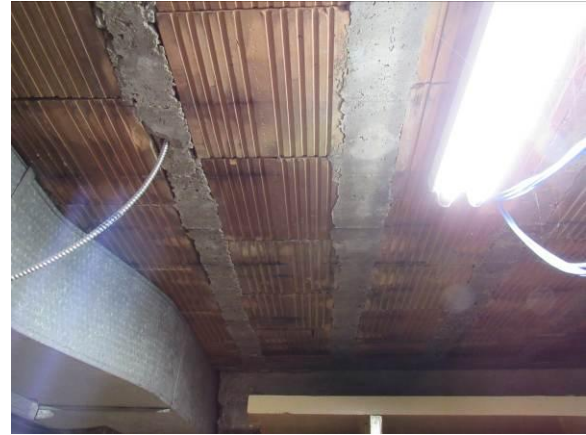
Figure 48 – Concrete floor joist system, notice how the electrical conduit was drilled through the joist, not the clay tile (2026).

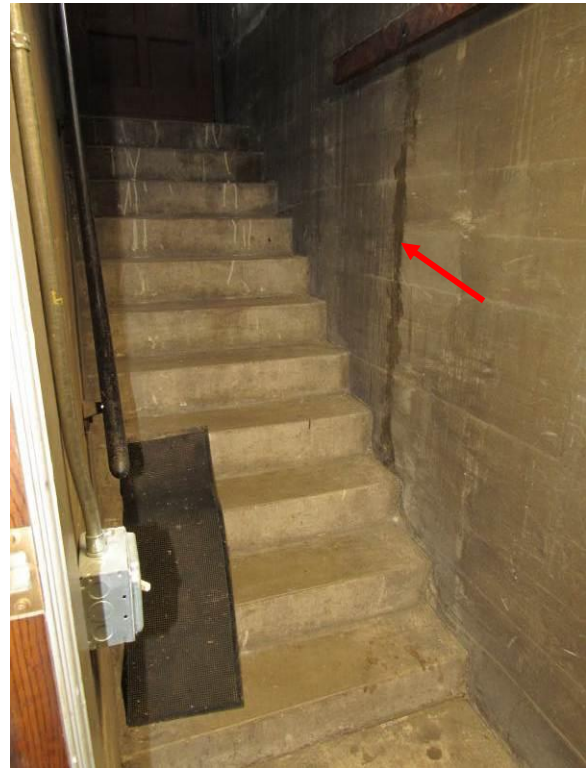
The roof framing is composed of wood joists bearing on the exterior brick walls. This roof structure has two main framing systems. The gables have rafters and collar ties with cross bracing. This roof was well designed due to the weight of the slate roof. The roof drains to eaves around the perimeter of the building. Not having gutters is creating a water issue at grade. The flat roof areas were completely concealed and could not be verified. It was common to use wood framing for flat roof structures during this period. Maintenance stated that there was a small leak somewhere near the southwest corner of the building.

Figure 51 – The stairs at the south end of the basement, notice the water (2026).

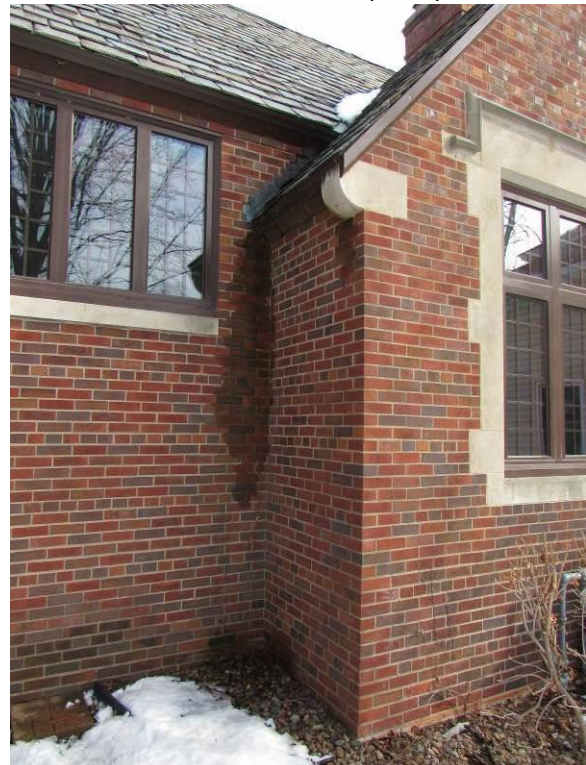
Figure 52 – The biggest threat to the masonry is water infiltration (2026).

help the building will be adding gutters and downspouts around the entire building.

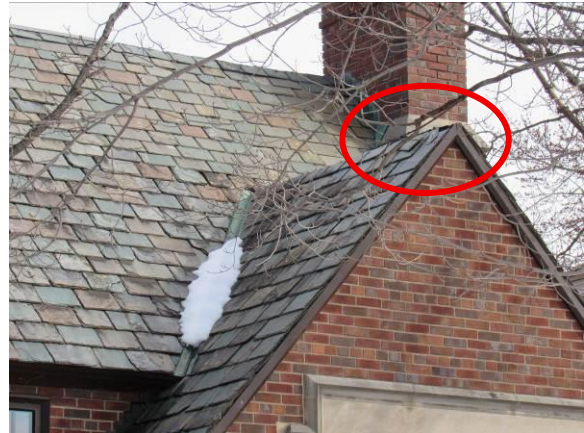
Figure 53 – The broken ridge slate and missing metal cap may be contributing to the roof leak (2026).

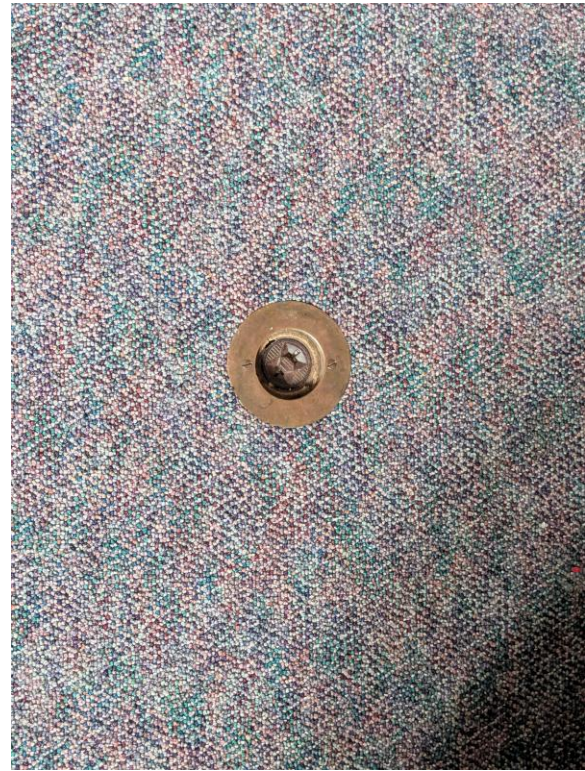
There are numerous floor-mounted receptacles throughout the main level of the Library. None of these were observed with a cover plate. Some did have Code-compliant receptacle with a ground pin. Others were older 2-wire receptacles without any ground.

Figure 67 – Old Floor-mounted Electrical Receptacle (2026).

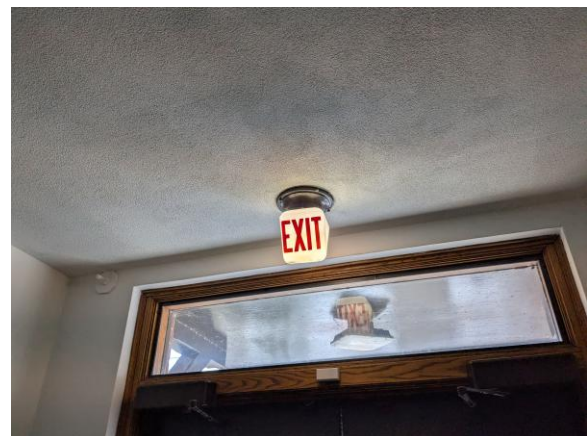
Figure 71 – Antiquated EXIT Light on the Main Level of the Library (2026).

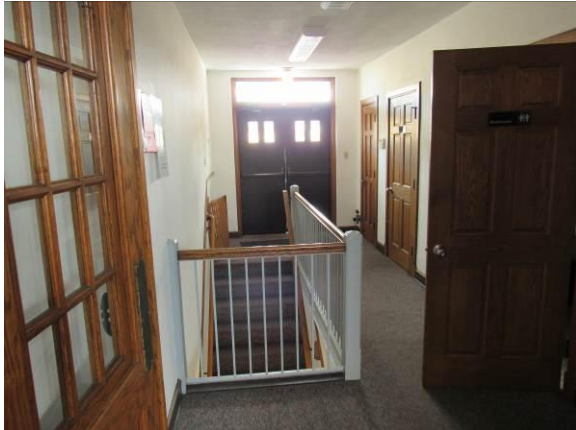
Figure 102 – The back entry and restrooms are not currently accessible (2026).

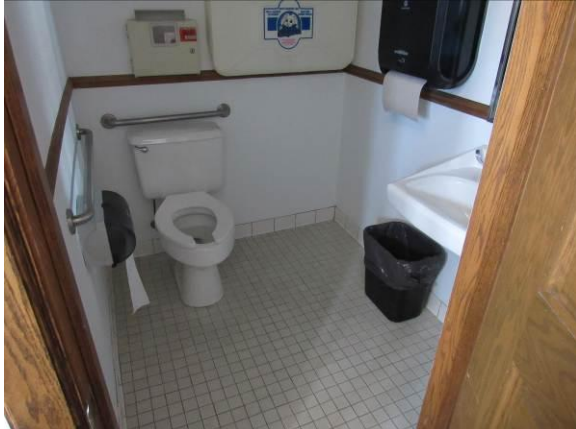
Figure 104 – The restrooms nearly comply with ADA requirements, but are still deficient in a few areas (2026).

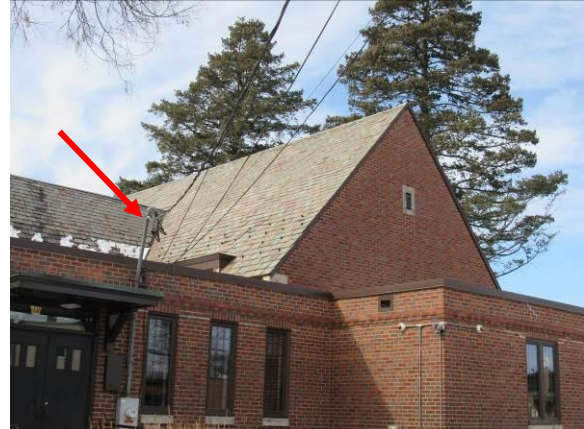
Figure 107 – Existing electrical service has seen better days, underground service would be a big upgrade (2026).

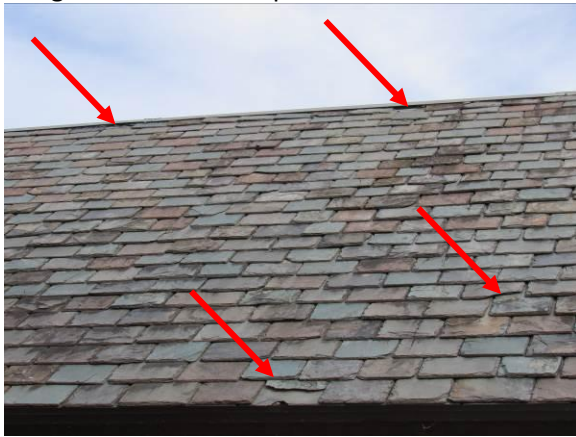
Figure 113 – There are some damaged slate shingles on the roof (2026).
