City of La Crosse
Housing Renovation Program
HOUSING RENOVATION APPLICANT SUMMARY

Application Number: Reno1619

Photo Summary Reno1619

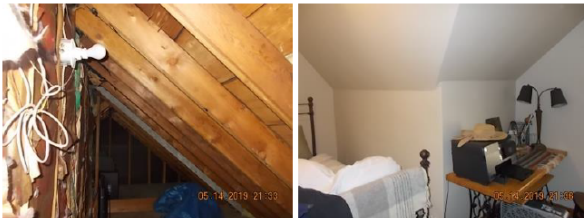
CONCERNING COMFORT AND DURABILITY

There are 2 options for properly insulating and air sealing the storage areas. The areas can be heated or unheated. If these areas are heated the roof cavities must be properly insulated with your choice of insulation. If fiberglass batts are installed into the rafters you must install ventilation chutes from the bottom of the cavities to the top of the roof. Dense packing the outer 2 feet of the floor cavities with cellulose insulation must be done to prevent air infiltration. Dense pack the entire cavity that runs parallel with the foundation. The gable end cavities would also need to be insulated with your choice of insulation.

Spray foaming the roof cavities with two part foam is also an option. After removing the roof sheathing material, apply drywall or Thermax to the bottom of the rafters and now the cavities can be insulated with two part spray foam. Leave an opening between the foam and roof sheathing for ventilation. Inspect the overhang soffit to make sure that it is truly ventilating because in the area that we inspected the soffit was not open.

If the storage areas are left as cold storage, the knee walls must be insulated properly and entire floor cavities must be dense packed with cellulose insulation past the knee wall connection.
