The Common Council
The Planning and Development Department
City of La Crosse

April 21, 2017

Chileda, a therapeutic living and learning residential and school program for children and youth with significant needs is requesting to replace the current fence with a higher, more secure one to significantly improve the safety of residents.

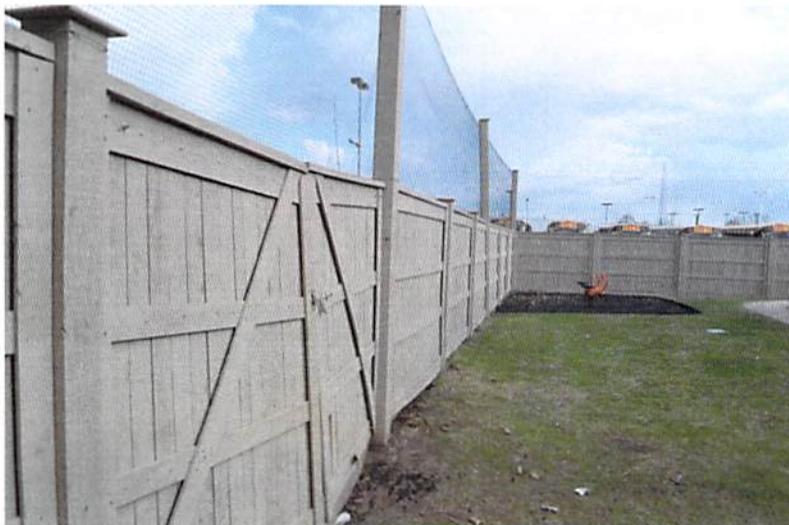
The northwest corner and northern portion of the property has a 6' wooden fence with another 4' of netting above it. The netting is secured on metal posts that are attached to the fence posts.

- Netting was installed in 2006 to extend the fence height when the building was new. This acts as a deterrent from throwing toys and other objects into the street, onto vehicles, or other property, however is not intended to stop students from climbing, as the netting is not strong enough to hold a person's weight. The netting poses a risk should a resident attempt to scale it.

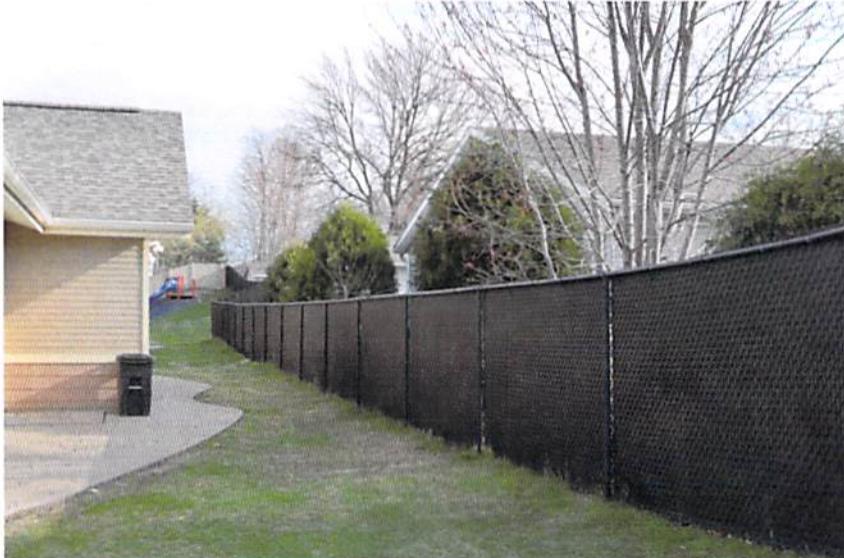
The western portion of the property is bordered by a standard 6' chain link fence with slats to fill the openings.

- Slats were inserted in the chain link fence, with the understanding that students would not be able to climb the fence because they would not be able to get a footing within the chain link. This has turned out to be inaccurate at Chileda, as some students are able to get a foothold, reach the top of the fence, and pull themselves up and over.

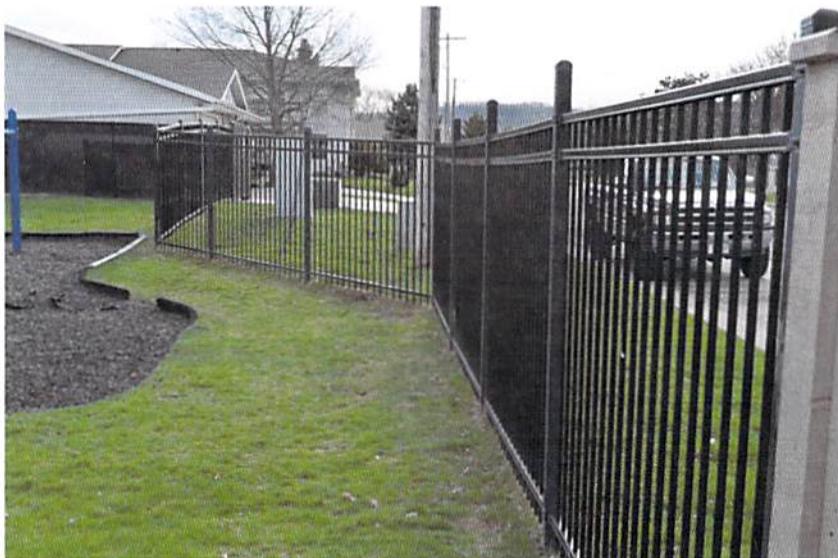
The southern and south eastern portion is bordered using a more decorative 5'6" aluminum fence as well as wooden fencing with netting above.

- Polycarbonate (Plexiglas) was added to the emergency gate after a student wedged through the aluminum fence's 4" bars and subsequently ran off campus. Prior to this incident, we were unaware that the fence material was pliable enough to squeeze through. We have 157' of this fencing material, including the fire gate, without Plexiglass due to the concern that a broken piece of Plexiglass could be a weapon, as well as creating flying objects if one were to get taken by the wind. The aluminum fence poses a safety risk.

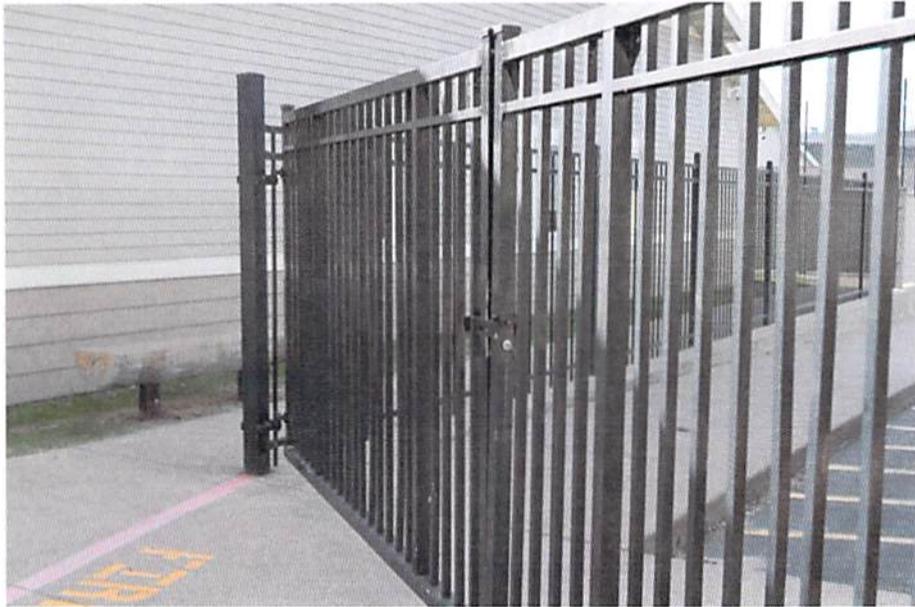
The fire gate, to provide access for fire trucks, is aluminum, as is the adjacent gate for staff to enter/exit in an emergency only.

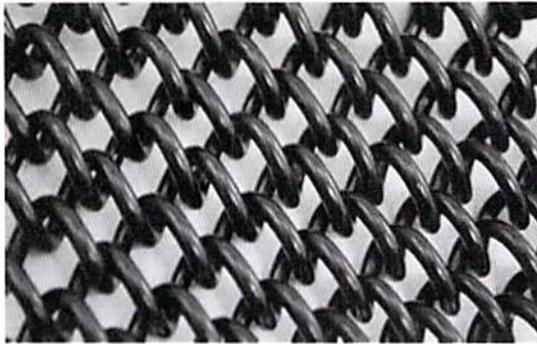
Maximum-mesh chain link fencing

A) Fence the entire area, approximately 840', with a contiguous 3/8" mini mesh chain link fence topped with a roller barrier (a non-aggressive, anti-climb barrier).

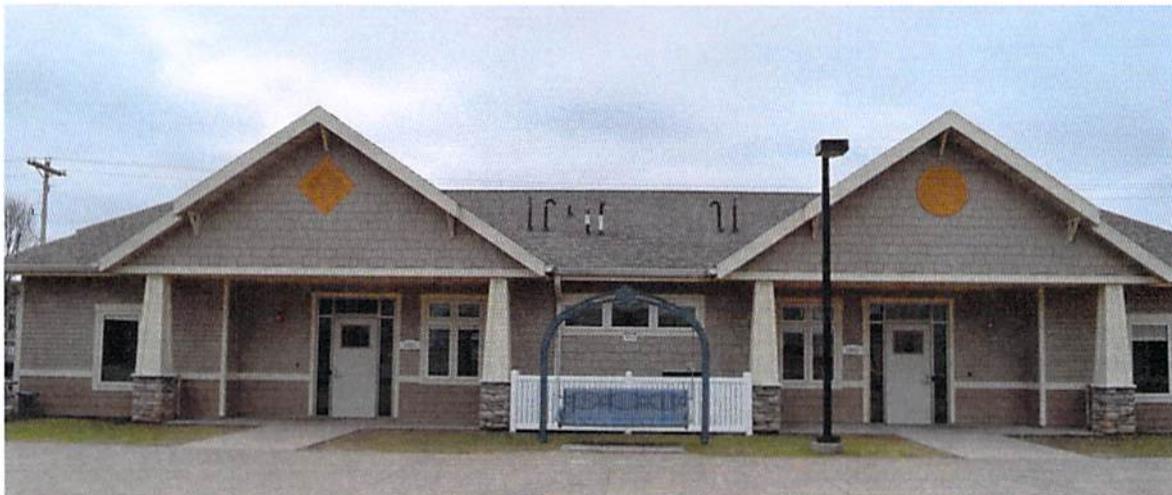
This is a photo of the front of one of our four duplexes. The white picket fence area hides utilities from a distance; however is not a secure area. Children can easily enter the area, having access to hazards of electric and gas lines.

B) Fence the utility areas in front of each of the four duplexes with an 8' high mini-mesh (maximum security 3/8" mesh fencing) with roller barrier.
