**ASBESTOS, LEAD, HAZMAT
PRE-DEMOLITION
BUILDING INSPECTION &
BULK SAMPLING
REPORT**

**Municipal Pool Bath House
1901 Campbell Road
La Crosse, WI.**

April 18, 2016

CRE Project Number: AS164818

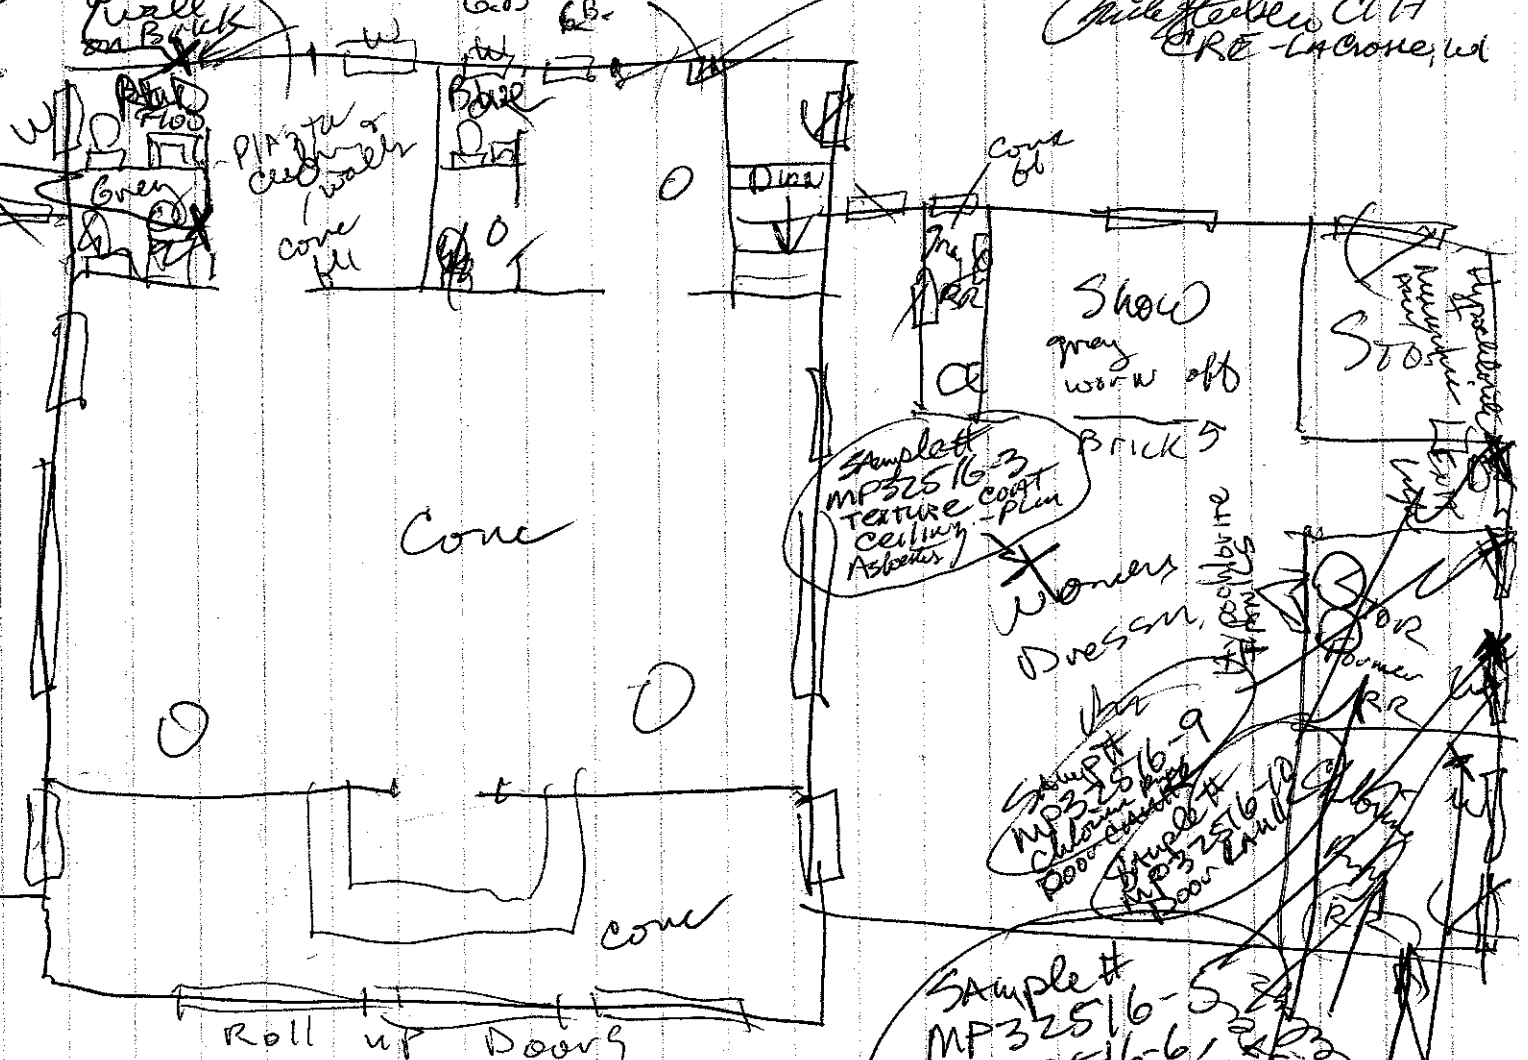
Figure 1 - Sample Locations, Ground Level

Sample #
MP32516-11
White Paint on Brick
No Bathroom
Lead - 90 AAS

Sample #
MP32516-12
Grey Painted Floor
NW Storage
Lead - 0 AAS

Sample #
MP32516-3
Texture coat
ceiling
Asbestos

Sample #
MP32516-4
Texture coat ceiling
PLM Asbestos

Sample #
MP32516-9
Culinary
Door
Sample #
MP32516-10
Door
Sample #
MP32516-11
Door

Sample #
MP32516-5
MP32516-6
Window Glazing
Compound

Sample #
MP32516-1
Plaster
ceiling
Asbestos
