Station 1 Windows

Maintenance or replacement needed

Station 1
726 5th Ave S

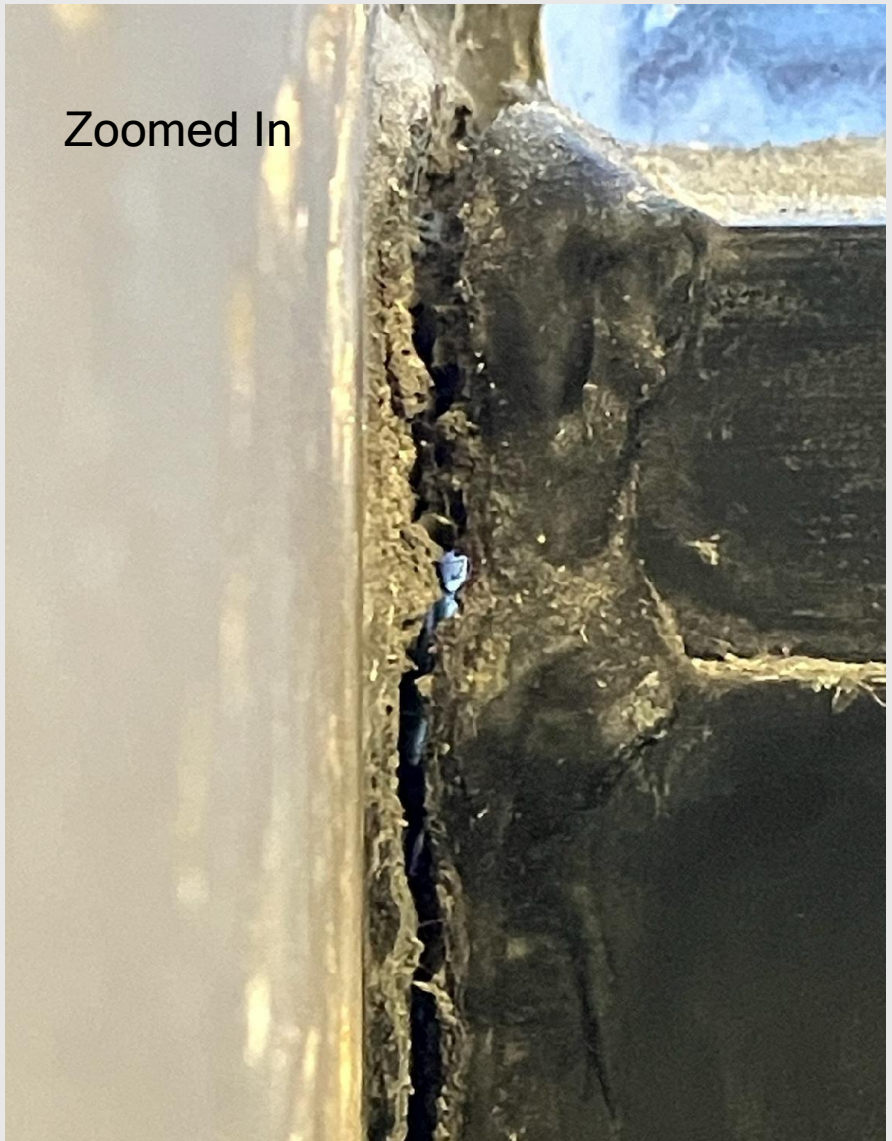
3 Windows were noted with enough caulk damage that you can see a visible gap to the outside. Causing an extreme amount of cold air into that area of the room.

Zoomed In
