**612 KANE ST LA CROSSE**

## EXECUTIVE SUMMARY

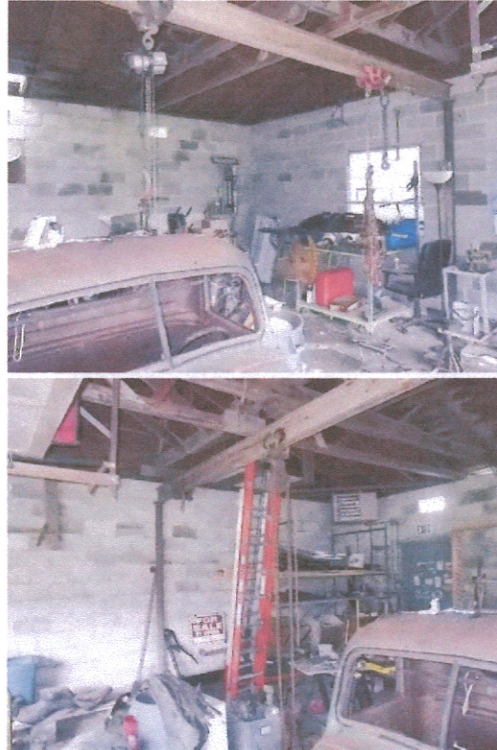
Maintenance Suggested:, Note Roof & Attic Structure: Boards as Sheathing & Rafter Framing -- Active leakage noted, (wet/dampness)

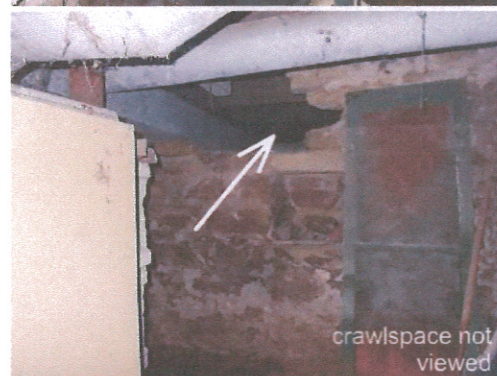
4. Maintenance Suggested:, Note Moisture Indications: Floor(s), Wall(s) -- [Standing Water](#), Review ["Drainage/Grade slope and Gutters/Downspout areas on the Grounds Stoops & Steps section of the report."](#) Also review the ["Foundation Drainage"](#) handout. Proper grade slope will help reduce freeze/thaw pressure on foundation wall thus reducing the potential for cracking, bowing, movement etc. of the foundation wall(s). Recommend operate a dehumidifier in the basement during the warm summer months and review our website newsletter titled ["Mold Walk-Thru"](#) for additional common sense practical advice. **CONSTANT WATER ENTRY, WATER CLEAN WHEN VIEWING THE FLOOR suggesting ongoing and continuous, sump never stops running.**

Please review our website newsletter titled: "Moisture & Mold" for interesting history/background and proactive recommendations to help control moisture and clean up mold.

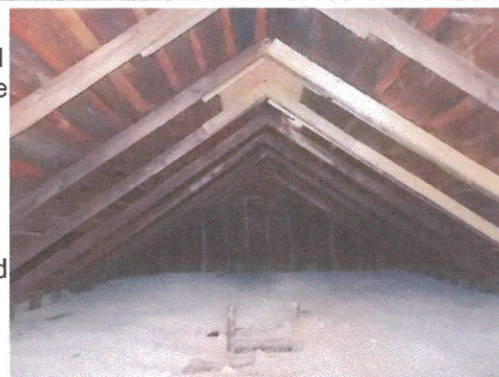
5. Functional-with Maintenance: **Chimney or Flue:** Masonry, removed -- Chimney/flue removed below roof line, Openings, voids noted around chimney/flue areas increasing heat loss reducing home energy efficiencies. Recommend seal and/or support accordingly.
