ARCHITECTURAL AND ENGINEERING ANALYSIS
FOR
ODD FELLOWS TEMPLE
(A.K.A. DALE'S CLOTHING)
121 SOUTH 4TH STREET

III. STRUCTURAL/ SYSTEMS ANALYSIS

RE: 121 4th Street So. – Condition Survey
MBJ Project No R15.250.0

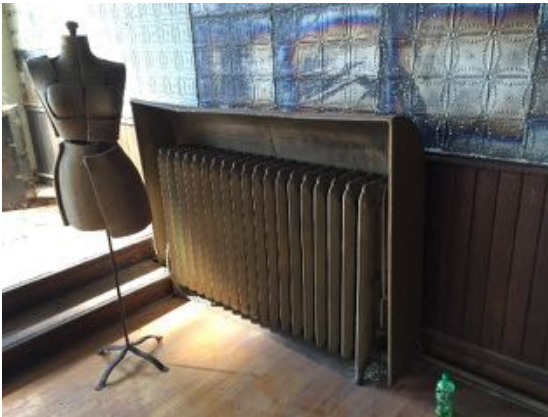
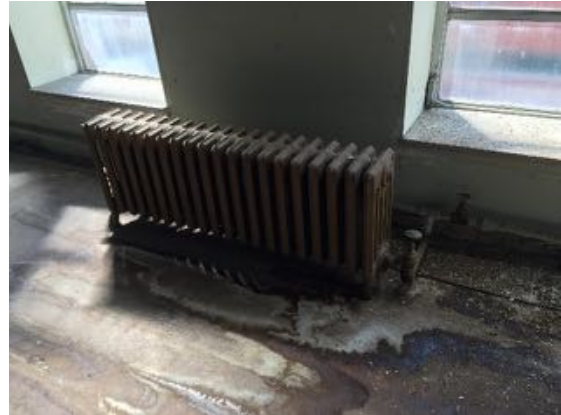
There are a number of cast iron radiators around the building from the original steam heating system. The boiler has been removed and the radiators only serve as decoration.

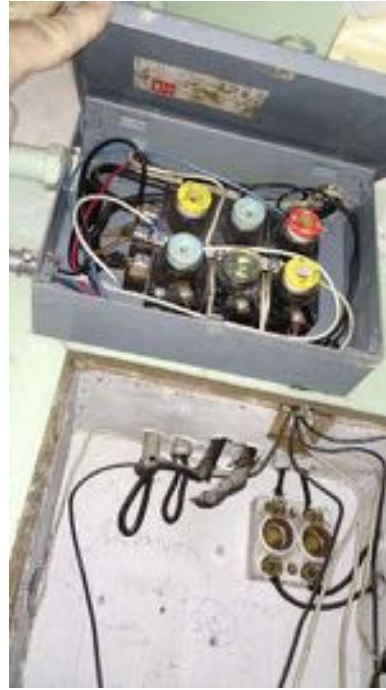
The above photograph shows an old fuse panel with remnants of knob and tube wiring. It appears that a few of these circuits have been routed into a newer metal fuse box and may still be energized. The original fuses are removed. Note that the white coloring in the box is likely asbestos.

The photograph below shows a number of runs of knob and tube wiring, as well as some newer armored cable wiring. We don't know if any of these circuits are still active.

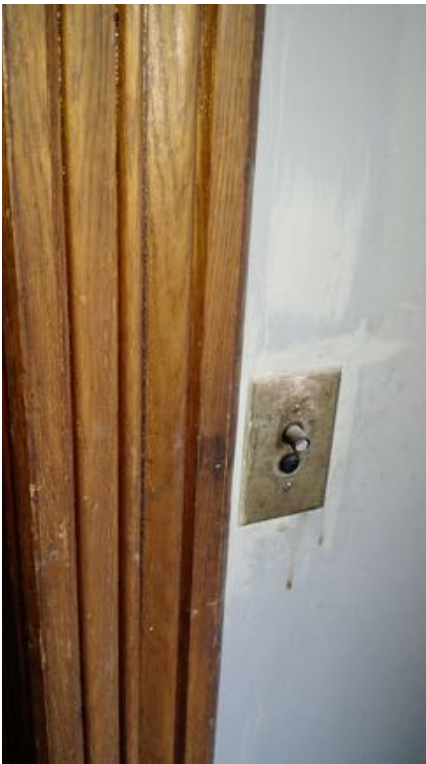
In the large room above Dale's Clothing store is this old Cutler Hammer manual dimming switch. It is unknown if it is still connected to any active lighting circuits and it may be best to retire it to artifact status, but it is a "neat" old switch. It would like to find a place to remain on display.
