# **THE CITY OF LA CROSSE**

## **Neighborhood/Community/Seniors Centers**

### **Facility and Programs Report**

December 2013

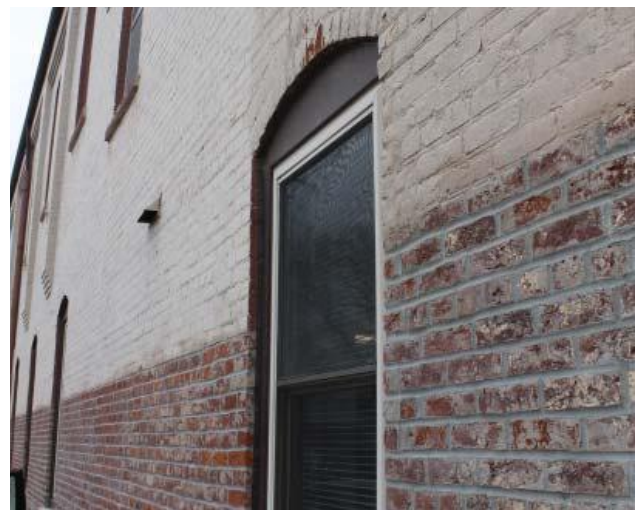
Cleaned and re-tuckpointed brick. (2012)

The exterior brick walls of the original building are showing their age and need maintenance. All four sides of the original structure exhibit deterioration of the brick, limestone, and mortar due to weathering, water infiltration, and age. At some point in the history of the building the exterior brick has been painted and this paint is now chipped and peeling. The lower portion of the west wall has had tuckpointing and paint removal work attempted, however, in the process the cleaning has marred the surface of the brick face. Many of the lower level limestone sills have been correctly replaced. Our recommendation

is to replace the rest of the excessively deteriorated limestone sills, the spalled and damaged bricks, and be even more careful with the paint removal process to clean and tuckpoint the grout joints on all the affected walls. The lower level of the north facade of the building has an applied stucco ashlar pattern faux stone. This is severely stained, cracking, and starting to fall off of the building. Its removal to return the building to its original appearance should be investigated. The concrete masonry unit walls of the 1977 addition have an applied EFIS coating. This surface is severely cracked and separating from the substructure, and there are no signs of expansion control. It is our recommendation to install movement control joints as required then affix expanded metal lath with anchors back to the CMU substrate and cover with a stucco system with an acrylic topcoat. It was not pos-

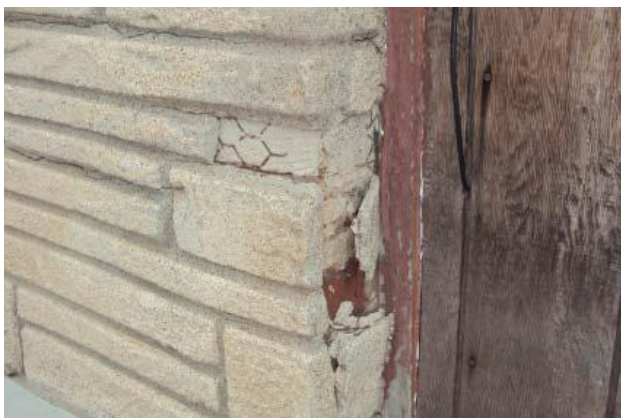
"Stone" patterned stucco on main facade. (2012)

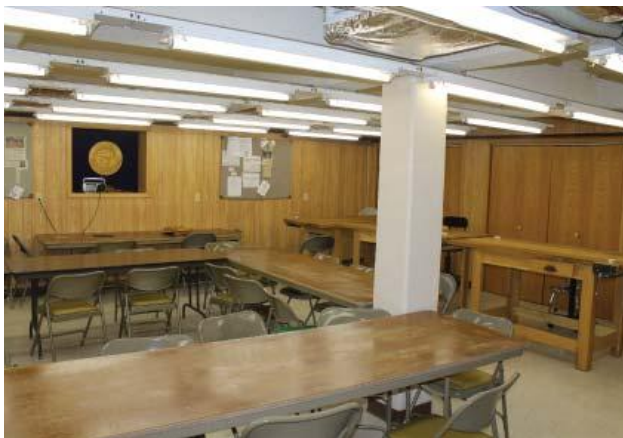
General view of basement toward northwest. (2012)

The basement of the Southside Senior Center is in generally good condition. It is used regularly and is well maintained. The finishes are dated but functional. There is some deterioration of the paint along the west wall at the ceiling. This was likely due to previous water issues that have been remedied with completed exterior drainage work. The interior of the closets lining the north end of the main room are not completely finished with untaped/mudded/painted gypsum wall board (GWB) and exposed insulation.

This minor repair should be completed. There is also unenclosed pipework and valves within this space. Exposed ductwork, piping, and conduits throughout this level should be considered for enclosure as they are run along the open ceiling structure. Infilled windows in this space are not visible but presumably the original window fenestration has been removed.

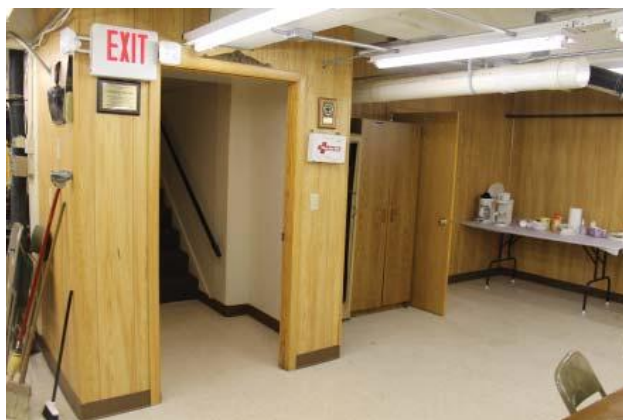
Central egress stair from basement. (2012)

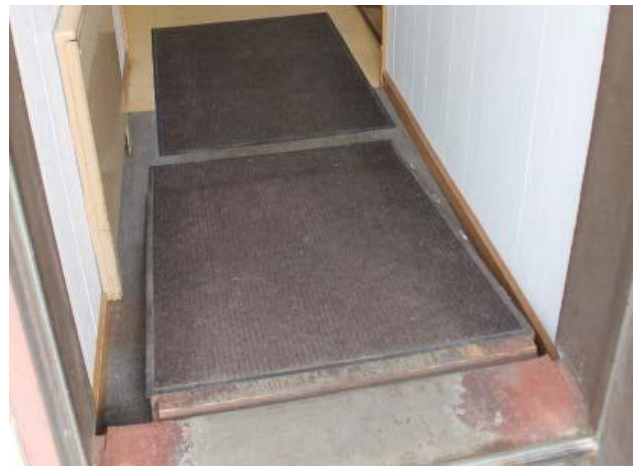
The corridor to the south exit is in fair condition generally. The exception to this is the temporary ramp that has been constructed to get through this required exit door. This ramp should be constructed

"Temporary" ramp at rear exit. (2012)

as a permanent part of the building meeting code requirements for such a ramp.

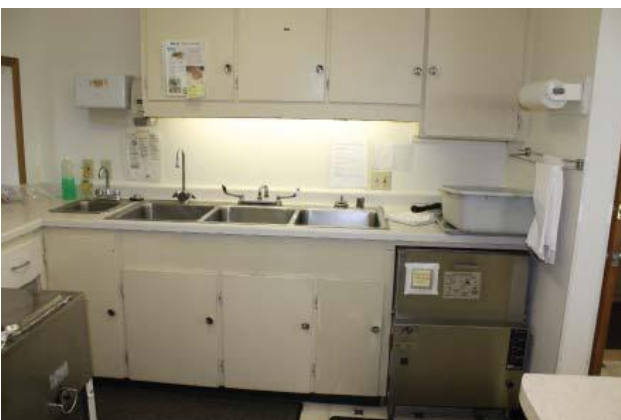
Sink area of first floor kitchen. (2012)

The kitchen is separated from the main room by a thickened wall with two pass-throughs and a door. The kitchen itself is in good condition. The appliances are older but functional. The layout of the sinks is not conducive to efficient work within the space. Also each of the sinks has a different style of faucet adding to the inconsistent appearance of the room. The

cabinetry is in fair condition but would benefit from a new coat of paint.

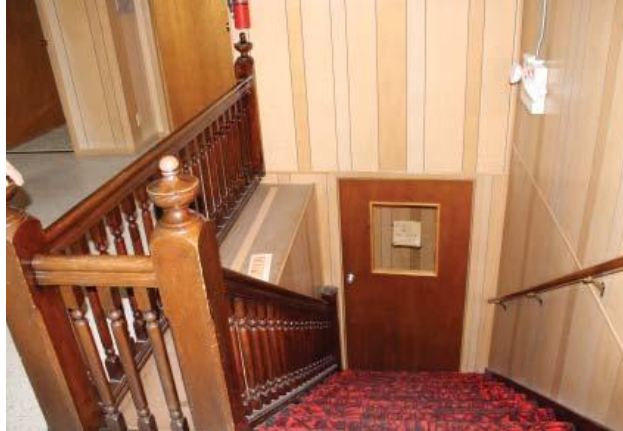
Added enclosure to central stair from second floor. (2012)

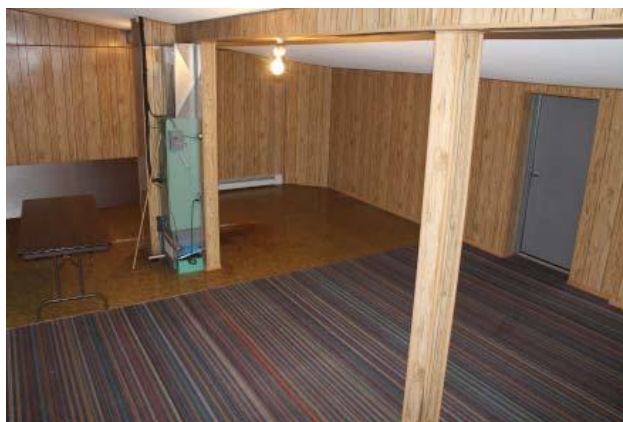
South end meeting room. (2012)

The meeting room at the south end of the second floor is not an accessible space. It is through this room that another means of egress is achieved from the second floor via an exterior stair. The room's finishes consist of plywood paneling on the walls, an gypsum board ceiling, and a combination of wall-to-wall carpet and vinyl flooring. These finishes are generally in fair condition. The carpet is stained and the vinyl flooring is ripped and stained. The replacement of these finishes should be considered.

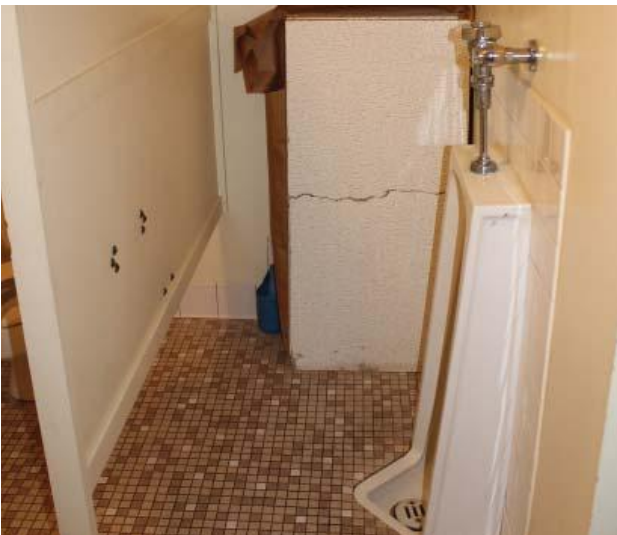
Men's room used for building material storage. (2012)

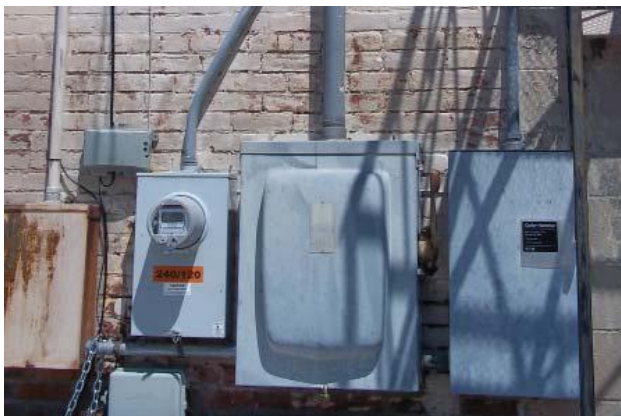
Exterior electric service switching. (2012)

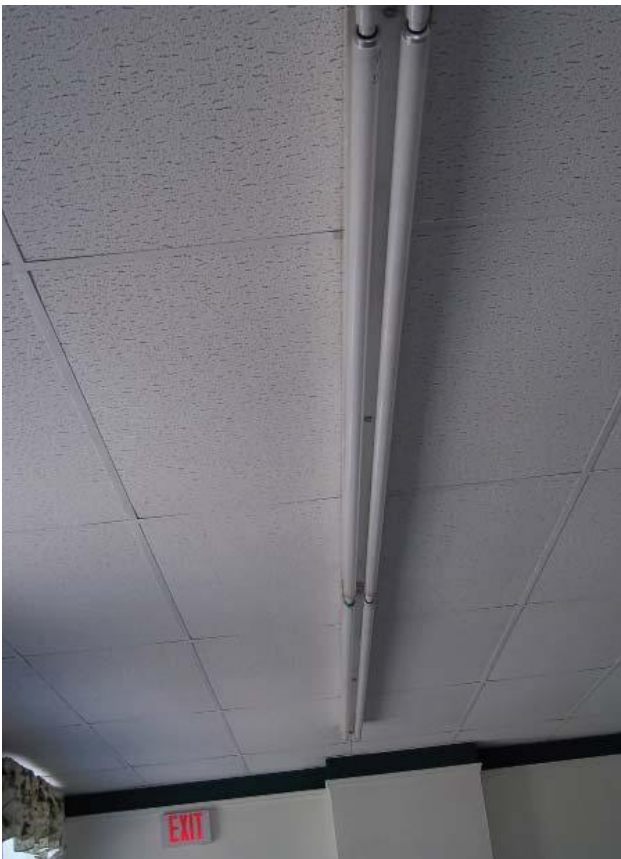
- A. Most of the lighting fixtures within this building are old and simple in form and construction. Fluorescent strip lighting using T12 lamps are the dominant lighting.
- B. Switching is entirely manual. Switching is simply – typically one switch per room. Switches are showing some age and probably should be replaced as time and budget permit.

Typical fluorescent strip lighting. (2012)

| ITEM | RATIONALE | COST | PRIORITY |
|---|---|---|---|
| <ul style="list-style-type: none"> <li>Update lighting systems. Replaced fluorescent strips with fluorescent trip lighting with high-performance T8 lamps. Replace surface-mounted incandescent fixtures with compact fluorescent or LED fixtures. Modify decorative lighting with compact fluorescent or LED lamps.</li> </ul> | | 15,000 | Low |

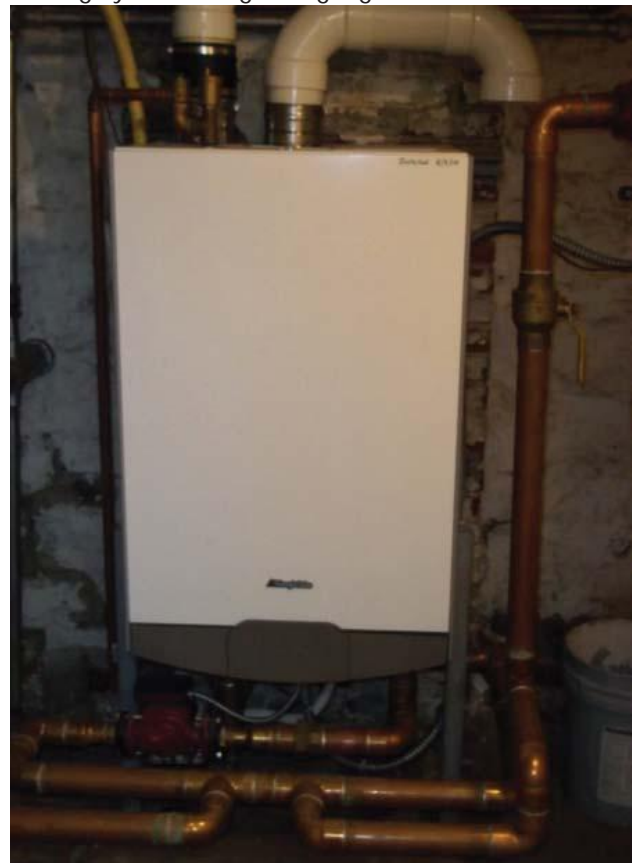
New boiler installed in 2010. (2012)

- B. The boiler is a new Triangle Tube high efficiency boiler reportedly installed in 2010. The boiler is rated at 399 MBH input capacity, which seems more than adequate in size for this building (but not too large to be a concern). This is a high efficiency boiler suitable for relatively low water temperatures. The re-use of the existing finned tube radiation will cause the boiler to operate at higher temperatures, resulting in less than peak efficiency, but certainly more efficient than a conventional boiler.

- C. Although the boiler is new, most of the existing piping, valves, and heating specialties were left in place. Many of the isolation valves are old gate valves, which likely do not seal water-tight anymore. A conventional expansion tank, without a gauge glass, was retained. The original water specialties were left in place. It would have been better to update these devices when the boiler was replaced, but they are easy to replace in the future if they fail.

| ITEM | RATIONALE | COST | PRIORITY |
|--|---|---|---|
| • Replacement of gate valves with new ball-type valves. | | 1,000 | Low |

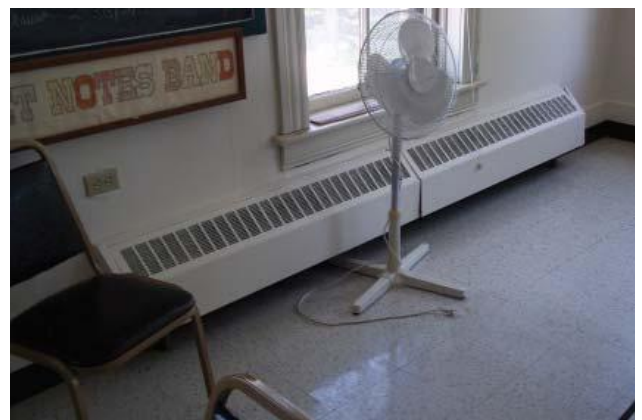
- A. The terminal heating equipment in this building is primarily hot water, “finned tube radiation” (commonly referred to as baseboard heat). There are, at least, two styles of finned tube radiation, indicating that it was installed, or replaced, at different times. In all cases, the finned tube radiation is heavy duty, in good condition, and virtually maintenance free. Use of hot water finned tube radiation results in a very comfortable interior environment, quiet, and efficient.

Finned tube radiation heating equipment. (2012)

- B. Although there is ample evidence of past piping leaks, we did not observe any leaks or other deficiencies while on site. Some of the old valves likely do not seal anymore and will eventually require replacement. Most of the piping is accessible and easy to replace when needed.
- C. The piping seems adequately-sized for the application.

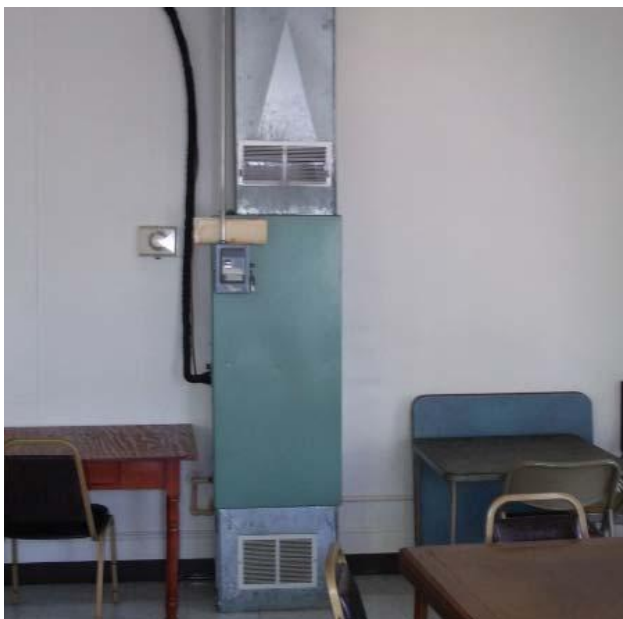
Cooling system vertical fan-coil. (2012)

Although all of these fan-coils are fairly old, they are in very good condition and seem to be fully operational. There are minimal maintenance needs to these units and they should continue to operate for many more years.

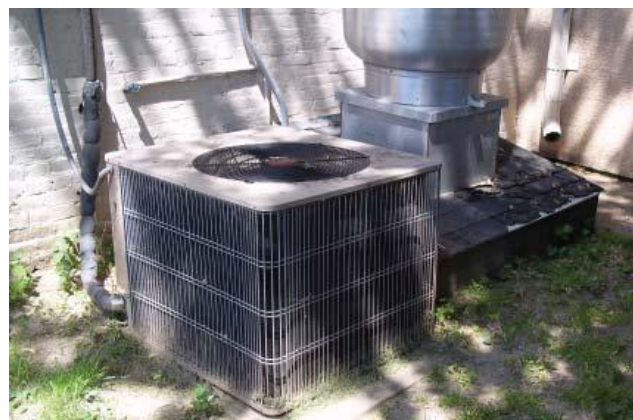
Exterior compressor-condensing unit at grade. (2012)

4. Energy Efficiency Commentary
  - A. The efficiency of these fan-coil systems is mostly a function of the efficiency of the exterior compressor-condensing units. We did not get on the roof to observe the two units there, but we did observe the unit on grade. This unit is "older" and mid-range in efficiency. It is generally not prudent to replace a compressor-condensing unit strictly for greater energy efficiency, but when the need for replacement is necessary, careful consideration should be given to the efficiency of the replacement unit.

| ITEM | RATIONALE | COST | PRIORITY |
|--|---|---|---|
| • Replacement of air conditioning units with more energy-efficient systems. | | 25,000 | Low |

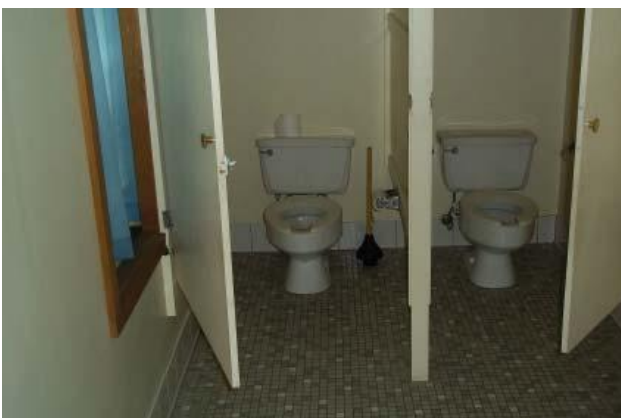
7. Plumbing Fixtures and Primary Equipment
  - A. Plumbing fixtures are showing some age, but generally are in very good condition.
  - B. In general, water closets (toilets) are floor-mounted tank-type, essentially "residential" in construction. Lavatories are wall-hung with manual faucets.
  - c. Fixtures are suitable for many more years of service based on the current use of this building.

Toilet fixtures in second floor women's restroom. (2012)

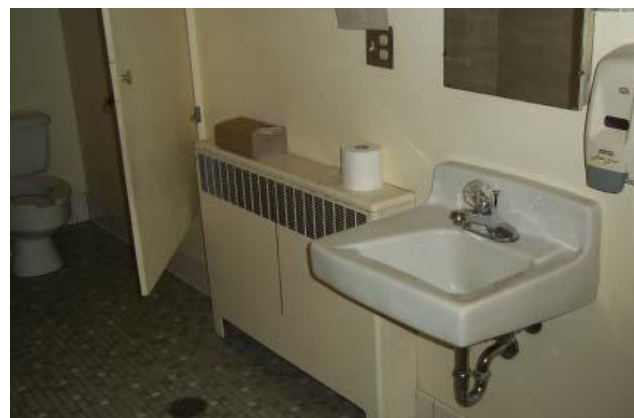
Second floor Women's restroom sink. (2012)

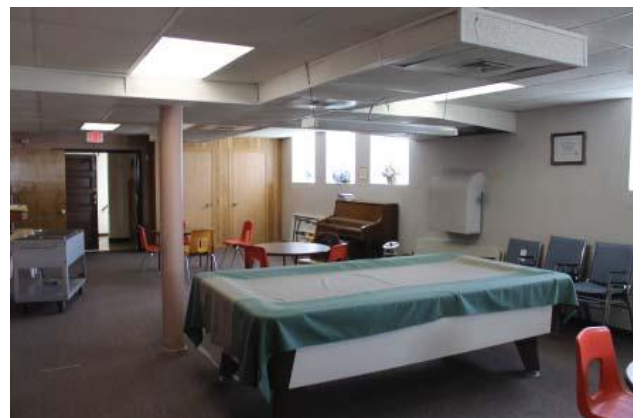
Multi-purpose room in original building lower level. (2012)

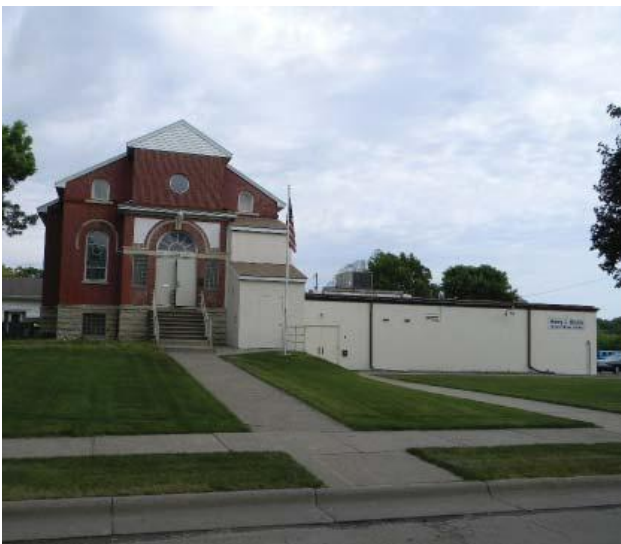
6. The exterior walls of the 1<sup>st</sup> and 2<sup>nd</sup> levels are multi wythe brick. The exterior wythe of brick is severely deteriorated as evidence by the attached photos and requires repair.

South Elevation showing original building and 1975-80 additions.

1. Hand excavate down on the exterior of the foundation wall to determine the condition of the mortar joints on the below grade portion of the building and if tuck-pointing is required tuck point the foundation walls.
2. The brick on the exterior is severely damaged and requires repair. Recommend developing a program and implementing a repair of the exterior masonry.

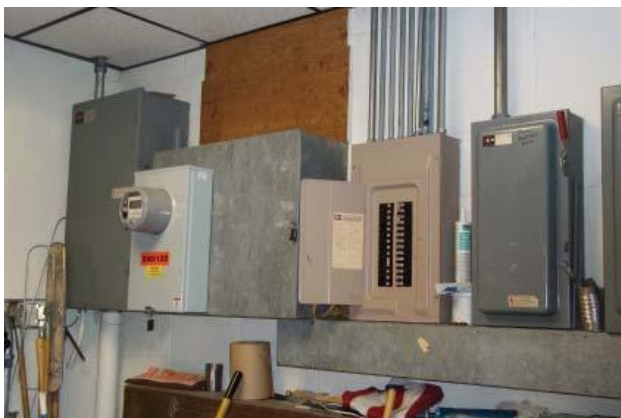
- C. The service equipment is located in a dedicated mechanical/electrical room and is in overall fine condition. In this building, the electrical supply penetrates the floor and terminates in a main disconnect switch. The service is nominally rated at 400 amp. The metering cabinet and utility meter are located "downstream" of this main disconnect switch. Although this is no safety hazard, and was commonly done in the past, this installation is contrary to current Xcel Energy service rules. At some time, Xcel Energy may require that

Multiple metering cabinets, load centers, and switches. (2012)

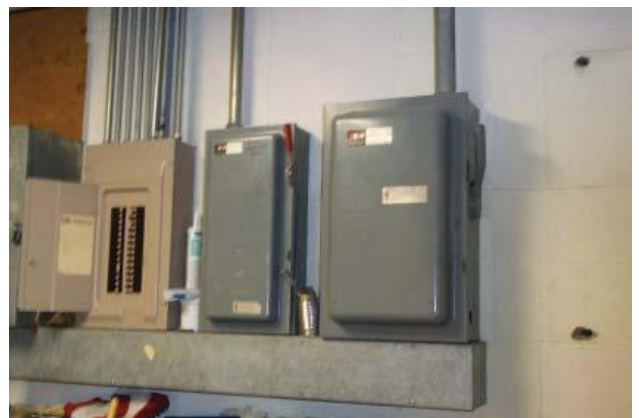
Multiple metering cabinets, load centers, and switches. (2012)

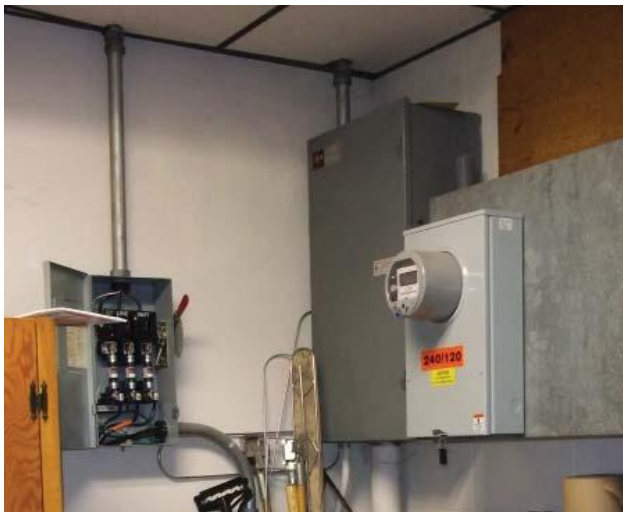
Multiple metering cabinets, load centers, and switches. (2012)

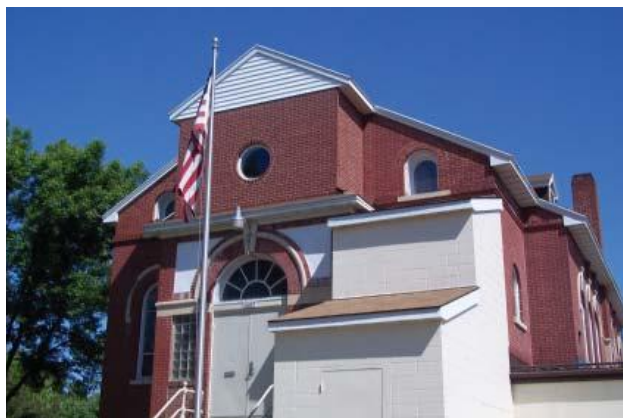
Exterior lighting fixtures. (2012)

- C. In general, all interior lighting fixtures should be considered for replacement with new fixtures using modern, energy-efficient lamps and ballasts.
- D. Exterior lighting is marginal, but probably adequate for the current needs. Although the original building has historic interest, the exterior lighting is mostly HID-style "farm lights". There is a flagpole at the entrance to the original building, but no flagpole lighting was observed. Control of the exterior lighting appears to be by photocell only (dusk to dawn operation).

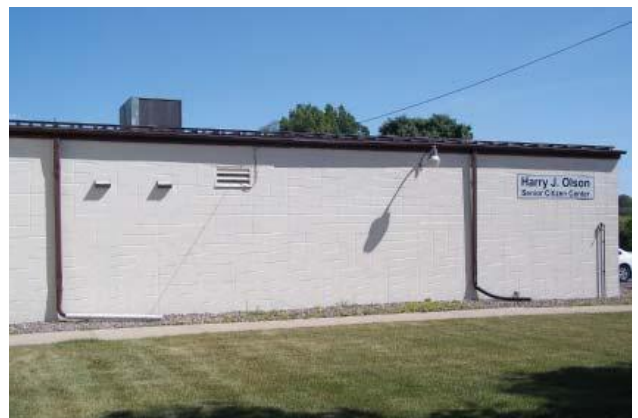
Exterior lighting fixtures. (2012)

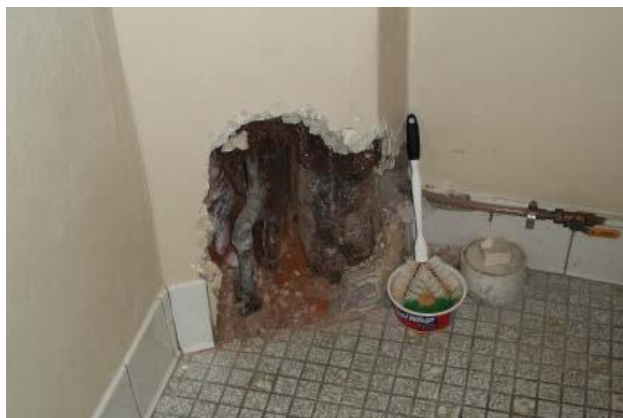
- C. In the original building, the wall has been opened in at least one location to access piping. It is not known if this was for sanitary drainage problems, or other reasons.

- D. The age of the original sanitary drainage piping is of some concern. Since much of this piping is not accessible, there is little to do prior to

Opening in wall to access piping. (2012)

problems developing. As new construction is contemplated, it would be best to abandon any existing sanitary drainage piping and to replace with new materials as much as possible.

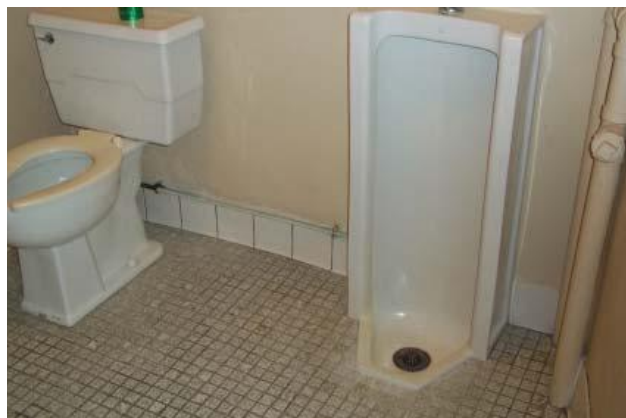
Lower level men's room in original building. (2012)

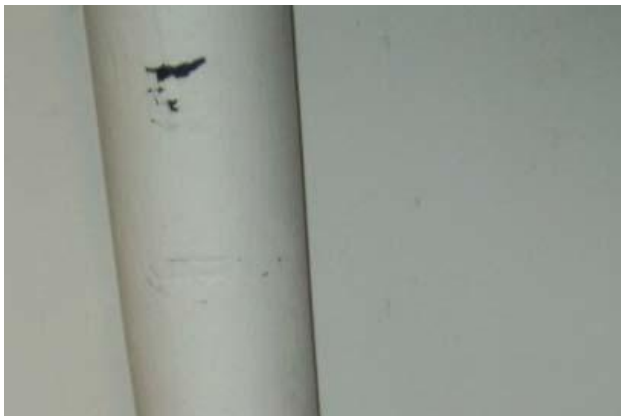
- A. Since there are no fire sprinkler systems currently installed within this building, there are no related alarm systems. There are no flow switches or other means to signal that the fire standpipe system is in operation.

Fire hose water supply pipe. (2012)
