Southside Senior Center
La Crosse, Wisconsin

6 September 2012 ARCHITECTURAL AND ENGINEERING ANALYSIS

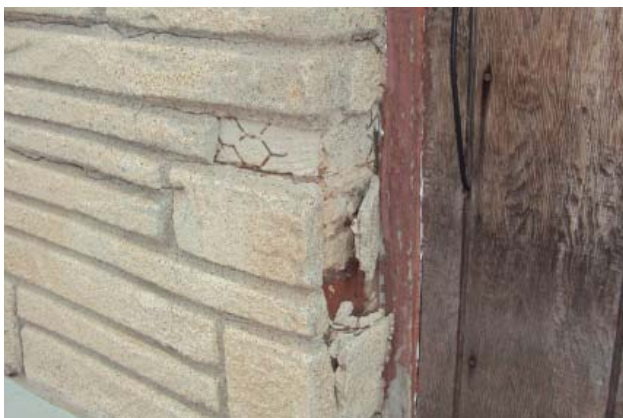
"Stone" patterned stucco on main facade. (2012)

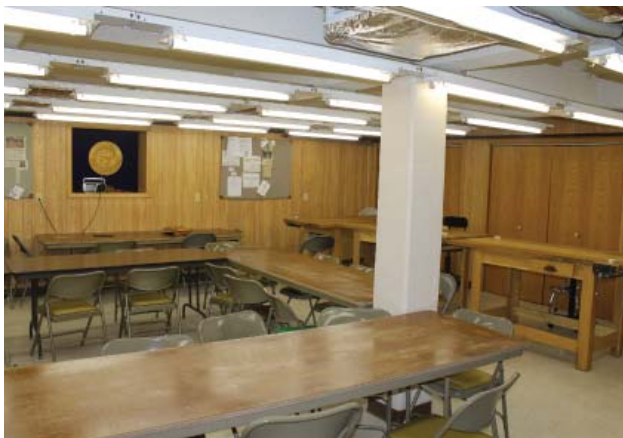
General view of basement toward northwest. (2012)

The basement of the Southside Senior Center is in generally good condition. It is used regularly and is well maintained. The finishes are dated but functional. There is some deterioration of the paint along the west wall at the ceiling. This was likely due to previous water issues that have been remedied with completed exterior drainage work. The interior of the closets lining the north end of the main room are not completely finished with untaped/mudded/painted gypsum wall board (GWB) and exposed insulation.

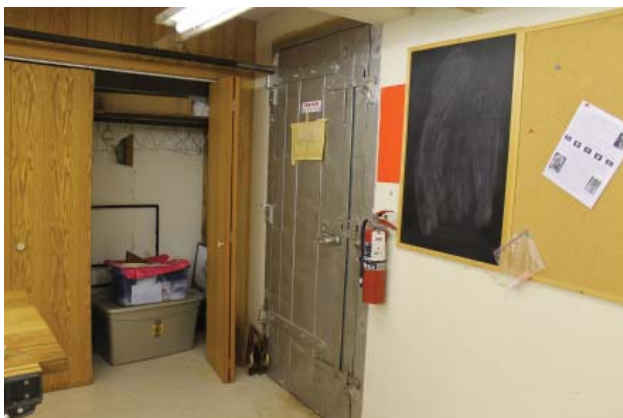
Closet on north wall and entrance to mechanical room. (2012)

wall, and a gypsum board wall. Penetrations through these walls are also unprotected. The frame on the door to this room is split at the head and should be repaired.

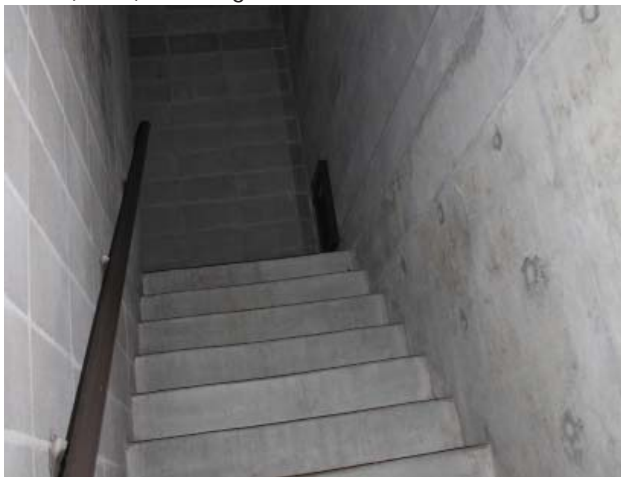
1977 Stair tower addition. (2012)

The 1977 stair and elevator addition are in fair condition and provides the most compliant means of egress from this space. The stair under current code requirements should have handrails on both sides of the stairs and at present only has one. As an existing building this is not required to be updated unless other work in the building is being done. The elevator mechanical room is in good condition. The original stair is in fair condition, this stair enclosure should have a one-hour fire-resistance-rating to separate it from the remainder of the building however.

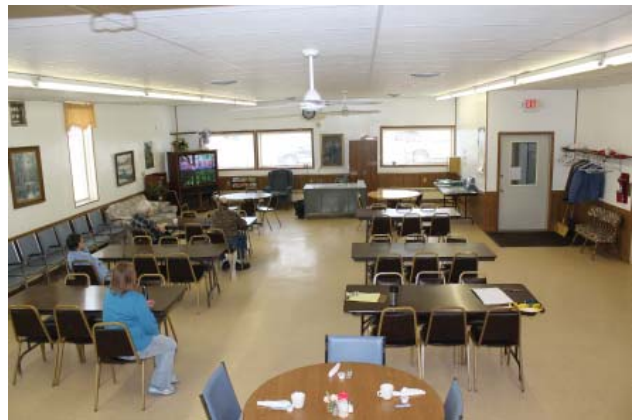
General view of main floor toward the north. (2012)

The main gathering space of the building is the first floor multi-purpose room. It is in good condition and does not require anything more than general maintenance to be continued. The drinking fountain for the

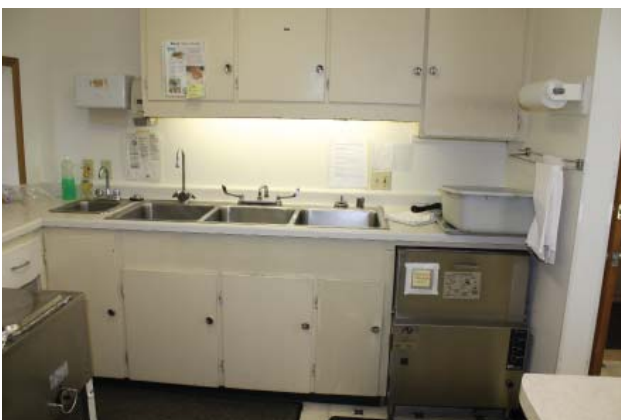
Sink area of first floor kitchen. (2012)

The kitchen is separated from the main room by a thickened wall with two pass-throughs and a door. The kitchen itself is in good condition. The appliances are older but functional. The layout of the sinks is not conducive to efficient work within the space. Also each of the sinks has a different style of faucet adding to the inconsistent appearance of the room. The

cabinetry is in fair condition but would benefit from a new coat of paint.

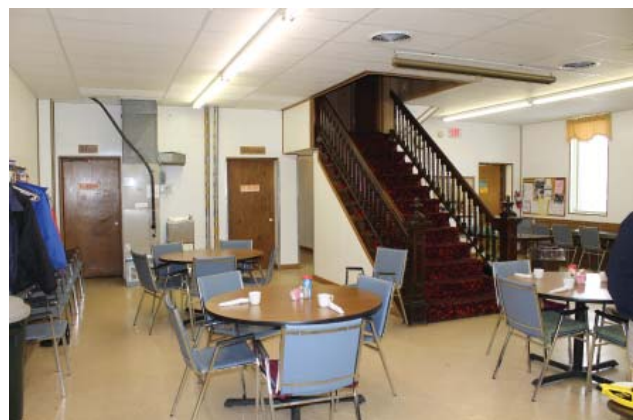
Original staircase to second floor in main space. (2012)

The original stair to the second floor is in good condition from the first floor to the first landing and overall has retained its historic integrity to this point. However, from this landing upward code violations and infill construction have altered this stairway. This stair is currently designated as the second means of egress from the second floor. The stair if not a required exit does not need to be enclosed. The enclosure that has been constructed violates code requirements for landings at stairs in the location of the door and is not a rated enclosure.

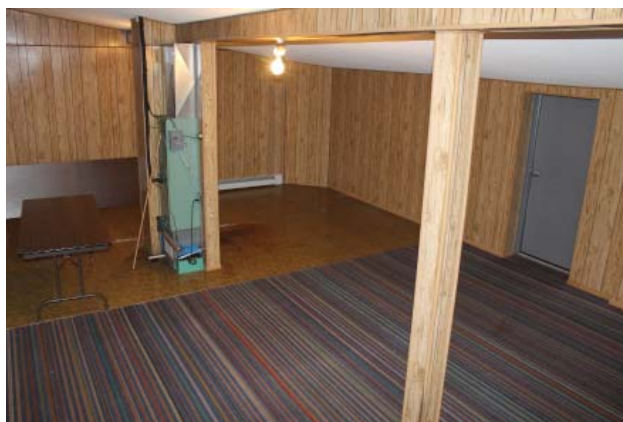
South end meeting room. (2012)

The meeting room at the south end of the second floor is not an accessible space. It is through this room that another means of egress is achieved from the second floor via an exterior stair. The room's finishes consist of plywood paneling on the walls, an gypsum board ceiling, and a combination of wall-to-wall carpet and vinyl flooring. These finishes are generally in fair condition. The carpet is stained and the vinyl flooring is ripped and stained. The replacement of these finishes should be considered.

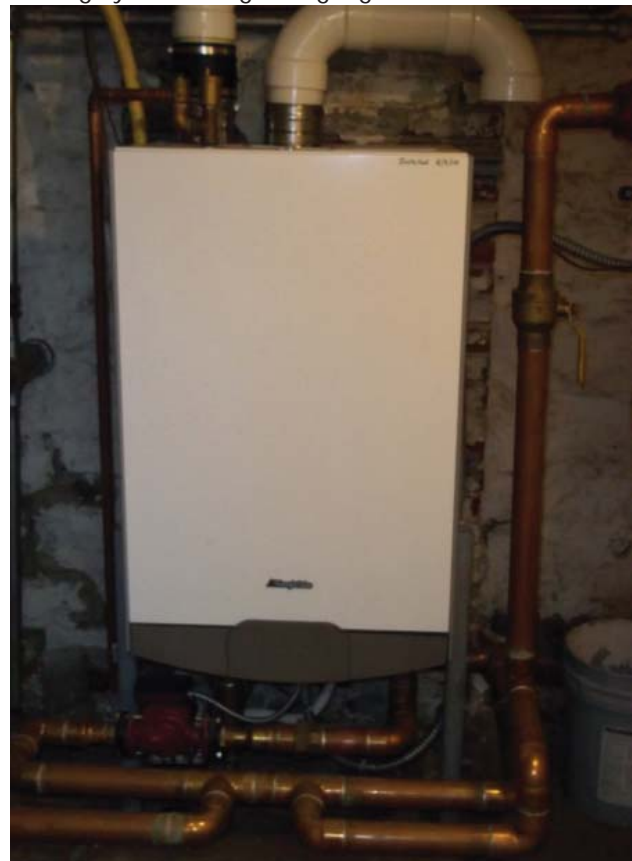
New boiler installed in 2010. (2012)

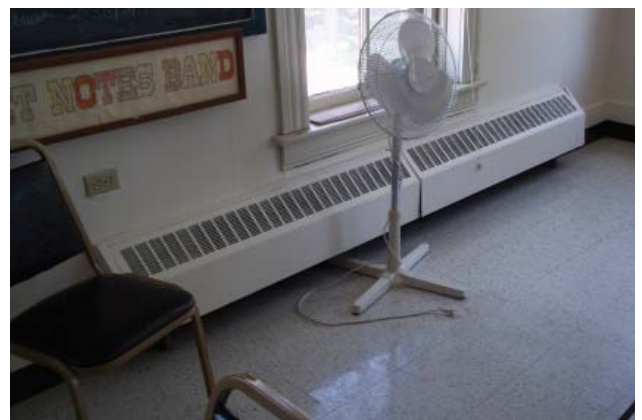
- A. The piping connecting the boiler plant to the finned tube radiation is a combination of both steel and copper. The older piping is presumably

Finned tube radiation heating equipment. (2012)

steel and the newer material is copper.

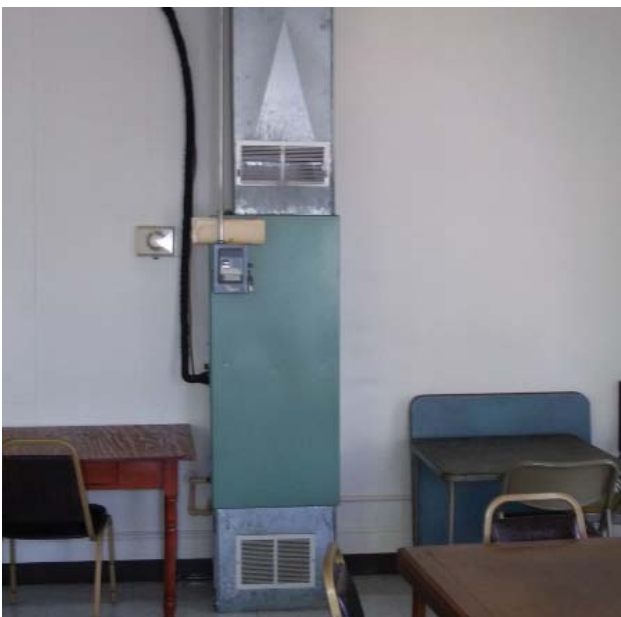
These systems consist of a vertical fan-coil located directly within the occupied space connected to a compressor-condensing unit located

Cooling system vertical fan-coil. (2012)

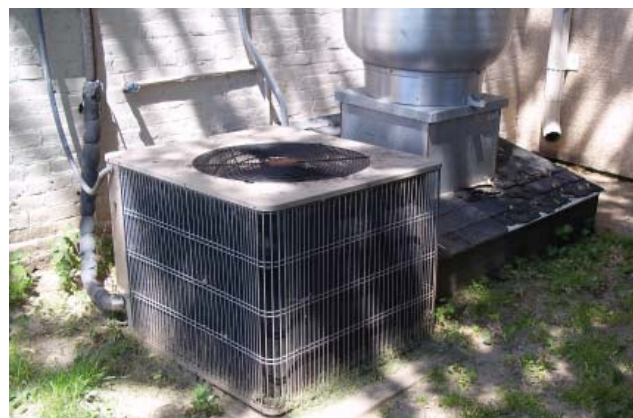
Exterior compressor-condensing unit at grade. (2012)

exterior to the building. One of the compressor-condensing units is located on grade and two are located on the roof. These systems have no outside ventilation air capabilities. The First Floor unit is approximately 5 tons in capacity and the Second Floor units are approximately 2 tons in capacity.
