# Assessment of Condition and Maintenance of Public Art La Crosse, WI 2021

On-site inspections completed by Luke Achterberg, Adam Oldre, and Michael Martino

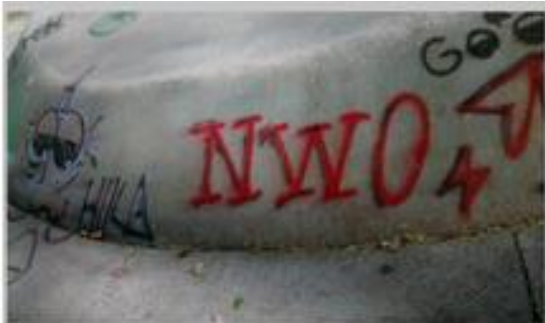
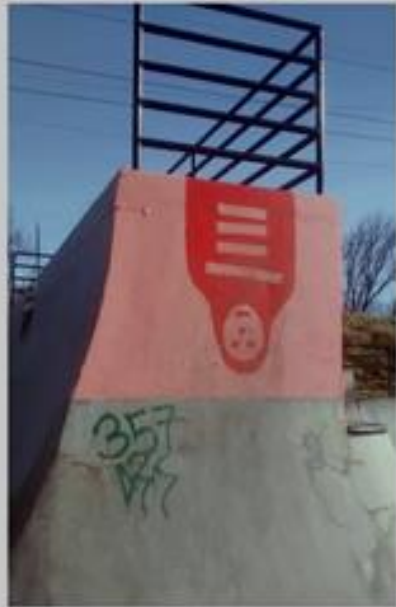
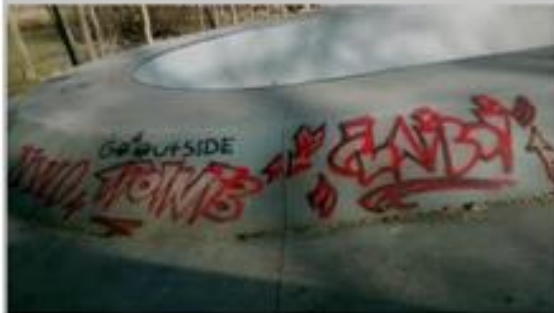
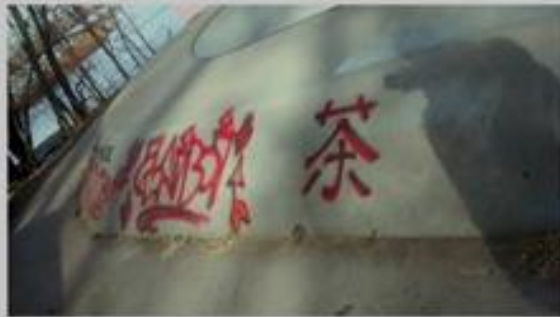
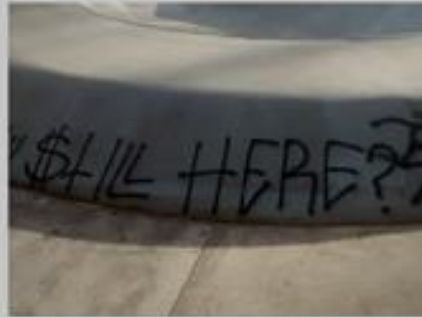
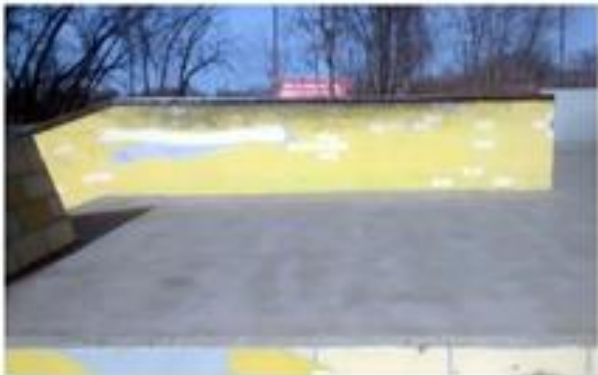
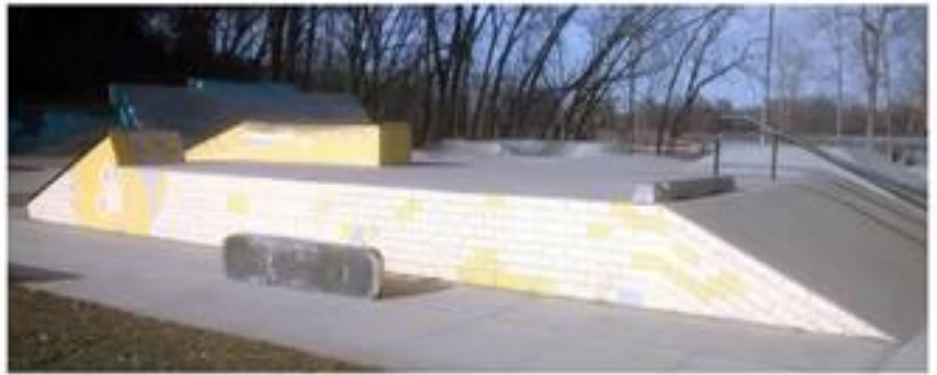
- Condition – Good.
- Some murals have abrasions due to activity.
- Tall weeds obscuring mural on the north wall.
- “Tagging” in several locations, unclear if it was allowed or vandalism.

- Inspect and clean annually.
- Touch up paint in high activity areas every five years.
