Architectural & Engineering Analysis

North Community Library

1552 Kane Street
La Crosse, Wisconsin

April 2026

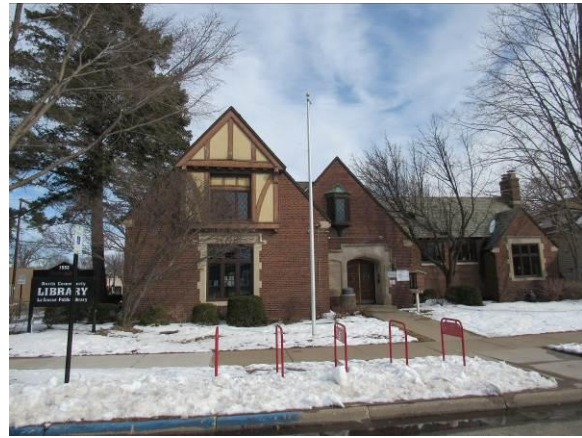
The above-grade walls on the west facade of the building are in fair-to-good condition. The brick shows little to no signs of deterioration, but sections of wall show signs of moisture saturation near grade. This is mostly caused by melting snow and backsplash from water running off the roof. Eventually, rising damp and backsplash from the roof will erode the mortar joints and increase the chances for brick spalling during freeze-thaw cycles. Adding gutters and creating a better slope away from the building would correct this situation. The limestone has held up very well and is in fair-to-good condition.

Figure 10 – Overall view of the west facade (2026).

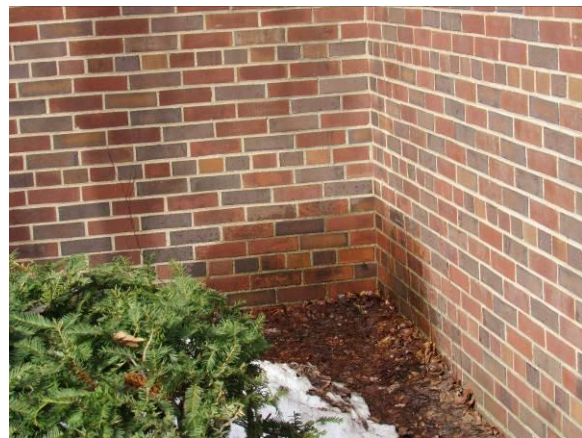
Figure 11 – Water runs off the roof, splashes at grade and saturates the walls (2026).

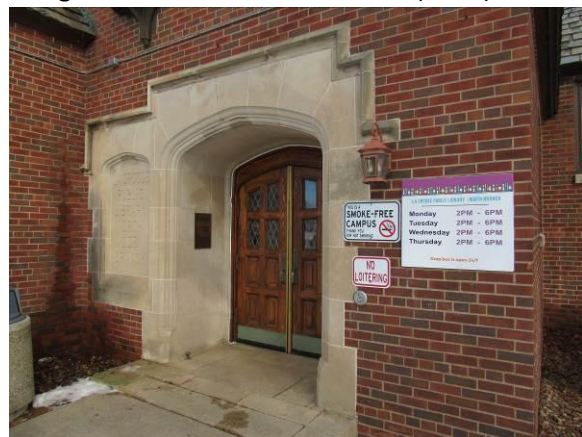
The stained wood entry doors appear to be original and have been well preserved over time. The brass hardware has patinaed gracefully over the years. This entry adds a great amount of historic character to the building. The doors operate well and the entire system is in fair-to-good condition. The windows are less than twenty years old. They have replaced earlier leaded glass windows. The loss of historic building fabric is unfortunate, but the new double-glazed windows are in fair condition. They loosely resemble the original windows with simulated divided lites. As long as the glazing seals hold, the windows still have years of serviceable life left. The sealant used around doors and windows appears to have been installed within

Figure 12 – Original front doors deeply recessed in the wall (2026).

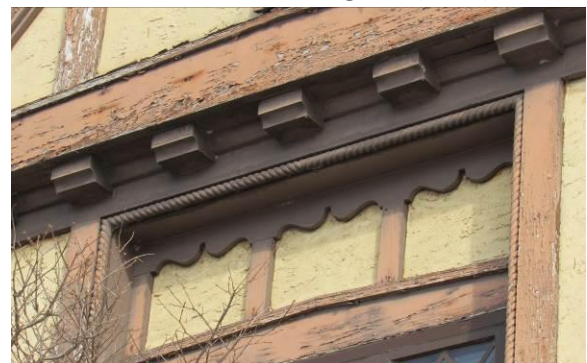
Figure 15 – The stucco and trim have exquisite detail, notice the rope mould and brackets (2026).

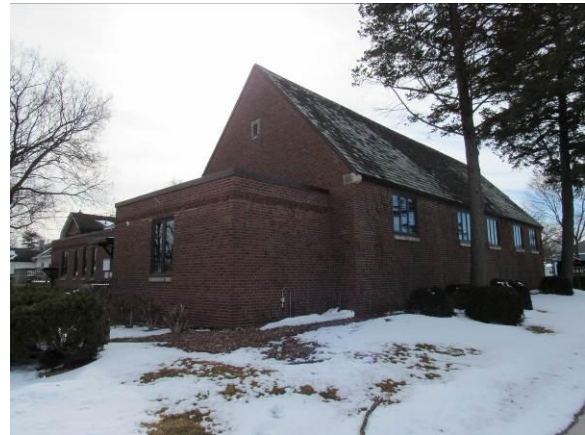
All five of the window openings have modern double-glazed window inserts installed. These windows have some minimal SDL to approximate the leaded glass windows that were removed. Each opening has three fixed window units. There is a flat steel header across the top with no special brick detailing. All openings have a limestone lug sill with a drip edge. No rust or other deterioration was noted at the time of this report. The windows appear to be in fair condition. The north façade of the building has no door openings.

Figure 16 – Overall view of the north façade looking southwest (2026).

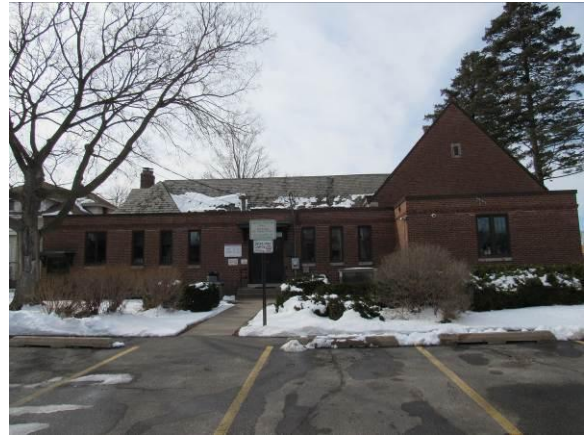
There are two door openings on the east façade, one at the midpoint of the façade and one at the southeast corner. The middle entry has a pair of modern doors that appear to have a fiberglass cladding, with a wood transom above. These doors are in fair condition. The south door is a wood rail and stile door, possibly original, and is in fair-to-poor condition. At a minimum it needs to be repainted. The windows are all modern replacement inserts that are in fair condition.

Figure 19 – Overall view of the east facade (2026).

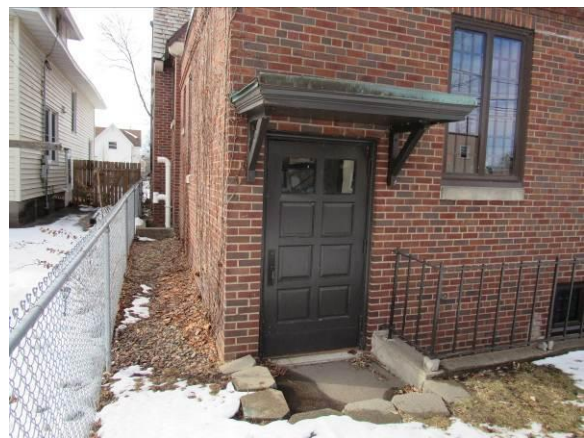
Figure 20 – Grade is above the threshold for the door leading to the basement (2026).

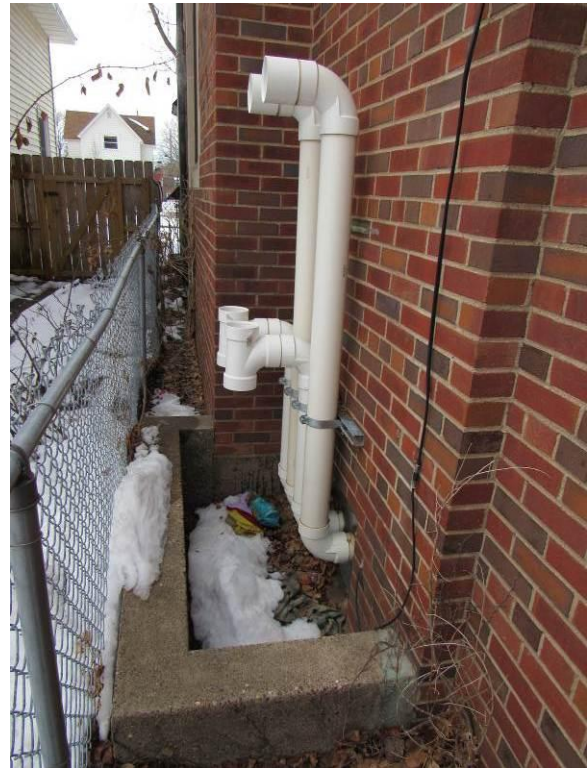
Figure 23 – Intake and exhaust for the HVAC are in a window well (2026).

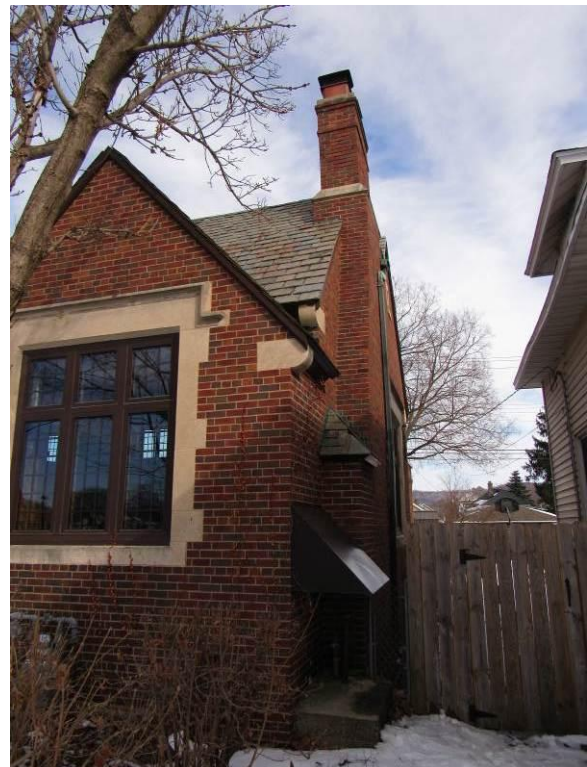
Figure 24 – The fence restricts access to the south facade (2026).

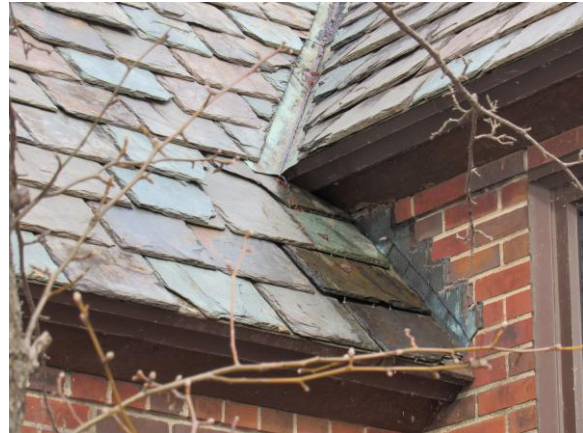
There are no gutters on the building. This is problematic because it allows storm water to

run off the building, saturating the soil and splashing back against the masonry. The gables on the roof also create pinch points where water is concentrated onto a small area of roof. The most concentrated spot is just to the north of the entry. The flat roof sections on the east have roof drains and overflow scuppers, discharging storm water to grade.

Figure 25 – Copper valley and step flashing is used to channel water off the roof (2026).

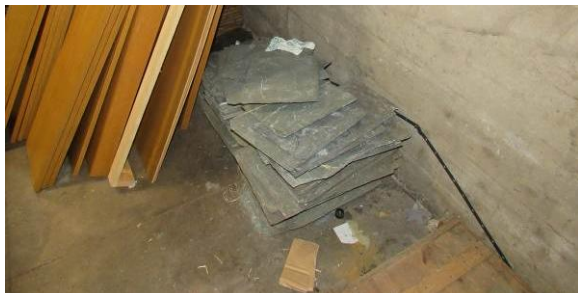
There are quite a few remnants in the basement. In addition to doors and cabinets, there is a stack or extra slate shingles that can be used to repair the roof. These should not be discarded even if the building is sold.

Figure 31 – Attic stock of slate roof shingles (2026).

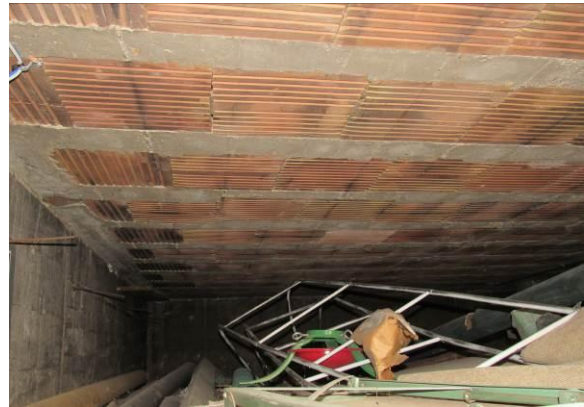
The ceilings throughout the basement are a mixture of plaster, wood fiber acoustic ceiling tile, and the exposed concrete floor structure. The plaster is in fair-to-good condition in most locations; however, there are a few sections in the mechanical areas that have been damaged by duct and pipe hangers. The wood fiber ceiling tiles are in fair condition, but have been painted thus losing their acoustic benefits. The exposed concrete joist floor system is in fair-to-good condition. Very few of the hollow clay tile pans have been damaged.

Figure 32 – Underside of concrete floor joist system (2026)

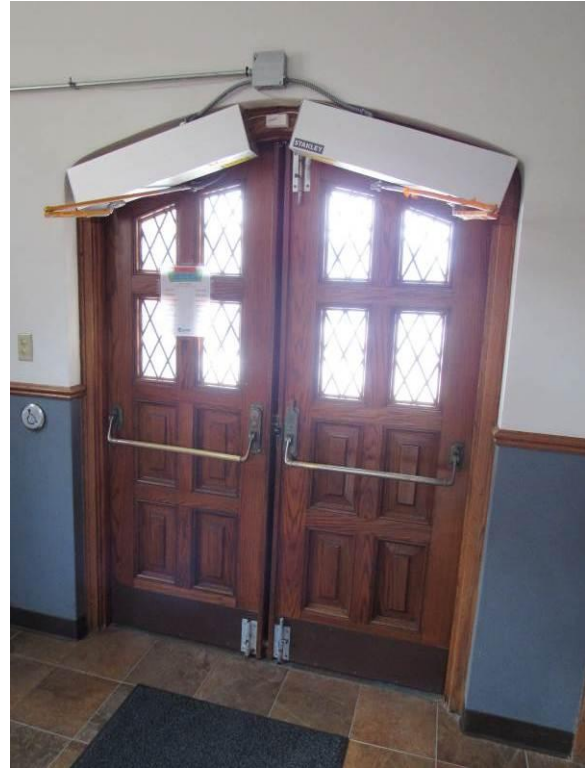
Figure 38 – The front doors have auto-operators to try and meet ADA req's (2026).

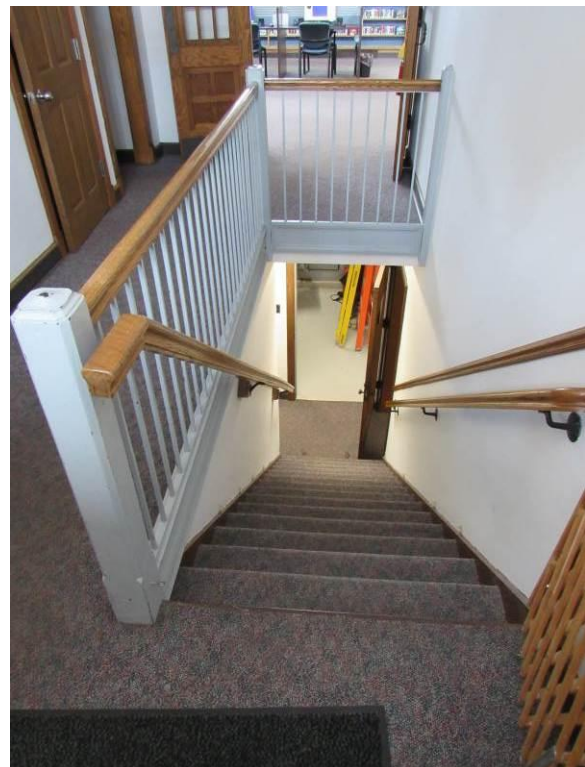
The main stair to the basement is of steel construction with concrete treads. The treads are currently covered with carpet. The stair is open to the back hall and is protected by a steel guard rail. The stairs are in fair-to-good condition with the exception of the carpet. Depending on the future use of the building, the stair may be allowed to remain open.

Figure 39 – Steel stairs to the basement meeting rooms and mechanical (2026).

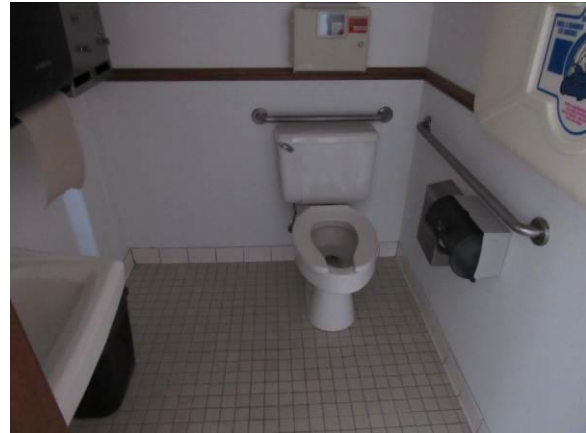
Figure 41 – The restrooms do not appear to be large enough to comply with current ADA requirements (2026).

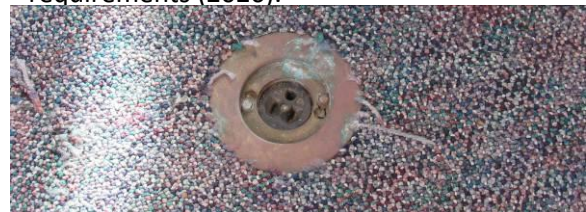
Figure 42 – Floor outlets may contain old wiring (2026).

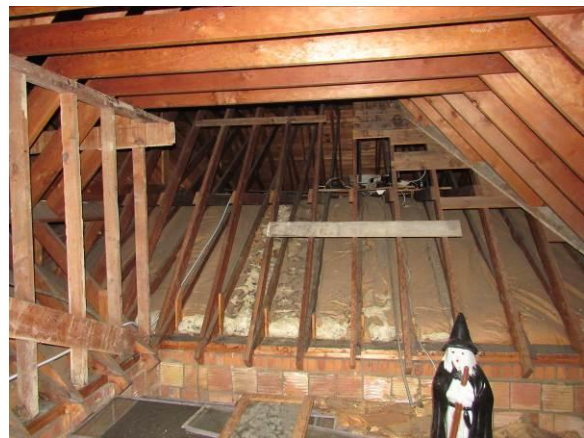
The windows into the attic are modern replacements matching the first floor. They are in fair condition. Much of the attic has insulation, but not enough to meet modern standards. There is batt insulation between ceiling joists. Some newspapers were discovered on top of the insulation. They date from the 1950s, it is unknown if this indicates the date the insulation was installed, or if the newspapers were left up there for some other reason. The insulation is in poor condition.

Figure 45 – Most of the attic has exposed roof structure with insulation below (2026).

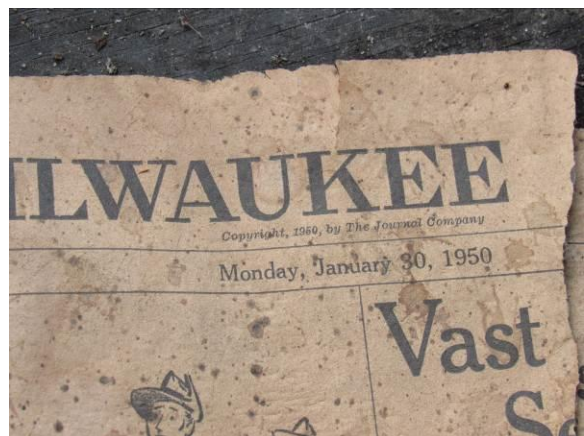
Figure 46 – Newspapers from the 1950s were discovered on the insulation (2026).

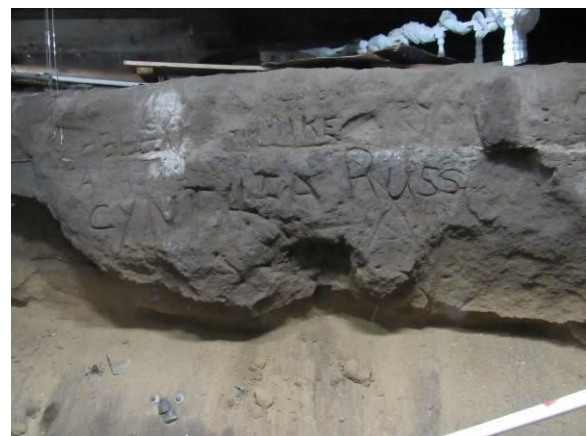
Figure 50 – Rock ledge at the north edge of the basement (2026).

The spring thaw was in progress at the time of this report. Most of the basement appeared to be dry. Only one small section of wall in the south stair had evidence of moisture.

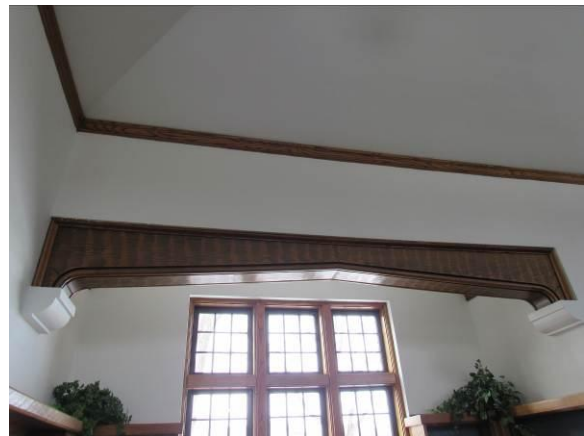
Figure 54 – The wood beams at the openings are decorative, the structure is above (2026).

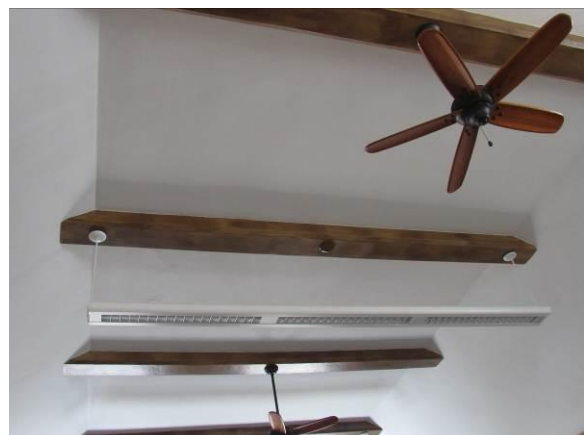
Figure 55 – The faux beams at the ceiling are decorative, not structural (2026).

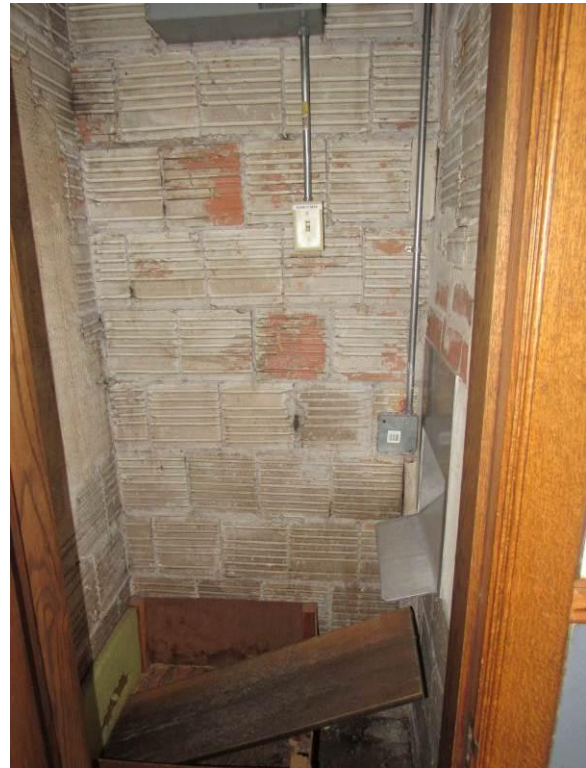
The exterior walls above grade are multi-wythe brick and clay tile bearing walls. These walls are in fair condition in most locations with areas around grade showing signs of moisture saturation. The chimney on the south side of the building had some deterioration of the mortar joints which will require tuckpointing. The area around the window heads on the east and south sides of the building have some slight brick displacement. This may have been caused by the steel lintels rusting. The building appears to be completely constructed out of a reddish-brown brick blend, except for the limestone trimmings around various door and window openings. This brick is significantly harder than the old La Crosse orange brick. Due to the period of construction, a mortar with some Portland Cement was probably used. The inner and outer wythes of masonry are tied together with a row of headers every sixth course. This is a good detail and was also noted on the interior face of the walls in the attic.

Figure 56 – The exterior masonry walls have an outside layer (wythe) of face brick and an inner layer(s) of hollow clay tile (2026).

The masonry on all exterior walls of the building needs a small amount of work. All deteriorated mortar joints should be re-pointed with appropriate mortar. As stated above, this brick is much harder than earlier local brick. For common bricks of this vintage, Type N mortar may be appropriate, but harder mortars such as Type 'S' should not be used. This building probably had mortar with some Portland cement used in the original construction. The original specifications are located at the public library archives and may have the original mortar mix called out. The largest area requiring masonry repairs is the chimney on the south wall of the library. The other area to monitor is the line at the window heads to the south and east sides of the building.

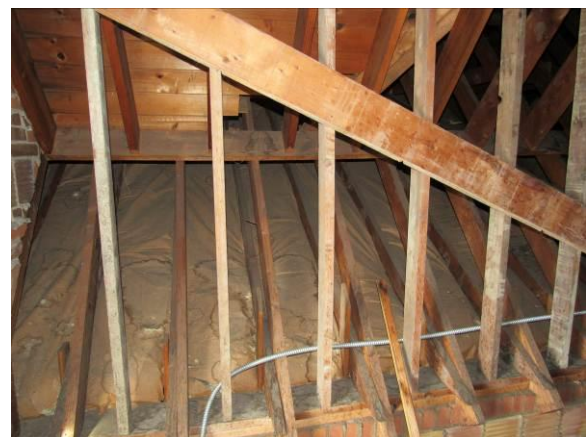
The roof framing is composed of wood joists bearing on the exterior brick walls. This roof structure has two main framing systems. The gables have rafters and collar ties with cross bracing. This roof was well designed due to the weight of the slate roof. The roof drains to eaves around the perimeter of the building. Not having gutters is creating a water issue at grade. The flat roof areas were completely concealed and could not be verified. It was common to use wood framing for flat roof structures during this period. Maintenance stated that there was a small leak somewhere near the southwest corner of the building.

Figure 57 – The attic is a mixture of walls, rafters and collar ties all constructed with dimensional lumber (2026).

The roof appears to have been well maintained, but there is apparently a small leak(s) at the southwest corner. This will need to be repaired. The roof appeared to be very well constructed. When it is time to replace the roof, a lift and relay should be done to preserve the slate. During this process any rotten or damaged wood framing members can be reinforced or replaced. The flat roof areas just had repairs done recently. The biggest thing to

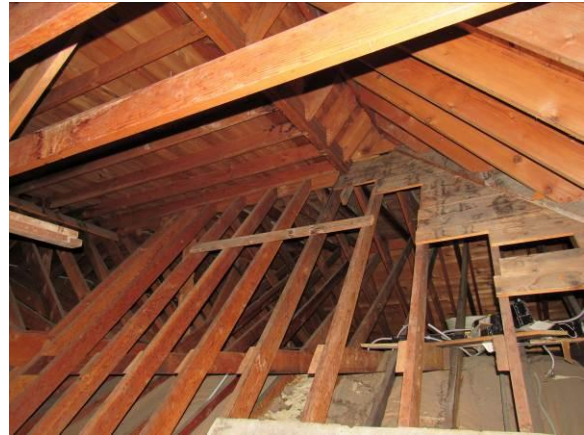
Figure 58 – Complex roof forms meet over the front entry with parallel gables and a cross gable, notice the cross bracing and collar ties (2026).

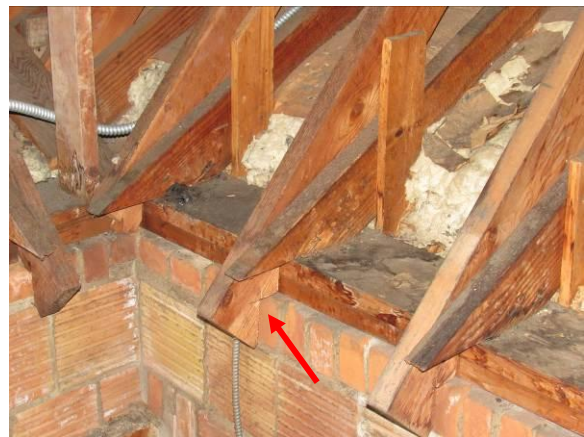
Figure 59 – Rafter ends were cut with a bird's mouth over the sill plates (2026).

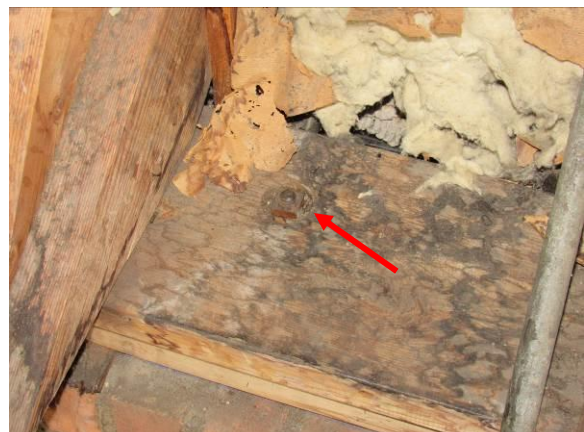
Figure 60 – Sill plates have anchor bolts embedded in the masonry below (2026).

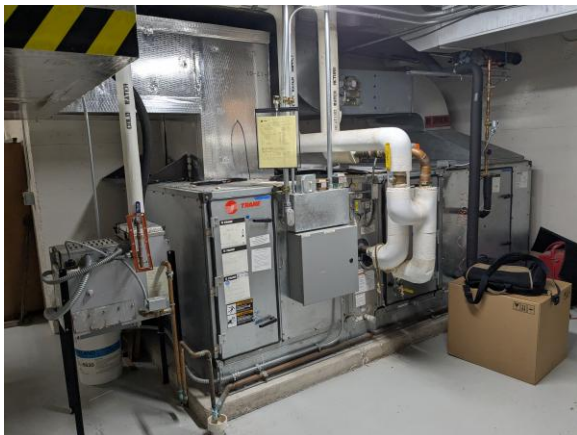
All of the major mechanical components have been replaced within recent years and appear to be in very good condition. The mechanical rooms are in exceptional condition and routine maintenance looks to be a high priority for this facility.

The original heating system was some type of furnace with under-floor ductwork radiating from the basement mechanical room to a combination of floor registers and wall registers located uniformly throughout the building. The furnace has now been replaced with a modern air handling unit which can supply both heat and mechanical cooling (air conditioning) to the building using the same underfloor ductwork.

Figure 61 – New Air Handling Unit in Basement (2026).

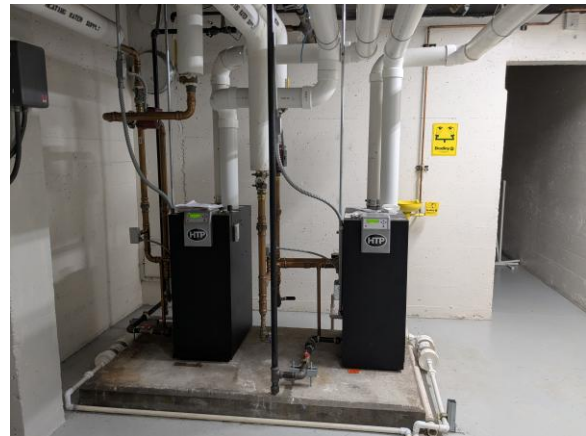
Heat is supplied from a new, modular, high-efficiency boiler plant comprised of (2) nominal 300,000 BTU/Hr. boilers. The boilers would appear to be the same age as the air handling unit. The boiler design is a traditional “primary-secondary” concept allowing for complete independent operation of a single boiler, if needed, while operating at peak efficiency.

Figure 62 – New Hot Water Boiler Plant in Basement (2026).

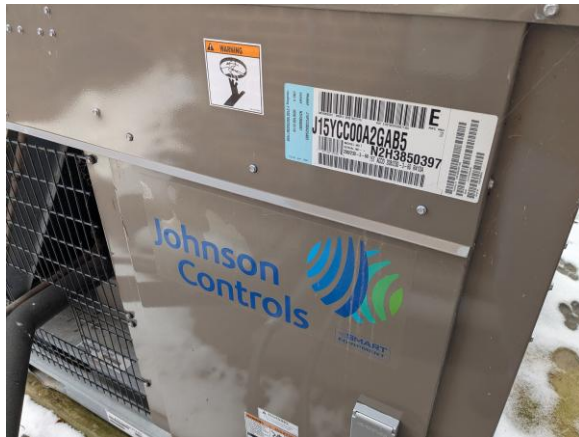
The air handling unit is **Trane**-brand unit, but the compressor-condensing unit appears to be newer and is a **Johnson Controls**-brand unit. Presumably the Johnson Controls unit replaced a similar unit that likely was Trane brand and installed at the same time as the air handling unit.

Figure 63 – New Air Conditioning Unit installed on Grade outside Building Entrance (2026).

It should be noted that the compressor-condensing unit, although quite new, uses R-410A as a refrigerant. As of this year, R-410A is being phased out of production for environmental reasons. It will have no impact

on the use of the unit for its likely life expectancy, but should the unit fail prematurely, or when it does require replacement, the entire refrigeration system might need to be modified or replaced to work with new refrigerants. This should not be construed as a negative point. R-410A has been the refrigerant of choice for nearly 30 years. Refrigerant for routine maintenance will be available for many years.

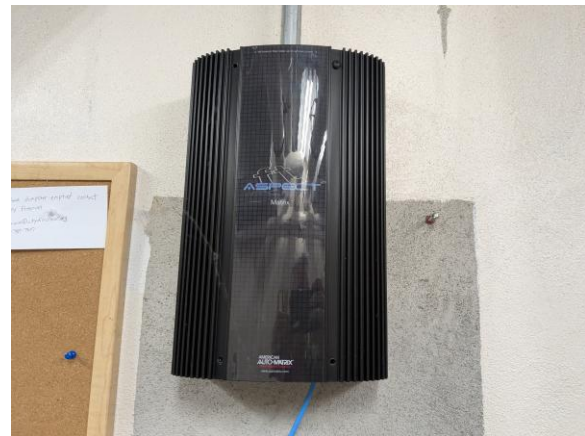
The heating-cooling plant at this facility is not controlled by a simple room thermostat. A true “energy management” system is installed to control the operation of the various components. The control system here is an **American Auto-Matrix** brand system. **Winona Controls, Inc.** out of Caledonia, MN is the local representative for American Auto-Matrix. While the system should operate on its own, any potential new buyer or user of the facility will want to maintain a relationship with **Winona Control, Inc.** to help with control of these components and to stay up to date on software upgrades.

Figure 64 – Energy Management System installed at this Facility (2026).

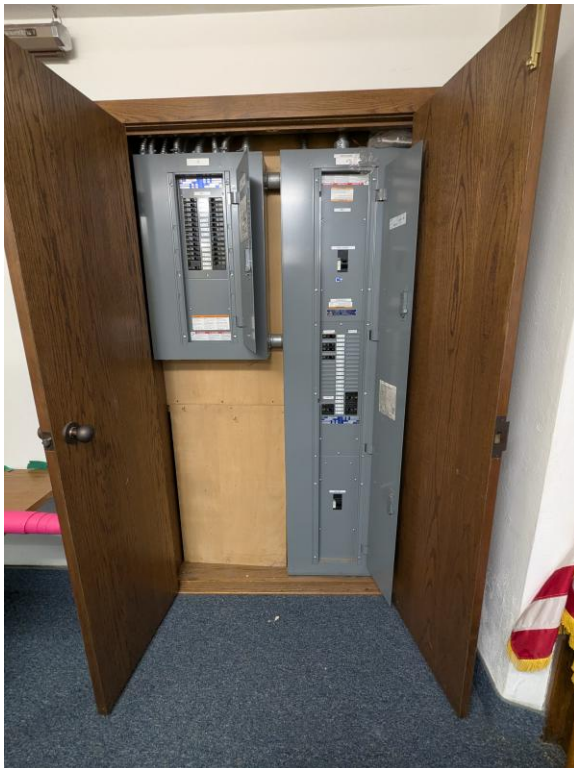
The electrical service and entire main distribution system has been replaced in recent years. The service entrance panelboard and majority of the distribution equipment is located in a closet in the Basement level.

Figure 65 – New Electrical Service and Distribution Equipment (2026).

The electrical service is a 240/120 VAC, three phase, four wire “Delta” service with a “B High Leg”. This is an older service configuration

It is believed that these new panelboards replaced old distribution equipment in the same location and that existing branch circuits were likely re-used and re-connected to these new panelboards. Flexible conduit is visible at these new panelboards and electrical devices observed in the Library are clearly not new.

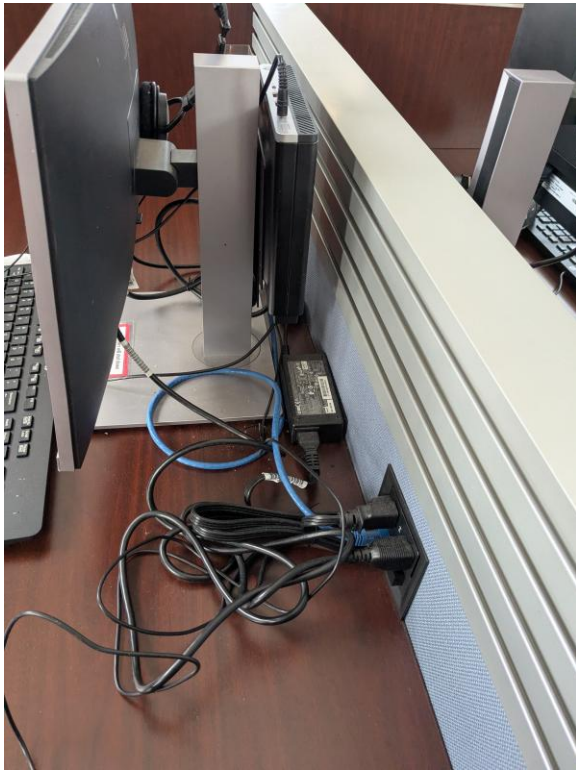
Electrical devices located in the Library are a mix of new and old. During some remodeling, a row of computer workstations was installed. The wiring at these locations is part of modular furniture and clearly is modern and relatively new.

Figure 66 – New Electrical Devices in Modular Furniture (2026).

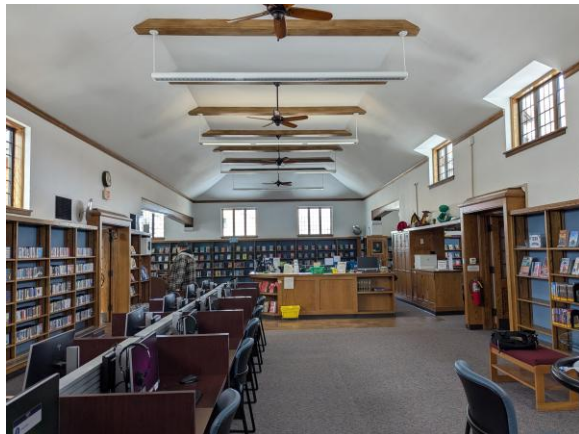
The main rooms of the Library are fitted with modern “linear” lighting with both an uplight and a downlight component. This was a good choice using the vaulted, white-painted ceilings at large reflectors to illuminate the space.

Figure 68 – Lighting in the Main Level of the Library (2026).

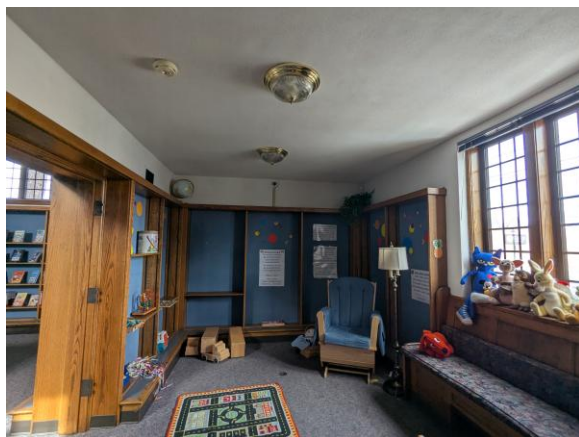
In rooms with lower ceilings, the lighting is a combination of decorative and utilitarian. The rooms with decorative lighting are under-lit by modern standards. The rooms with utilitarian lighting provide good lighting levels.

Figure 69 – Lighting in the north reading room of the Library (2026).

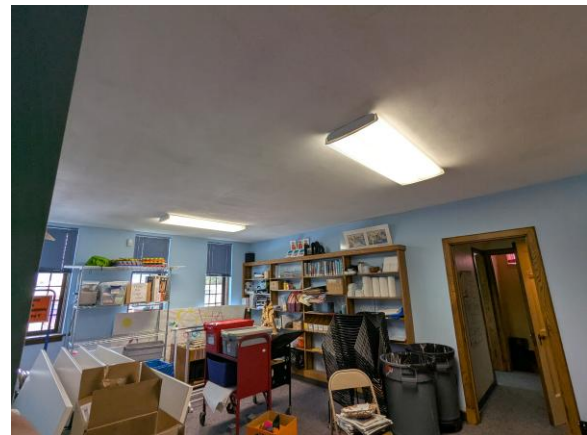
Figure 70 – Lighting in Other Areas of the Main Level of the Library (2026).

There are opportunities for lighting improvements, but in general, the lighting is adequate, functional and in physically good condition.

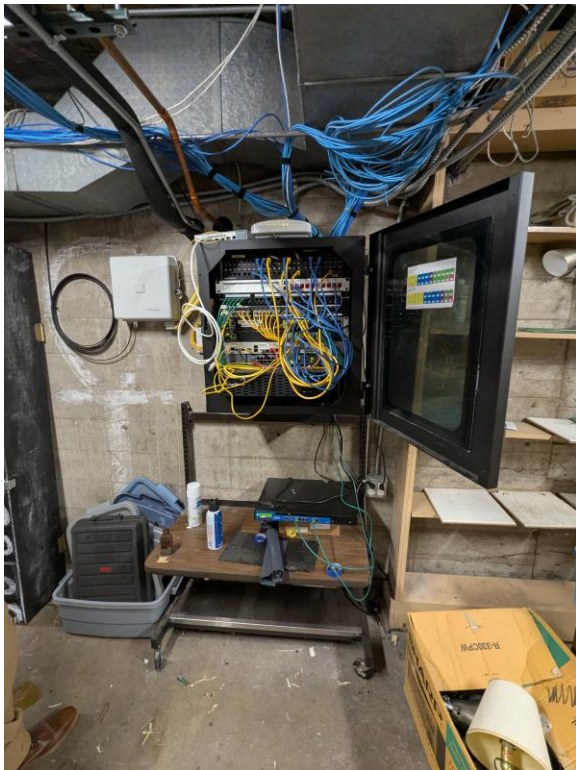
Currently the building has an extensive array of modern communications wiring, although the City of La Crosse intends to remove all of the electronics when they vacate the building. The building wiring (mostly Category 5 or better) will remain for reuse.

Figure 72 – Communications Equipment in the Lower Level of the Library (2026).

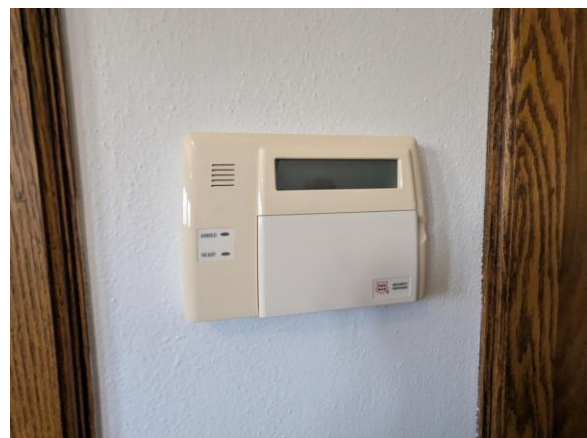
The main portions of the Library are fitted with wall-mounted cameras. Motion detectors are assumed to be present, but not documented. **PerMar** is the current system vendor.

Figure 73 – Security System Keypad at Main Library Entrance (2026).

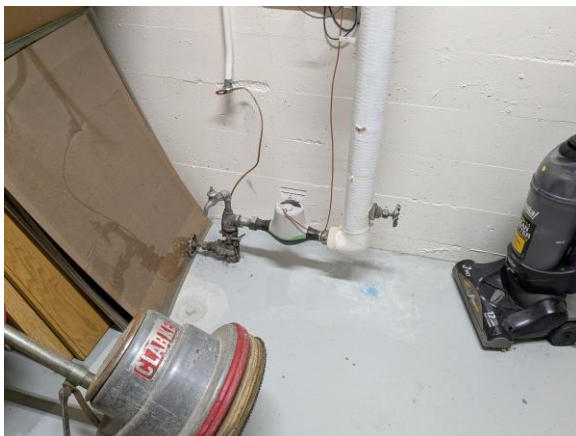
Water supply comes from the La Crosse municipal system and enters the building through the Basement level floor. The water supply pipe appears to be original to the building construction. The main control valve is an old gate valve and there is a water quality sampling valve installed upstream of the meter, which is not done anymore.

Figure 74 – Domestic Water Service Entrance and Water Meter (2026).

The water meter is 1" size, which is probably too large for the actual plumbing fixtures within the building, but might be needed for the lawn irrigation system.

All of the water supply piping in the vicinity of the water service entrance is older galvanized steel piping and all valves are generally old gate valves. Despite the age, there is no evidence of any current leakage, or any past leakage.

Plumbing improvements probably want to occur with building renovations. Everything seems to be functional and in good working order. Normally we would recommend replacing old valves with new valves to ensure they will actually work when needed. That would be recommended here as well, but replacement of these old valves might result in pipe damage and a greater project than intended.

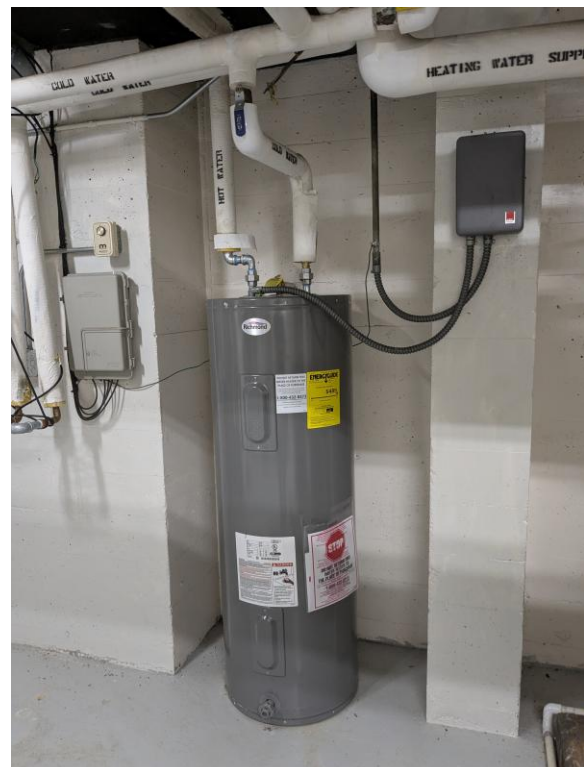
The single water heater is a new electric heater of 50 gallon capacity with standard 4,500 watt heating elements. The water heater is electrically fed through a timeclock so it can be disabled during portions of the day.

Figure 75 – Domestic Water Heater (2026).

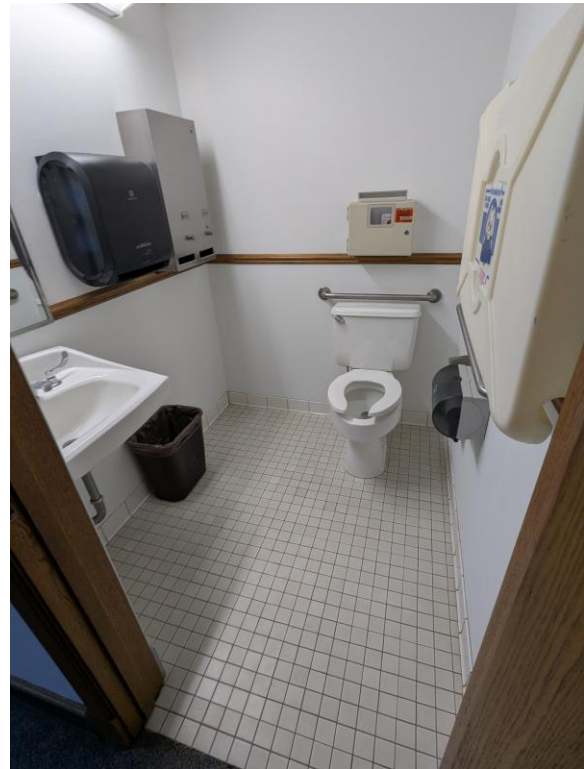
All three toilet rooms contain a single water closet (toilet) and a single lavatory (sink). Water closets are “residential” floor-mounted, tank flush units in all locations. The lavatories are all wall-hung with manual faucets. The renovated public toilet rooms were clearly remodeled to meet handicapped requirements at the time, with grab bars for the water closets and long lever handles (wrist blades) on the lavatories.

Figure 76 – Main Level Public Toilet Room (2026).

All of these toilet room fixtures appear to be in satisfactory condition and fully functional. No issues were observed.

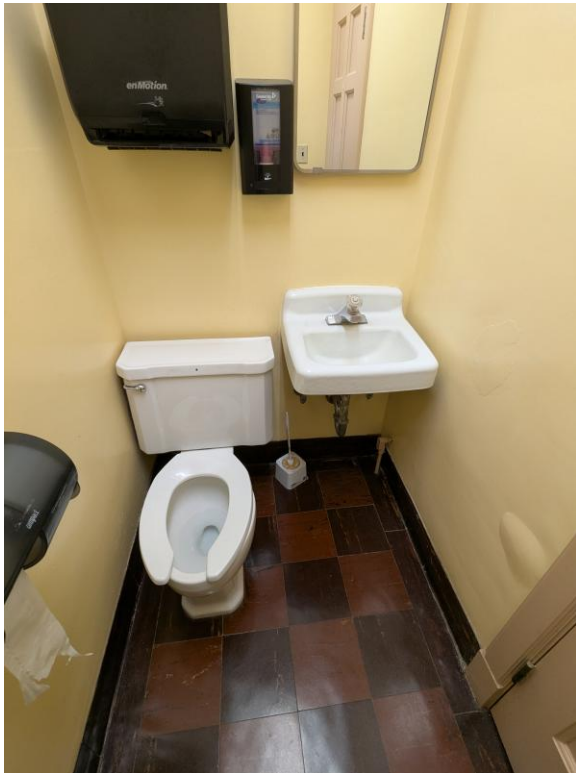
Figure 77 – Staff Area Toilet Room (2026).

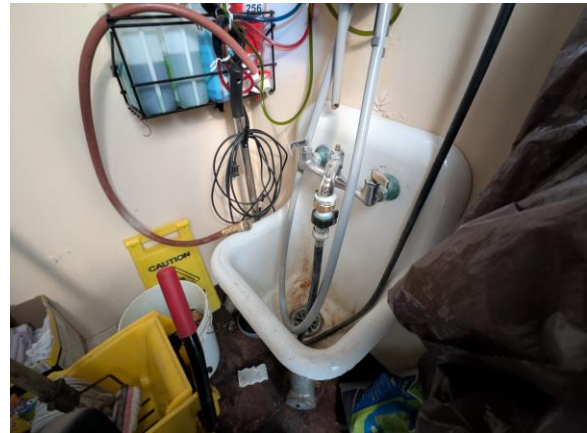
There is also a Janitor Closet with service sink on the Main Level of the Library in close proximity to the public toilet rooms. A traditional service sink is located in this room. The sink is showing its age, but appears to be in satisfactory condition considering its likely age. The sink is clearly used on a regular basis.

Figure 78 – Janitor Closet Service Sink (2026).

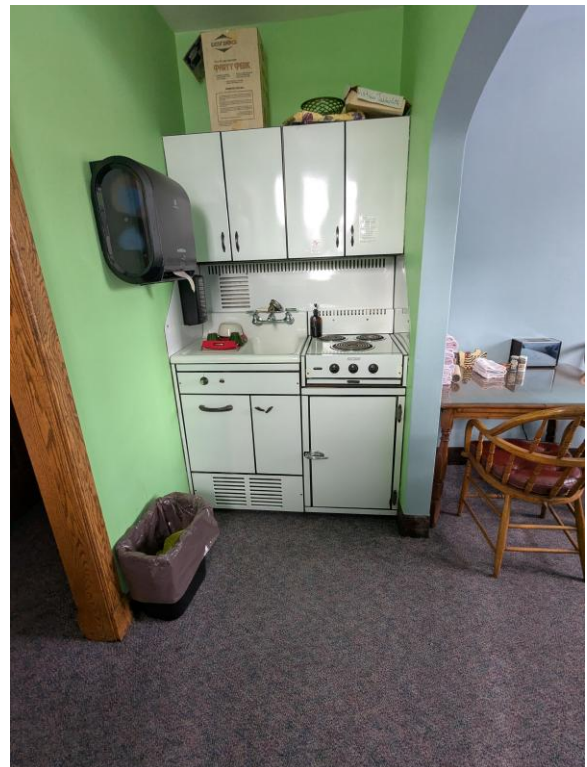
Figure 79 – Break Room Compact Kitchen Unit (2026).

This compact kitchen unit appears to be in very good condition. These units were last manufactured in the early-to-mid 1950's, making this unit approximately 75 years old, if not considerably older. The faucet on the sink appears to be original and most of the knobs and handles are intact.

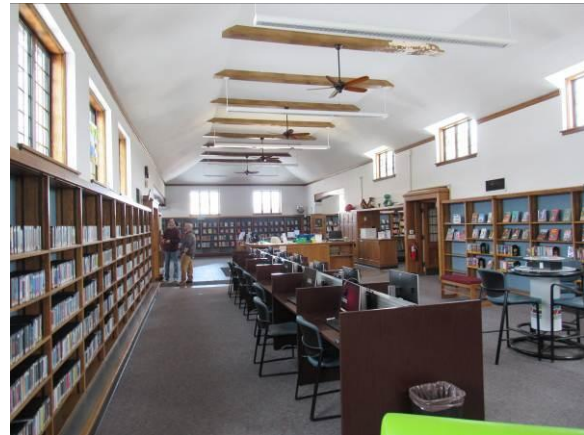
Figure 101 – Most of the square footage of the main floor is wide open space (2026).

First Floor Renovation: The first floor has always been used as a library. This floor should be rehabilitated for the new owner/tenant. The actual design will vary significantly depending on what kind of use moves into the building. An assembly use may only need minor reconfiguration and would keep the large open

spaces. An office could have work stations in the wide open space, or may have smaller, enclosed office spaces created. Residential uses will divide up the space into many smaller rooms and areas and will require fire separation between individual units and common spaces.

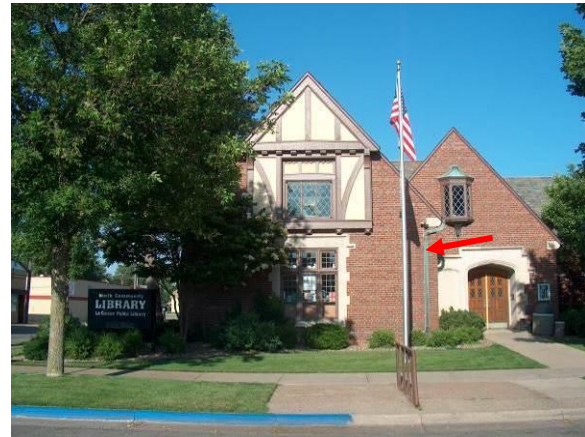
Gutters and Downspouts: The building originally had half round gutters and downspouts, but there are currently none on the building. This has created a continual moisture issue with the masonry walls, especially near grade. New half round gutters and downspouts should be added to the building as soon as possible. This will direct water away from the building and increase the life span of the mortar joints. The small leak(s) in the roof should be found and repaired. The longer these leaks are allowed to remain, the worse they can get and the greater the potential for rot in the roof structure and damage to the interior finishes. The small gable at the southwest corner of the building is missing a ridge cap and a couple of slate shingles may be loose/missing. This is a logical place to start looking for a roof leak. Slate shingle roofs often have a life span of 80-100 years. This roof shows some signs of wear, but it does not appear that a major roof project needs to be part of Phase I. The larger roof project will be discussed under Phase II. All roof flashings should be evaluated to check for breaks and other possible areas where leaks are occurring.

Figure 103 – The building originally had copper gutters and downspouts (2006).

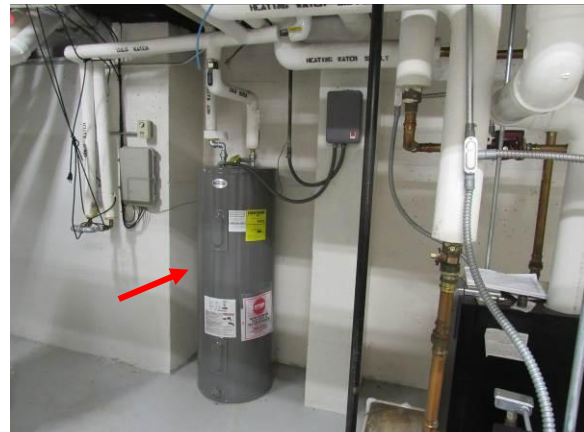
Figure 105 – The water heater is fairly new, circa 2024 (2026).

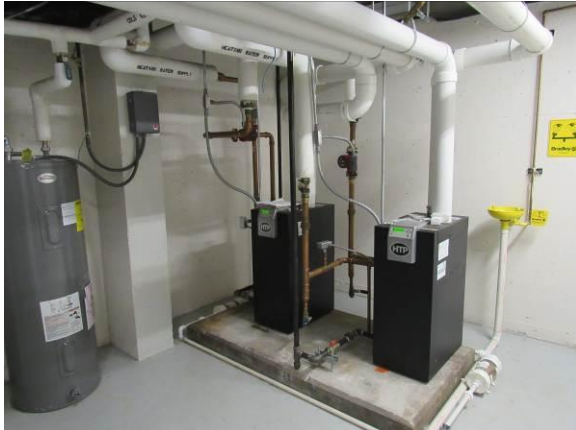
HVAC: According to City records, the mini-boilers in the basement were installed in 2020 and still have quite a bit of serviceable life left. The City has upgraded the HVAC system over the years and it appears that most of the equipment is from this century. The climate changer and humidifier are identified as being from 2002, and may be nearing the end of their serviceable life. The air conditioning is identified as being installed in 2022. Parts of the system could remain in service if the new building use is compatible with the existing system. Assembly or office use may be able to save costs on a renovation project by reusing as much of the existing equipment and ductwork as is feasible. If a residential use goes into the building, it may be more difficult to justify keeping the existing HVAC for the building. This

Figure 106 – The mini-boilers were installed circa 2020 (2026).

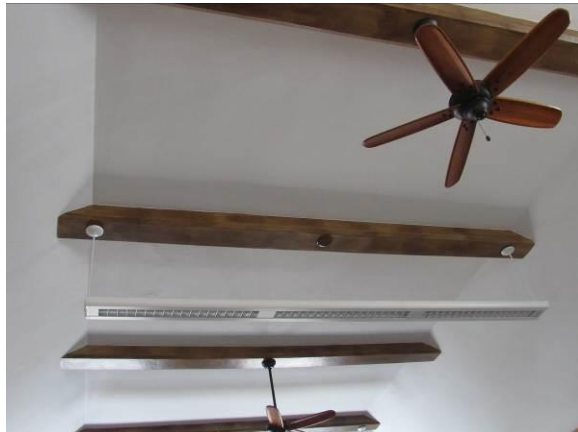
Figure 108 – Modern LED light fixtures and newer ceiling fans are in the main library space (2026).

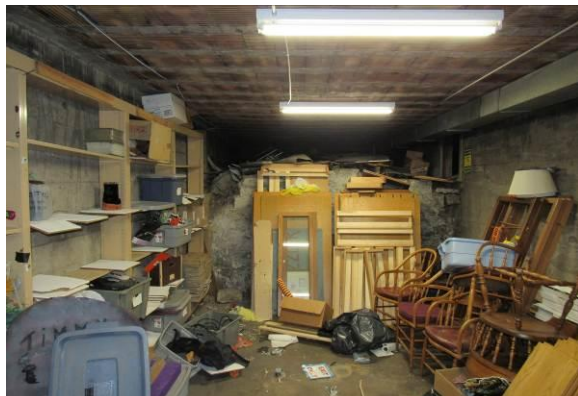
Figure 109 – Some older fluorescent fixtures remain in the basement (2026).

The lighting will probably need significant modification depending on the new use of the building. The back parts of the building and basement have rooms with minimal lighting that would benefit from additional light fixtures, or more efficient light fixtures. While the first floor was upgraded to efficient LED fixtures in many locations, there were still some T8 fluorescent lights, especially in the basement. Any bulb fixtures can have screw-in type LED bulbs that can replace incandescent bulbs without changing out the entire light fixture. LED strip lights give more light with less

energy than fluorescent lights. Emergency egress lighting with battery backups will need to be redone based on any changes to the building layout.

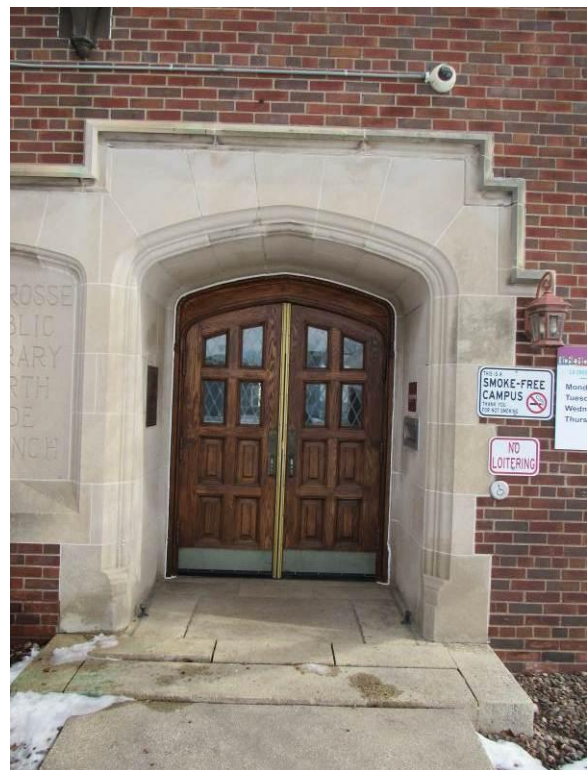
Figure 110 – The building has numerous security cameras, but they could have been installed to be more sympathetic to the architecture (2026).

Fire, Smoke Alarms and Security System: The requirement for a fire alarm system will be dependent on the building’s future occupancy. Some uses require a fire alarm system while it is optional in other occupancies. A hard-wired smoke alarm system shall be installed at a minimum. The existing security system appears to provide very good coverage of the interior and exterior of the building. It would be nice if the security system was less visually intrusive especially on the exterior of the building.

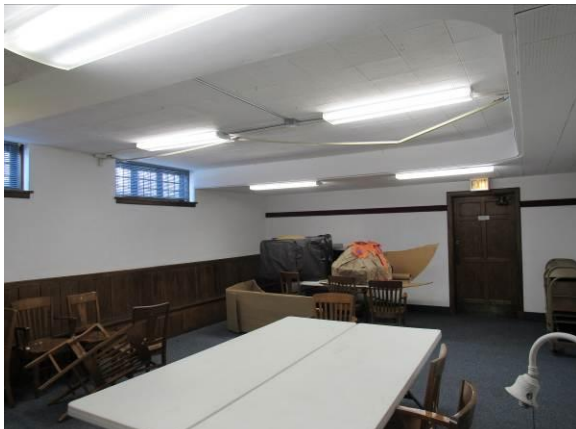
Figure 111 – The basement meeting rooms could be upgraded depending on the building occupancy (2026).

Basement Renovation: The basement has some potential for usable space. The two meeting rooms flank the main stair. It would be difficult to make these rooms accessible, but if the same uses are provided on the main level and disproportionality of an elevator can be documented during building code review, some of the basement could have usable space for the upstairs occupancy. Historic doors and trim should be retained, but new wider doors may be required to enter into these rooms. The ceiling in the large meeting room should be removed and replaced if this room is to be used for anything more than storage or mechanical. The fiber tile ceiling has some loose tiles, is covering existing ductwork, and has exposed conduit and wire mould surface mounted in some areas.

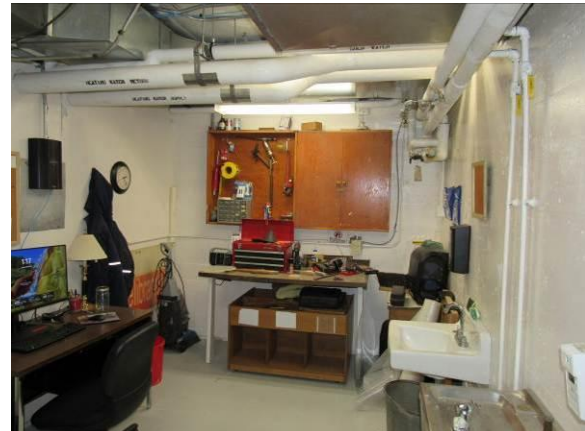
Figure 112 – The mechanical spaces are very clean and organized (2026).

The mechanical spaces are clean and logically laid out, it makes sense to keep these spaces for mechanical equipment. The north part of the basement is only partially excavated and will probably remain miscellaneous storage with any building use.

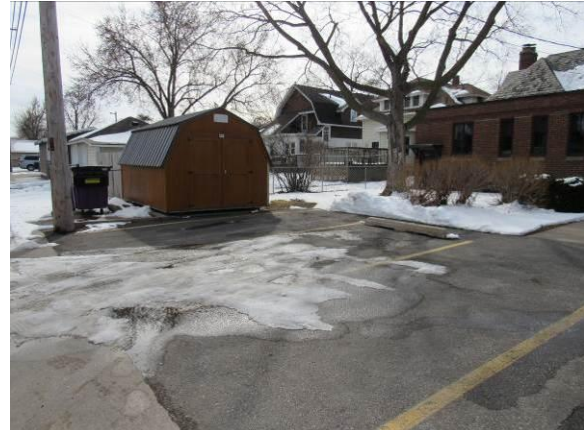
Figure 114 – There is currently a storage shed in the southeast corner of the property (2026).

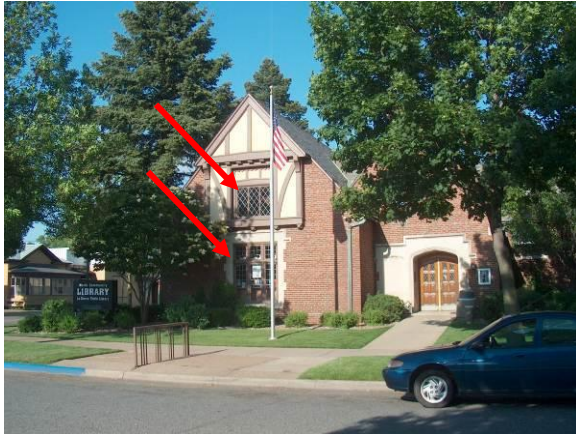
Figure 115 – The original windows were still extant until the 2007 window replacement project (2006).
