Architectural & Engineering Analysis

North Community Library

1552 Kane Street
La Crosse, Wisconsin

April 2026

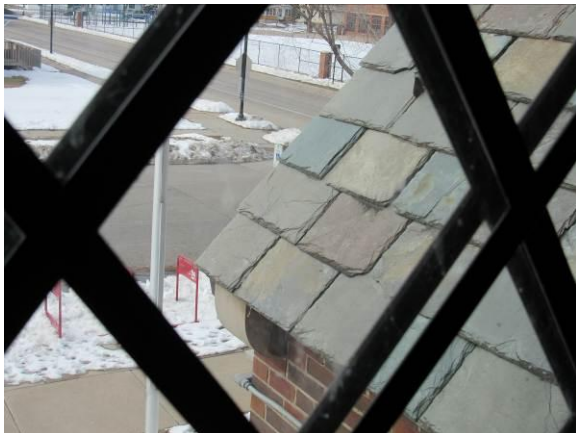
Windows: City records indicate that the existing windows were installed circa 2007. These windows have held up well over the past 19 years. It is too bad that the original steel windows with leaded glass were removed, but they were probably very inefficient. Good replacement windows can last 30-40 years or longer, but lower quality windows can fail in 10-15 years. The important thing to watch on these windows is the glass itself. When the seals between the panes of glass start to fail, the windows generally “fog up” where condensation occurs between the panes of glass. The frames can also fail by opening up on the seams. When these windows begin to show signs of failure, they should be replaced with new windows that are closer in appearance to the original windows. The original windows were steel with leaded glass, so the new windows could be a modern thermally broken aluminum unit with insulated glass and simulated divided lites to look like the old lead comes. The new window units will probably have insulated glass (double-pane filled with argon gas) with no tint. A low-E coating may be allowed but only if historic tax credits are not

Figure 116 – The current windows have fake divided lites to mimic the lead comes (2026).

pursued. The windows have some serviceable life left so replacing them is not a high priority.
