RE: City of La Crosse Ebner Coulee Flow Calibration SEH No. LACRS 142540 14.00

LOMR APPROACH

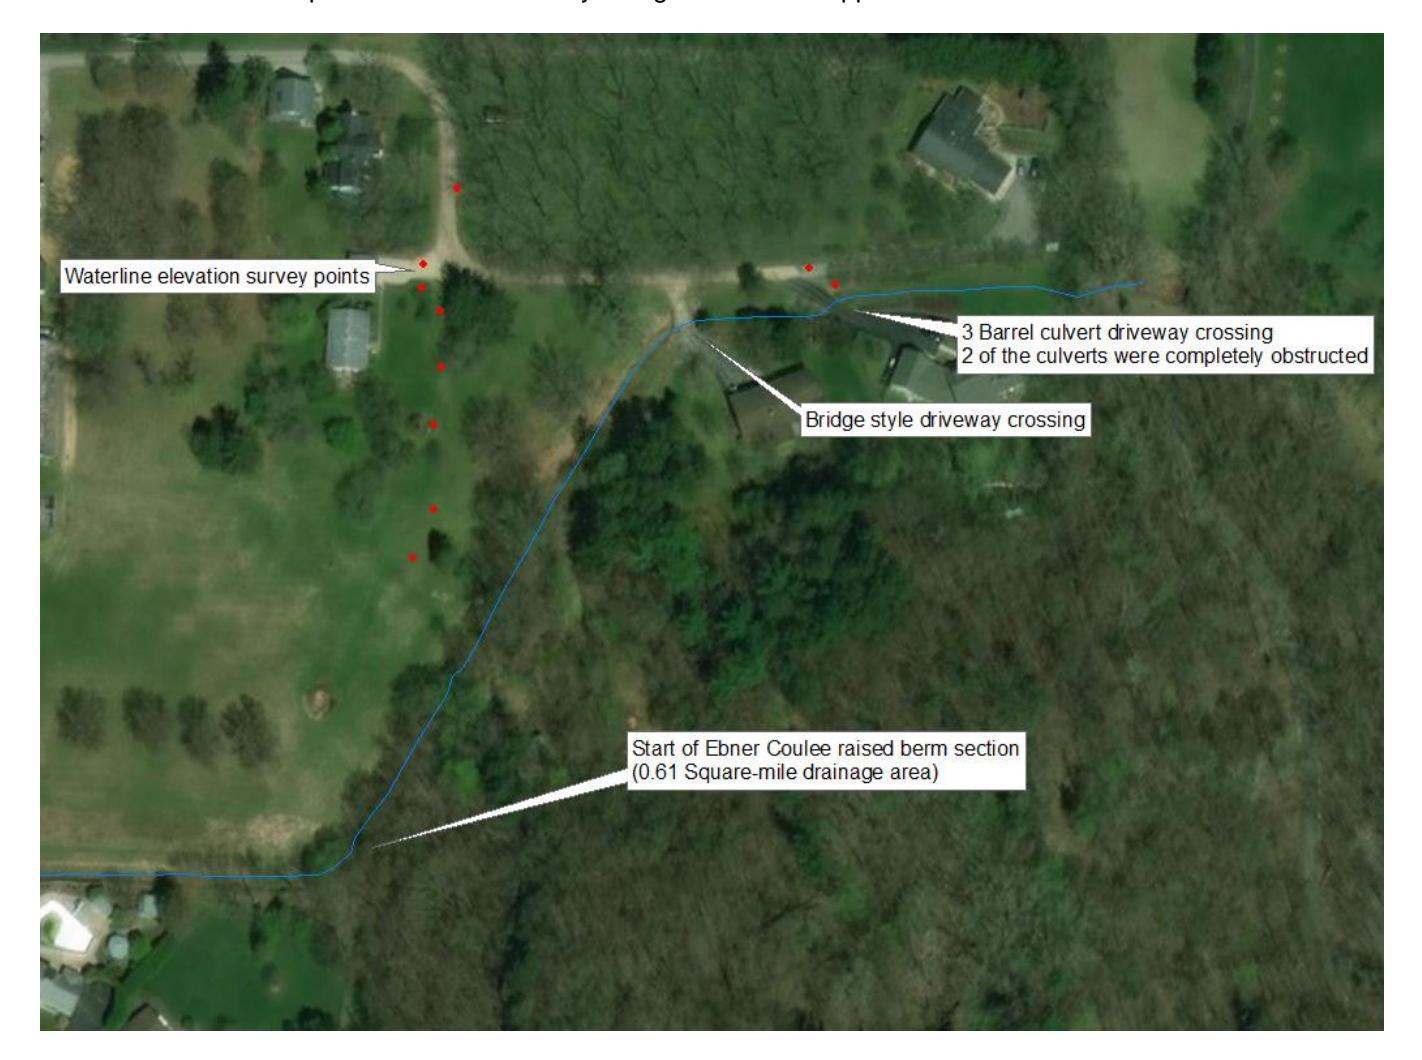
Based on information collected, under the 2017 event, the three barrel culvert crossing had two barrels completely plugged and one full open and unrestricted. This caused a significant amount of flow to overtop and travel in the overbanks. The collected field topographic survey outlines the edge of this overtopping flow and is based on interviews of the residents and photographic data. The information collected in this area will be valuable in further refining the model calibration as this project moves forward into the development of a calibrated hydrologic model for support of a LOMR.

The second area in which flooding was noted is near Floral Lane just Northwest of the location in which Ebner Coulee exits the confined valley section and enters the channelized raised berm section. Given the available information from the 2017 event in this area, the information gathered for provides useful information for a further refinement in the estimated discharge associated with the 2017 flood event to further calibrate the hydrologic and hydraulic modeling.
