## **Existing Conditions Summary: Southern Bluffs Elementary School Zone**

## Dismissal Observations at Southern Bluffs Elementary School

## **Priority Observations for the Entire Analysis Zone**

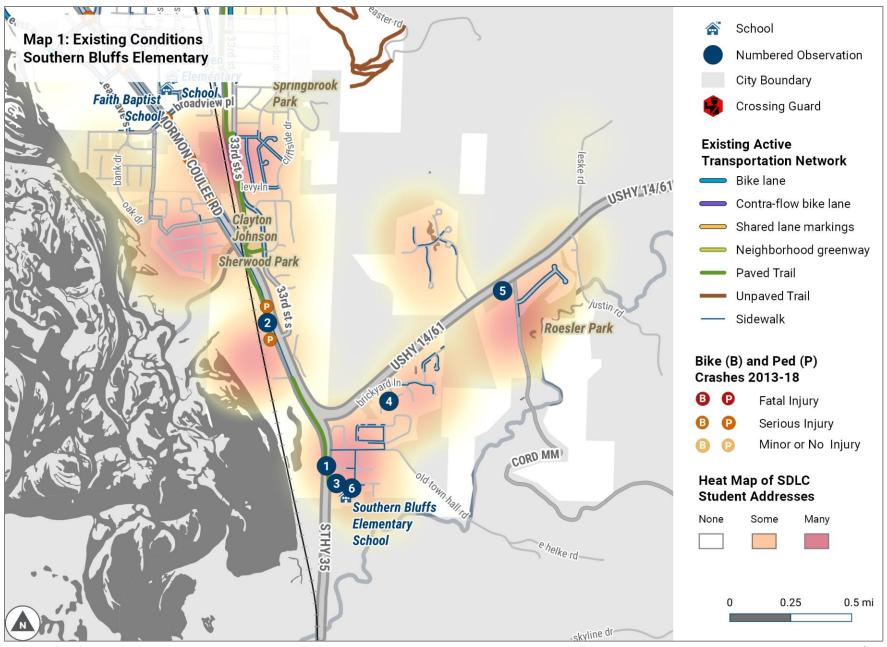
The numbered observations in the table below correspond to the points in Map 1.

#	Location	Observations
1	Great River Road (State Hwy 35) and Riverview Drive	<ul> <li>A flashing school speed limit sign slows traffic in advance of the crossing at Sunnyside Drive.</li> <li>Great River Road (State Hwy 35) is a high speed and high volume street. Vehicles appear to exceed the posted speed limit (25 mph) during school arival and dismissal times.</li> <li>Continental crosswalk markings are faded.</li> <li>An existing RRFB at the intersection provides increased pedestrian visibility across Great River Road. However, families report that drivers often do not yield to pedestrians in the crosswalk.</li> <li>Parents and staff report that this crossing is dangerous and discourages students from walking and biking.</li> </ul>
2	Mormon Coulee Road north of Calvert Road	• Connections between the Pammel Creek Trail and the Southern Bluff Trail along Mormon Coulee Road are missing. Staff mentioned that Walk to School events start near Fiesta Mexicana.

3	Sunnyside Drive east of the vehicular driveway	<ul> <li>Curb extensions across Sunnyside Drive shorten crossing distances.</li> <li>The existing crossing has school crossing assemblies and curb ramps but is not highly visible to drivers (no crosswalks markings are present).</li> </ul>
4	Brickyard Neighborhood (northeast of the school and south of US Hwy 14/61)	<ul> <li>Missing or discontinuous sidewalks present a barrier to walking and bicycling to school.</li> <li>A curving and discontinuous street network between Old Town Hall Road and US Hwy 14/61 discourages walking and biking. For example, there are no connections between Fireclay Court and Mariah Drive North.</li> </ul>
5	US Hwy 14/61 west of Roesler Park	<ul> <li>No walking or bicycle facilities are present on or along US Hwy 14/61 to connect a large mobile home park with Southern Bluffs Elementary School.</li> </ul>

#	Location	Observations
6	Bicycle Parking	<ul> <li>Existing "wave" bicycle racks can result in damaged bikes and can make it difficult to securely lock a variety of different types of bicycles.</li> </ul>
