## MEMORANDUM

RE: Riverside North Residual Contamination  
SEH No. WIRRN 148437 14.00

The purpose of this memorandum is to provide a preliminary review of the current conditions of the Riverside North property as it pertains to past industrial activities and associated residual contamination. All of the sites referenced in this memo have received regulatory closure, however residual contamination remains. This memorandum will serve as a reference point for the engineers, architects, and planners and will provide guidance regarding development consideration due to the presence of said residual contamination.

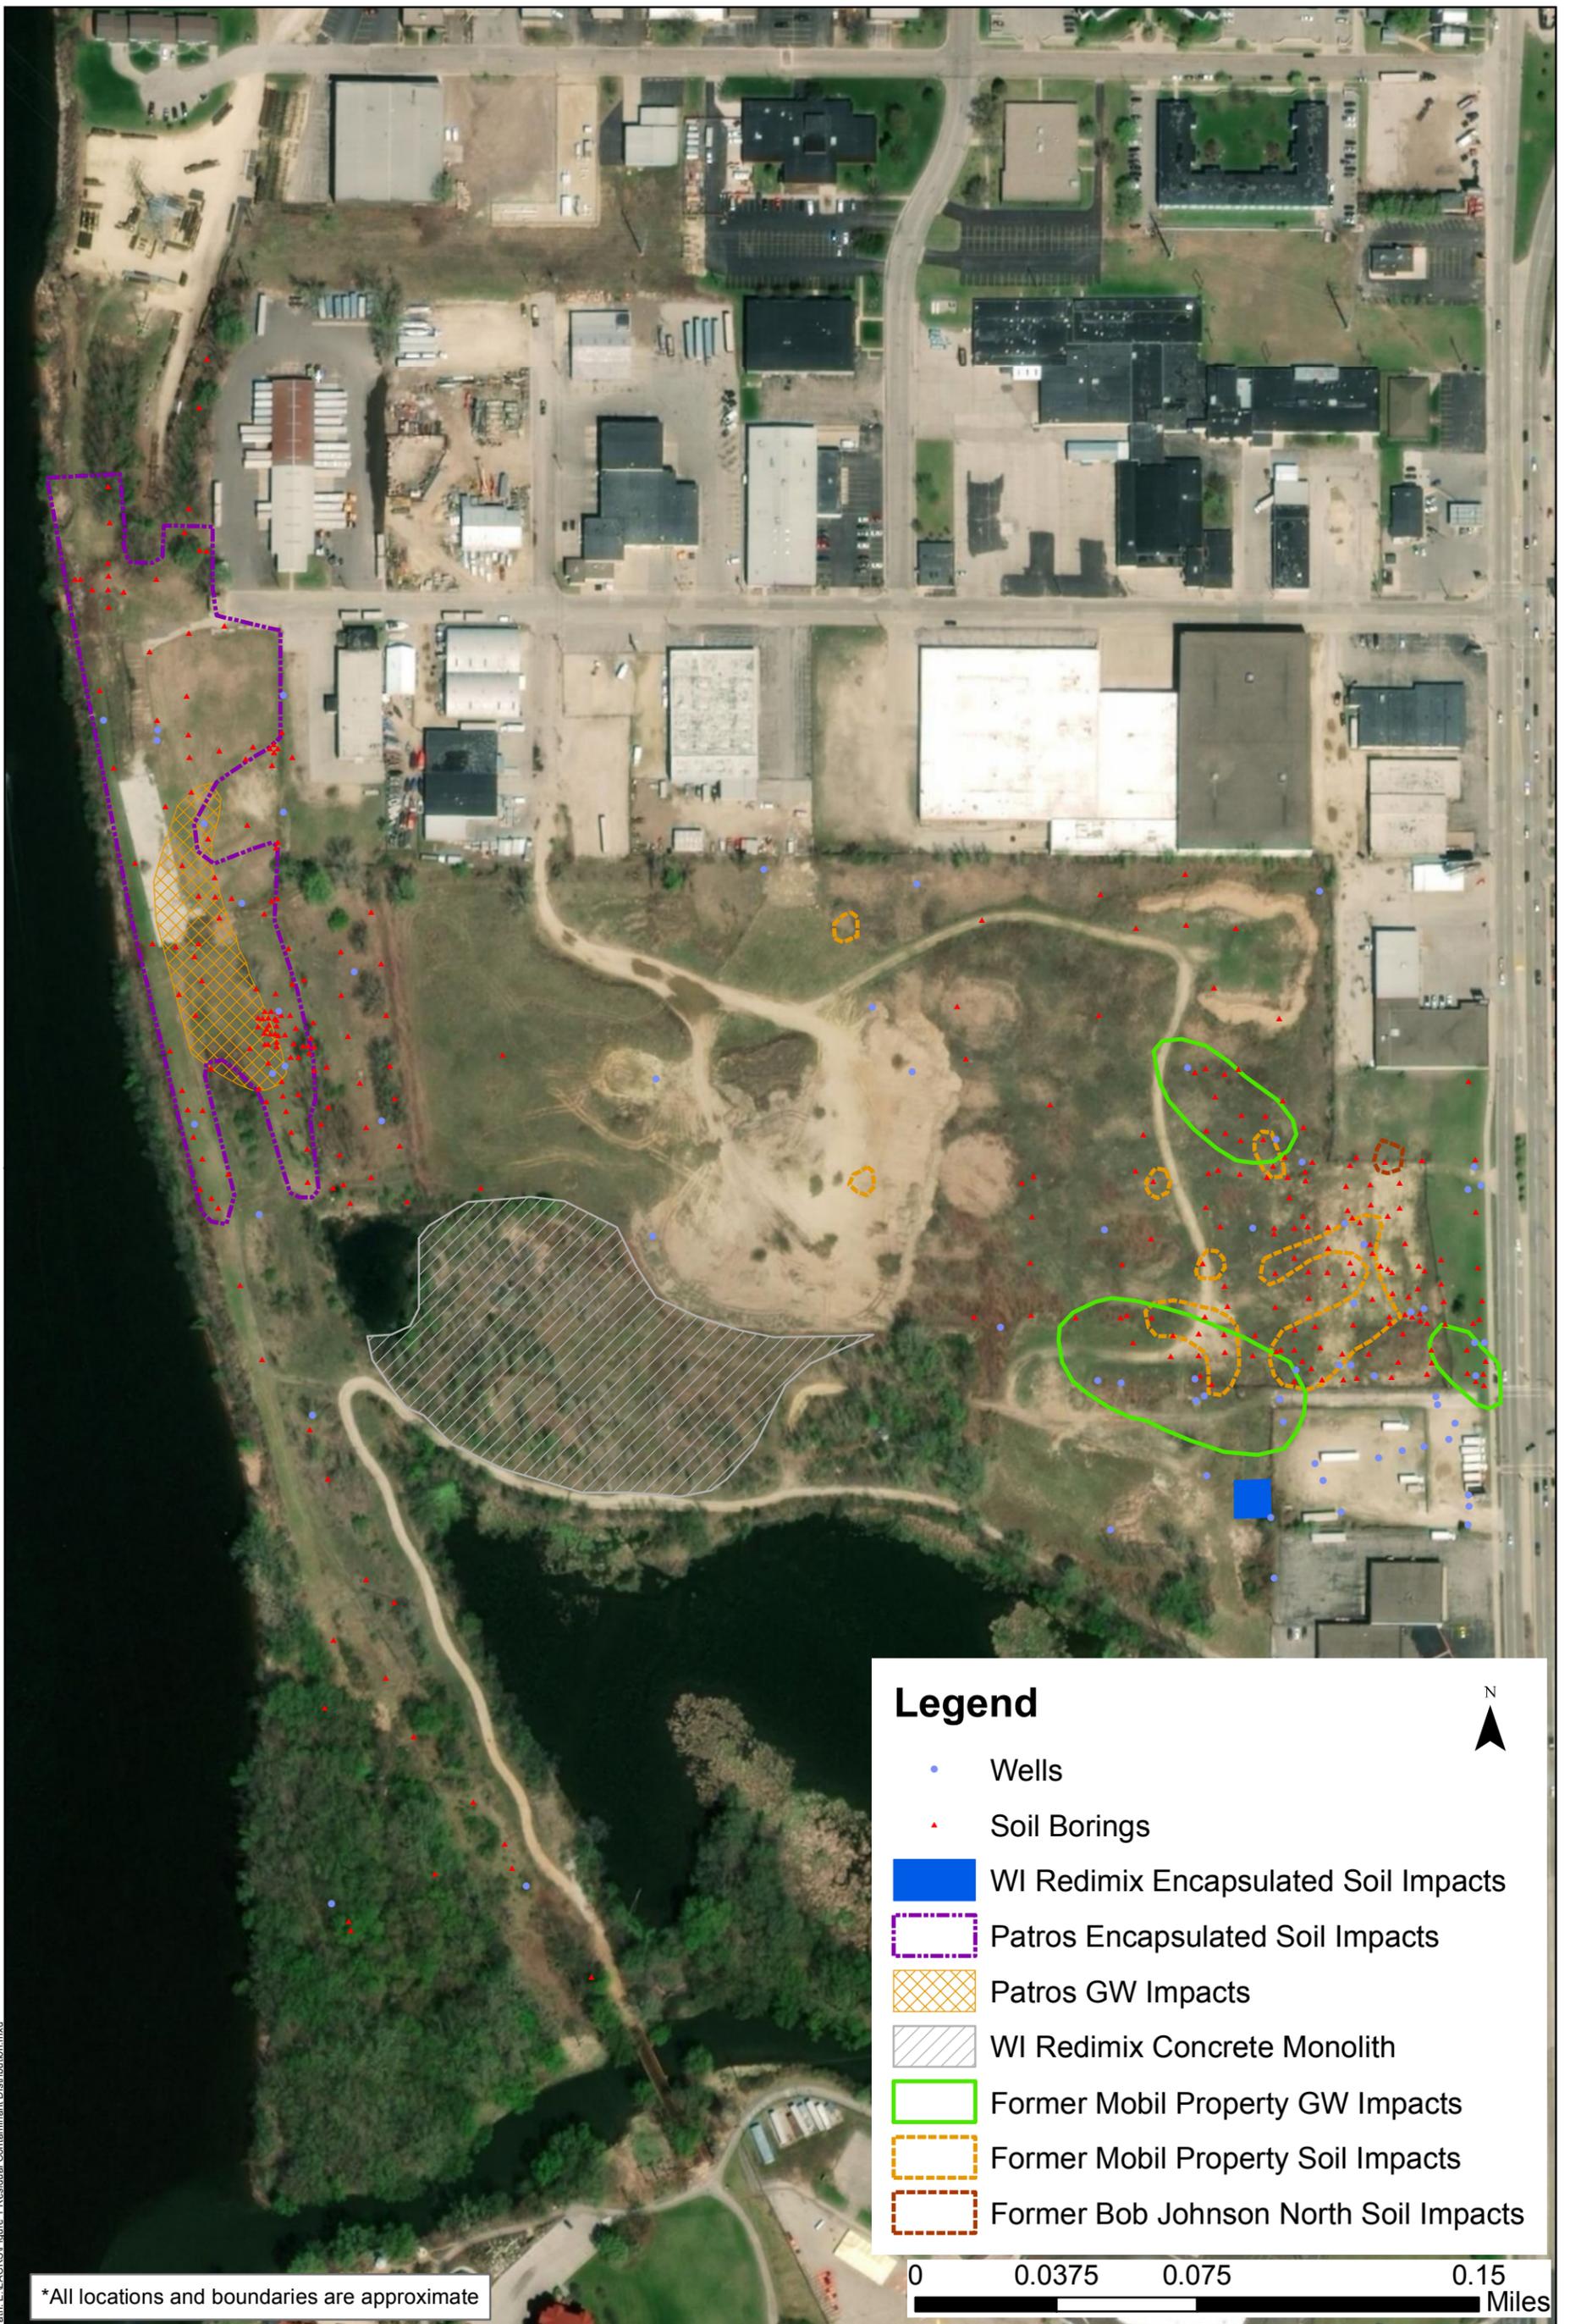
Figure 1: Residual Contamination Distribution

The former Patros property consists of a roughly 300 foot wide piece of land along the Black River that makes up the western perimeter of the proposed development. The property was operated as a scrap yard for several decades. Over this time period various pieces of equipment that were collected on site for the purpose of recycling leaked or otherwise impacted the property. This, combined with the property's long history of rail activity, resulted in soil contamination including lead, arsenic, polynuclear aromatic hydrocarbons (PAHs), volatile organic compounds (VOCs), and polychlorinated biphenyls (PCBs). Soil remediation consisted of excavating 1,594 tons of the most significantly impacted soils and encapsulating widespread moderate PAH and arsenic contamination in the shallow soils. Impacted soils were encapsulated by placing a 2 ft layer of clean fill on top of the impacted soils. Figure 1 shows the portion of the property that has been encapsulated.

Figure 1 shows the approximate extent of residual soil contamination above NR 720 RCLs in effect at the time of closure.

As of 2013 residual groundwater contamination remained at the site. Figure 1 shows the estimated extent of groundwater contamination remaining above NR 140 enforcement standards. While it is likely that the degree and extent of petroleum impacts to both soil and groundwater have changed since 2013, it is anticipated that residual impacts remain and will persist for some time.

Groundwater contamination at the site consists of chlorinated hydrocarbons. No specific source of contamination has been identified; however, it is speculated that a leaky piece of equipment was the source. The highest concentrations are recorded on the northern portion of the property near the location of the former buildings. No active groundwater remediation was conducted at the site; however, the Wisconsin Department of Natural Resources (WDNR) determined that natural attenuation is adequately addressing the contamination. The vapor pathway has not been evaluated at the site and the potential for vapor migration associated with groundwater impacts has not been established.

The site was also investigated in relation to metals contamination resulting from concrete disposal at the site. As a result of the investigation, an area along the border with the BJO south property was identified as having elevated lead concentrations and a one foot cap was required to provide protection from direct contact. Unsubstantiated reports indicate that the City of La Crosse removed the cap and the underlying lead-contaminated soils so that cap maintenance would not be needed. However publicly available data does not mention this excavation and this assertion cannot be confirmed without a file review.

unset concrete. Over time some of the concrete set and hardened into a continuous concrete deposit. Mr. Joseph called the deposit a “concrete monolith” and indicated it was several feet thick in some areas. He indicated there is a report with more information on the “concrete monolith” in the WDNR project files.
