HERITAGE PRESERVATION COMMISSION REPORT

Certificate of Appropriateness for Major Work- 10th & Cass Historic District. Section 115-319(d)(2)

PROPOSAL: The applicant is proposing to demolish the existing detached accessory structure/detached garage.

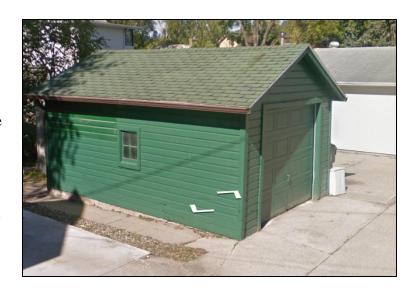
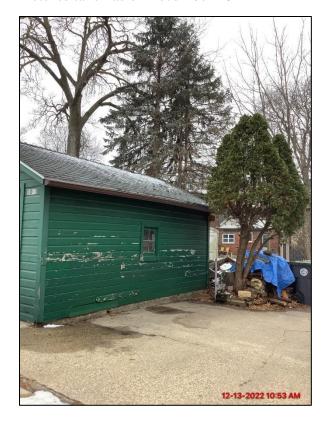
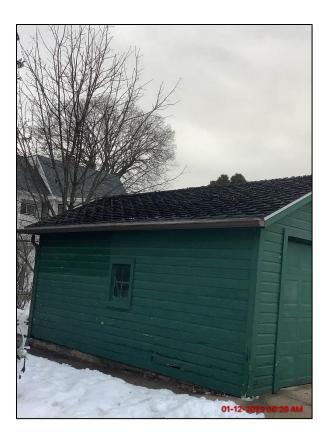
Pictures taken as of December 2022

PROJECT DESCRIPTION: The applicant is requesting to demolish the existing detached garage that serves 1003 King St. The existing garage is a one-story, single car, and approximately 12x20sqft in size. The Community Risk Management Department issued a Raze or Repair Order on the garage due to its condition. The applicant's plan is to building a new accessory structure in the next 1-2 years so is electing to pursue its demolition rather than repair it.

While the garage is considered in a state of disrepair by the Community Risk Management Department, it is not in such a condition where it could not be repaired.

RECOMMENDED ACTION BY STAFF: This Certificate of Appropriateness is recommended for approval.

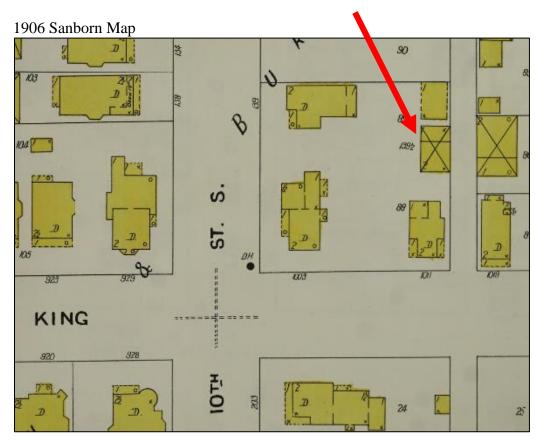
Sanborn Maps to help determine date of construction. The 1906 Sanborn Map (pictured below) depicts a much larger, likely carriage house type, accessory structure at this location.

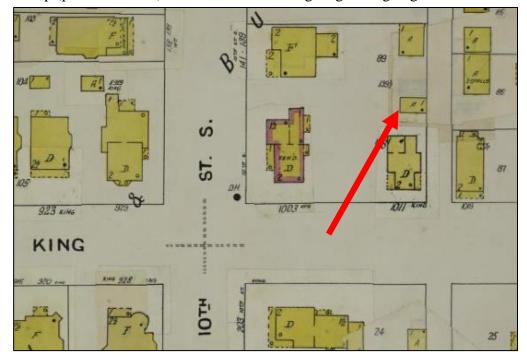
The 1949 Sanborn Map (pictured below) shows that the existing single car garage.

These maps provide evidence that the existing single car garage was constructed between 1906 and 1949, supporting the 1925 date and indicating that it was built during the time period when these types of structures where becoming popular nationwide. It may even be one of the first ones built in the district but more research is needed to confirm. What these maps also tell us is that this was not the original accessory structure serving the primary building. There was likely a larger, likely carriage house type, structure at this location. While the time period that this garage was built falls within the district's period of significance (1858-1940) there was a carriage house at one time and rebuilding a new carriage house structure could be considered more appropriate to the district.
