**HERITAGE PRESERVATION COMMISSION REPORT**  
Certificate of Appropriateness- Downtown Commercial Historic District.  
Section 115-320(d)(2)

**PROPOSAL:** The applicant is proposing to fill in one (1) existing window opening on the north facade facing State Bank's surface parking lot.

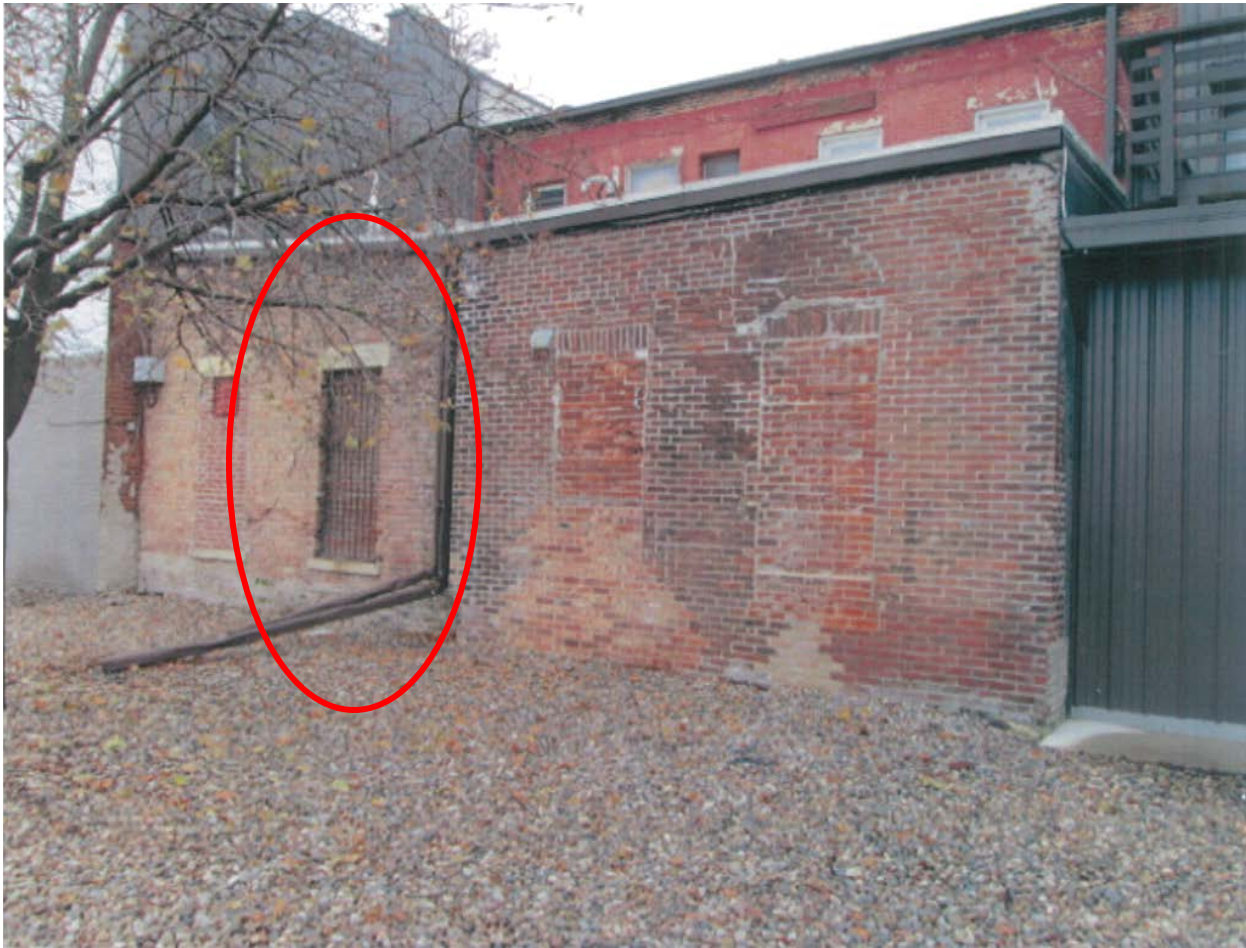
**PROJECT DESCRIPTION:** The applicant was issued an Order to Correct from the Fire Prevention and Building Safety Department in December 2016 that included 1 window opening that was filled in with non-permitted siding materials. The applicant would like to replace the non-permitted material with brick and not install a window. Currently there are four (window) openings, three (3) of which are already filled in with brick and one (1) filled in with plywood. The applicant would like to match the other three openings. Additionally, the applicant has cited

security issues/concerns with installing a window as this is located in the back of the building and their workshop where they make and repair watches and jewelry is on the interior.

This Certificate of Appropriateness for the one (1) window on the north facing (rear) façade is recommended for approval with the condition that it be filled in with brick that is appropriate to the brick size and type on the building.
