Station 1 Windows

Maintenance or replacement needed

Station 1

726 5th Ave S

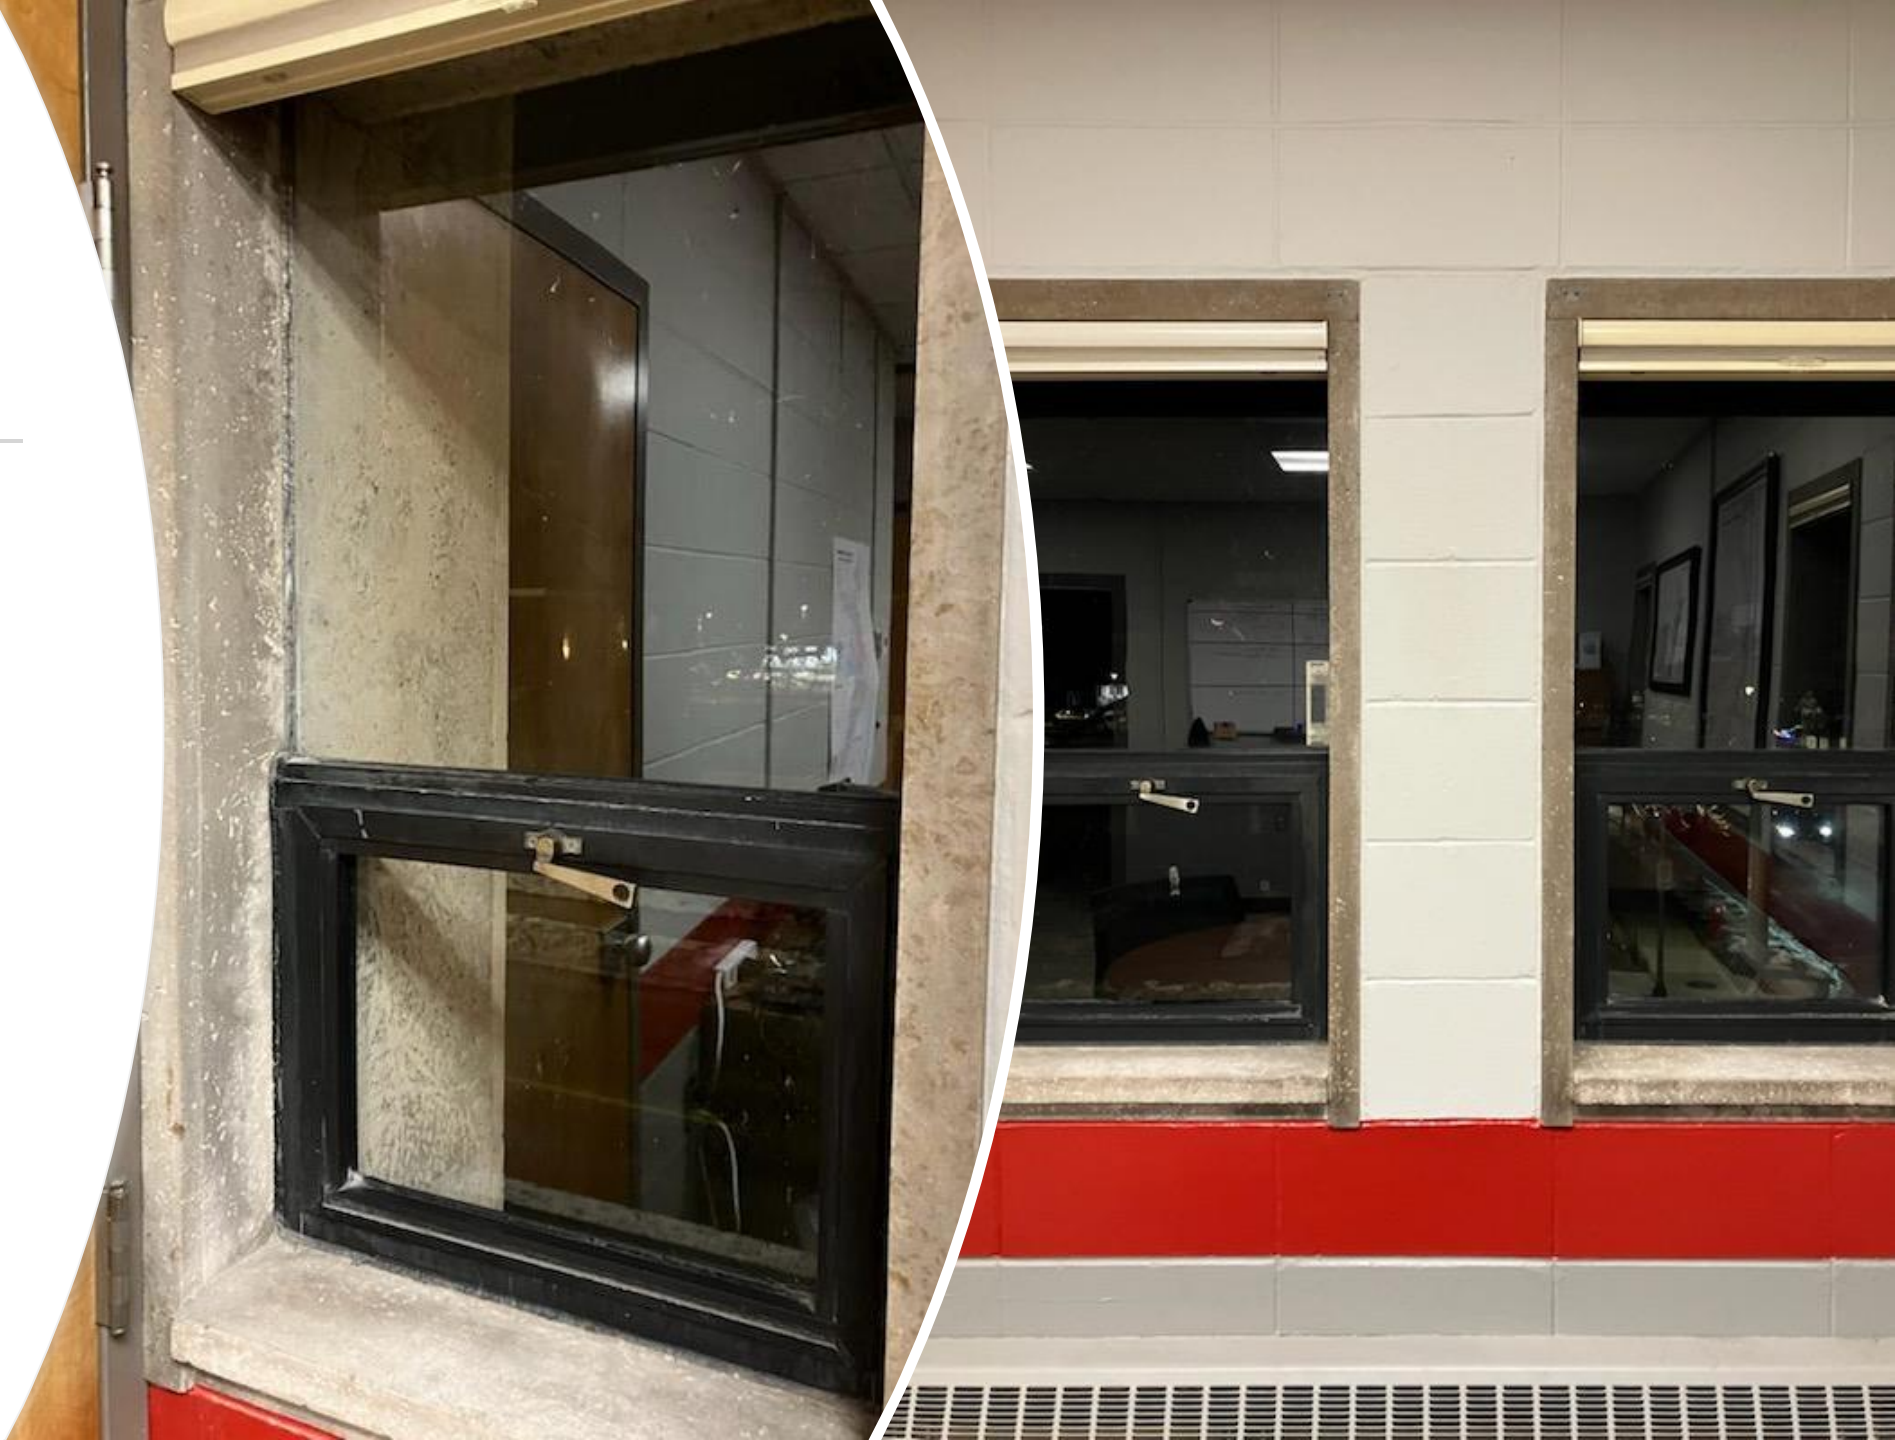
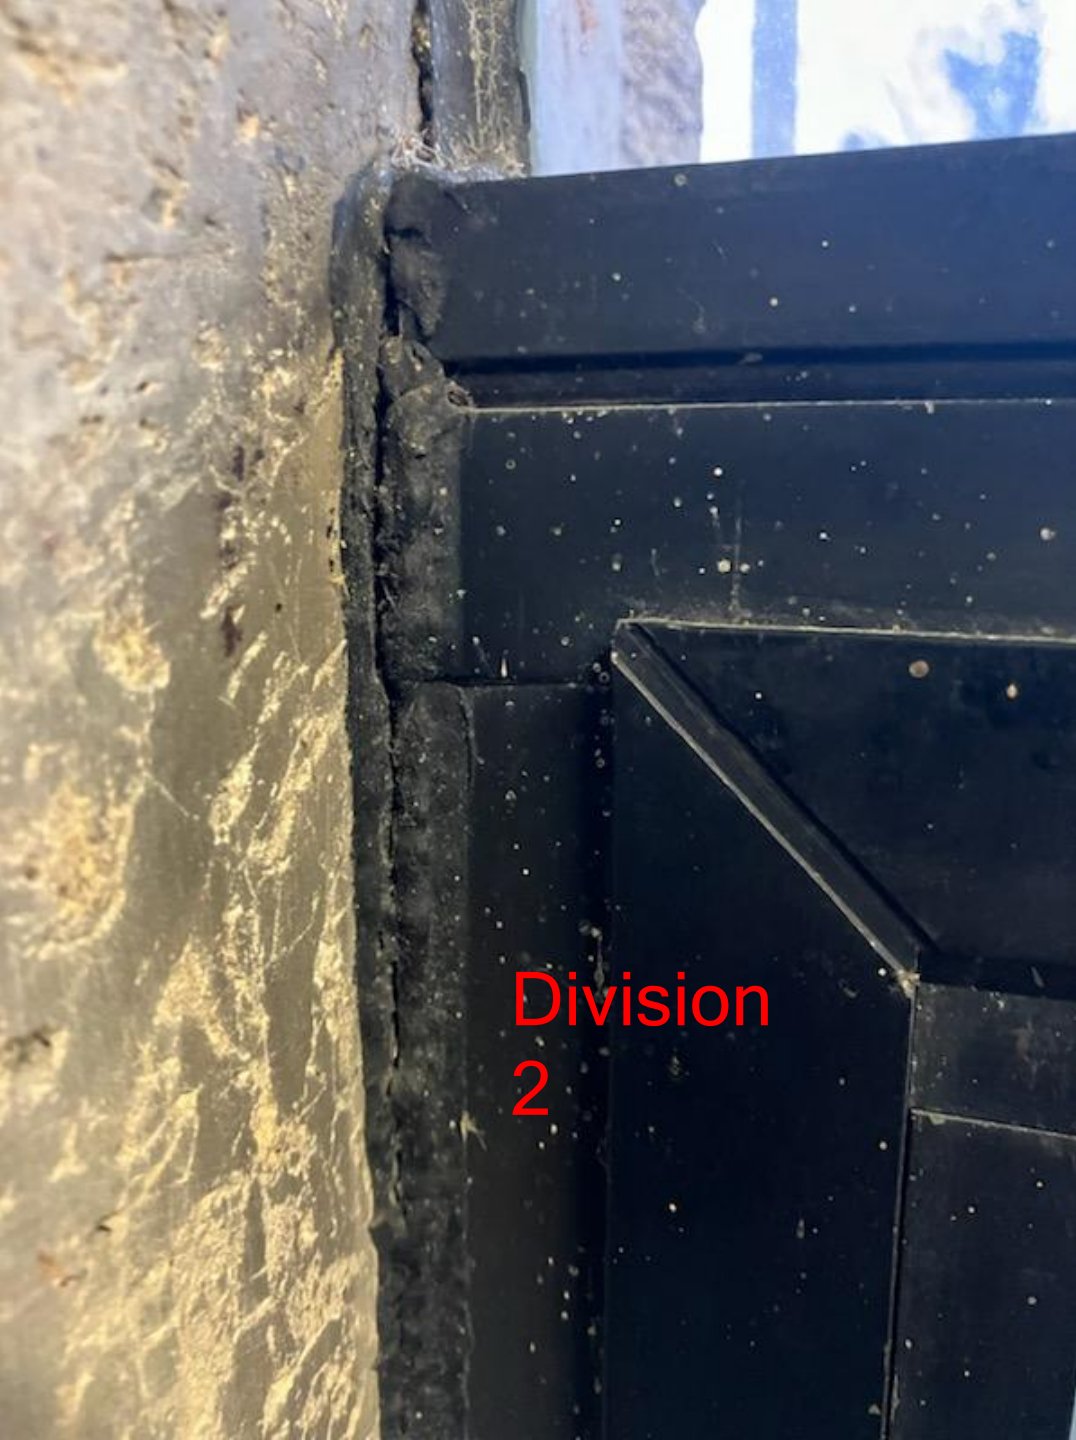
Caulk has become dry and is causing cracking. Examples from both divisions of Station 1.

Half the windows in the station are starting to get caulk cracking.

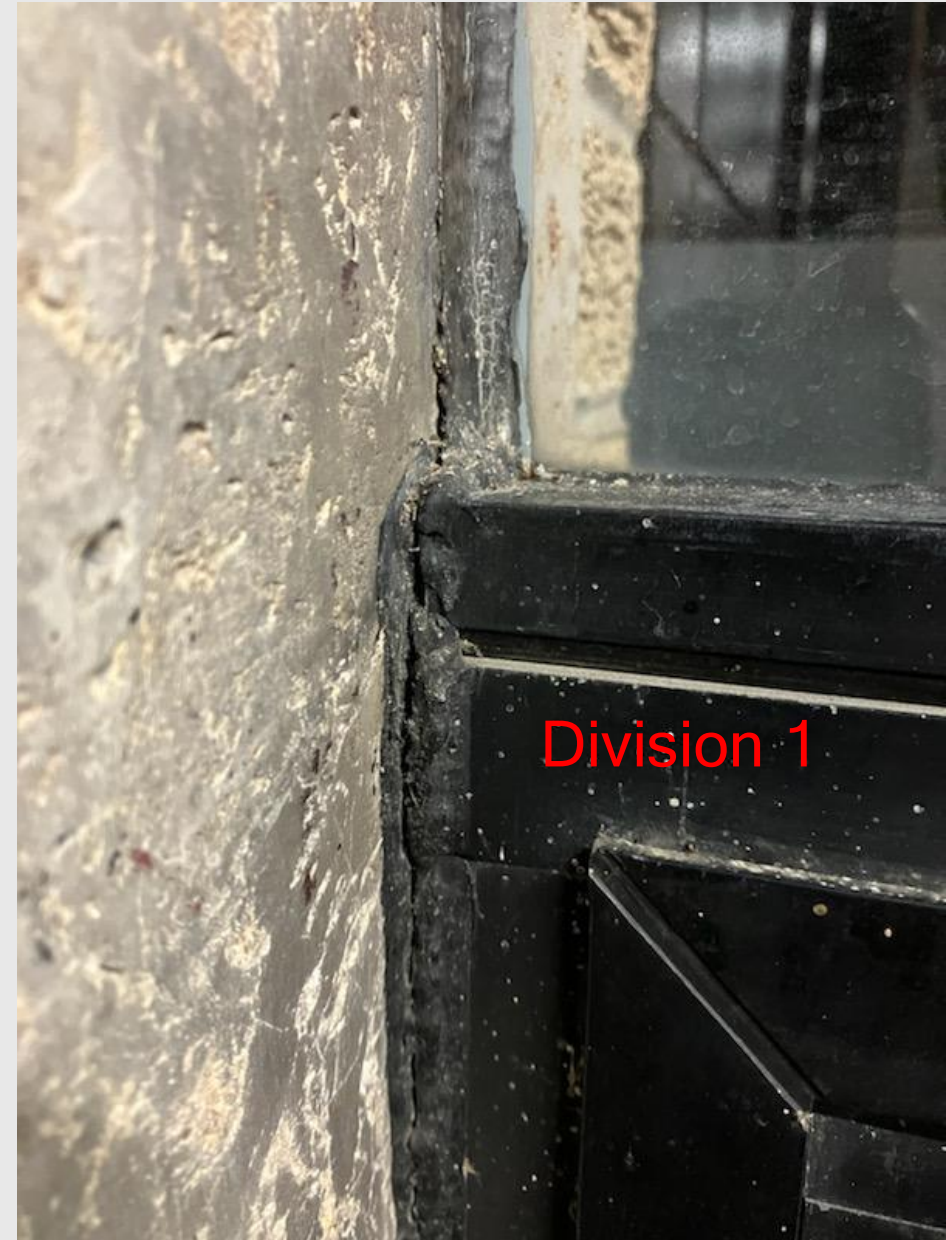
Zoomed out

3 Windows were noted with enough caulk damage that you can see a visible gap to the outside. Causing an extreme amount of cold air into that area of the room.

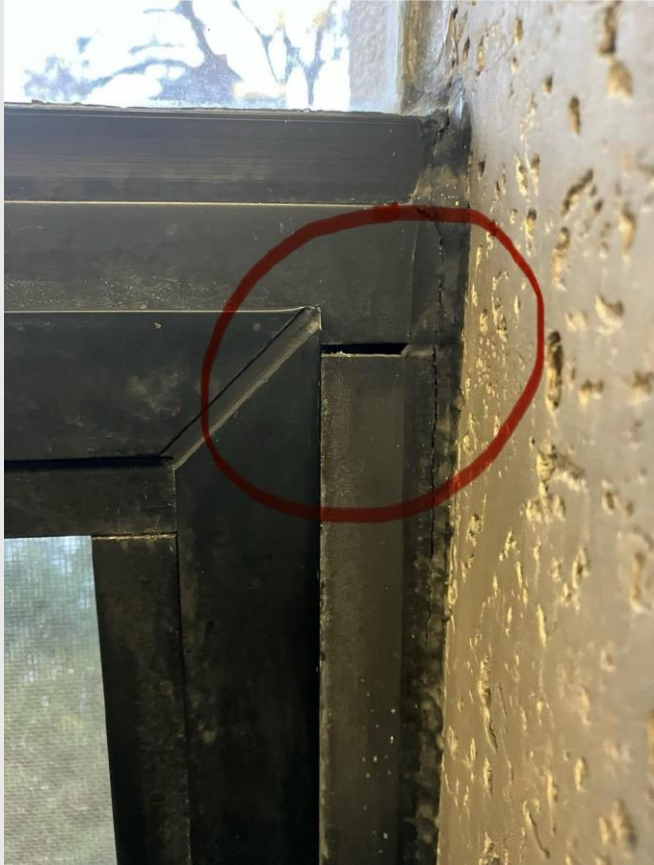
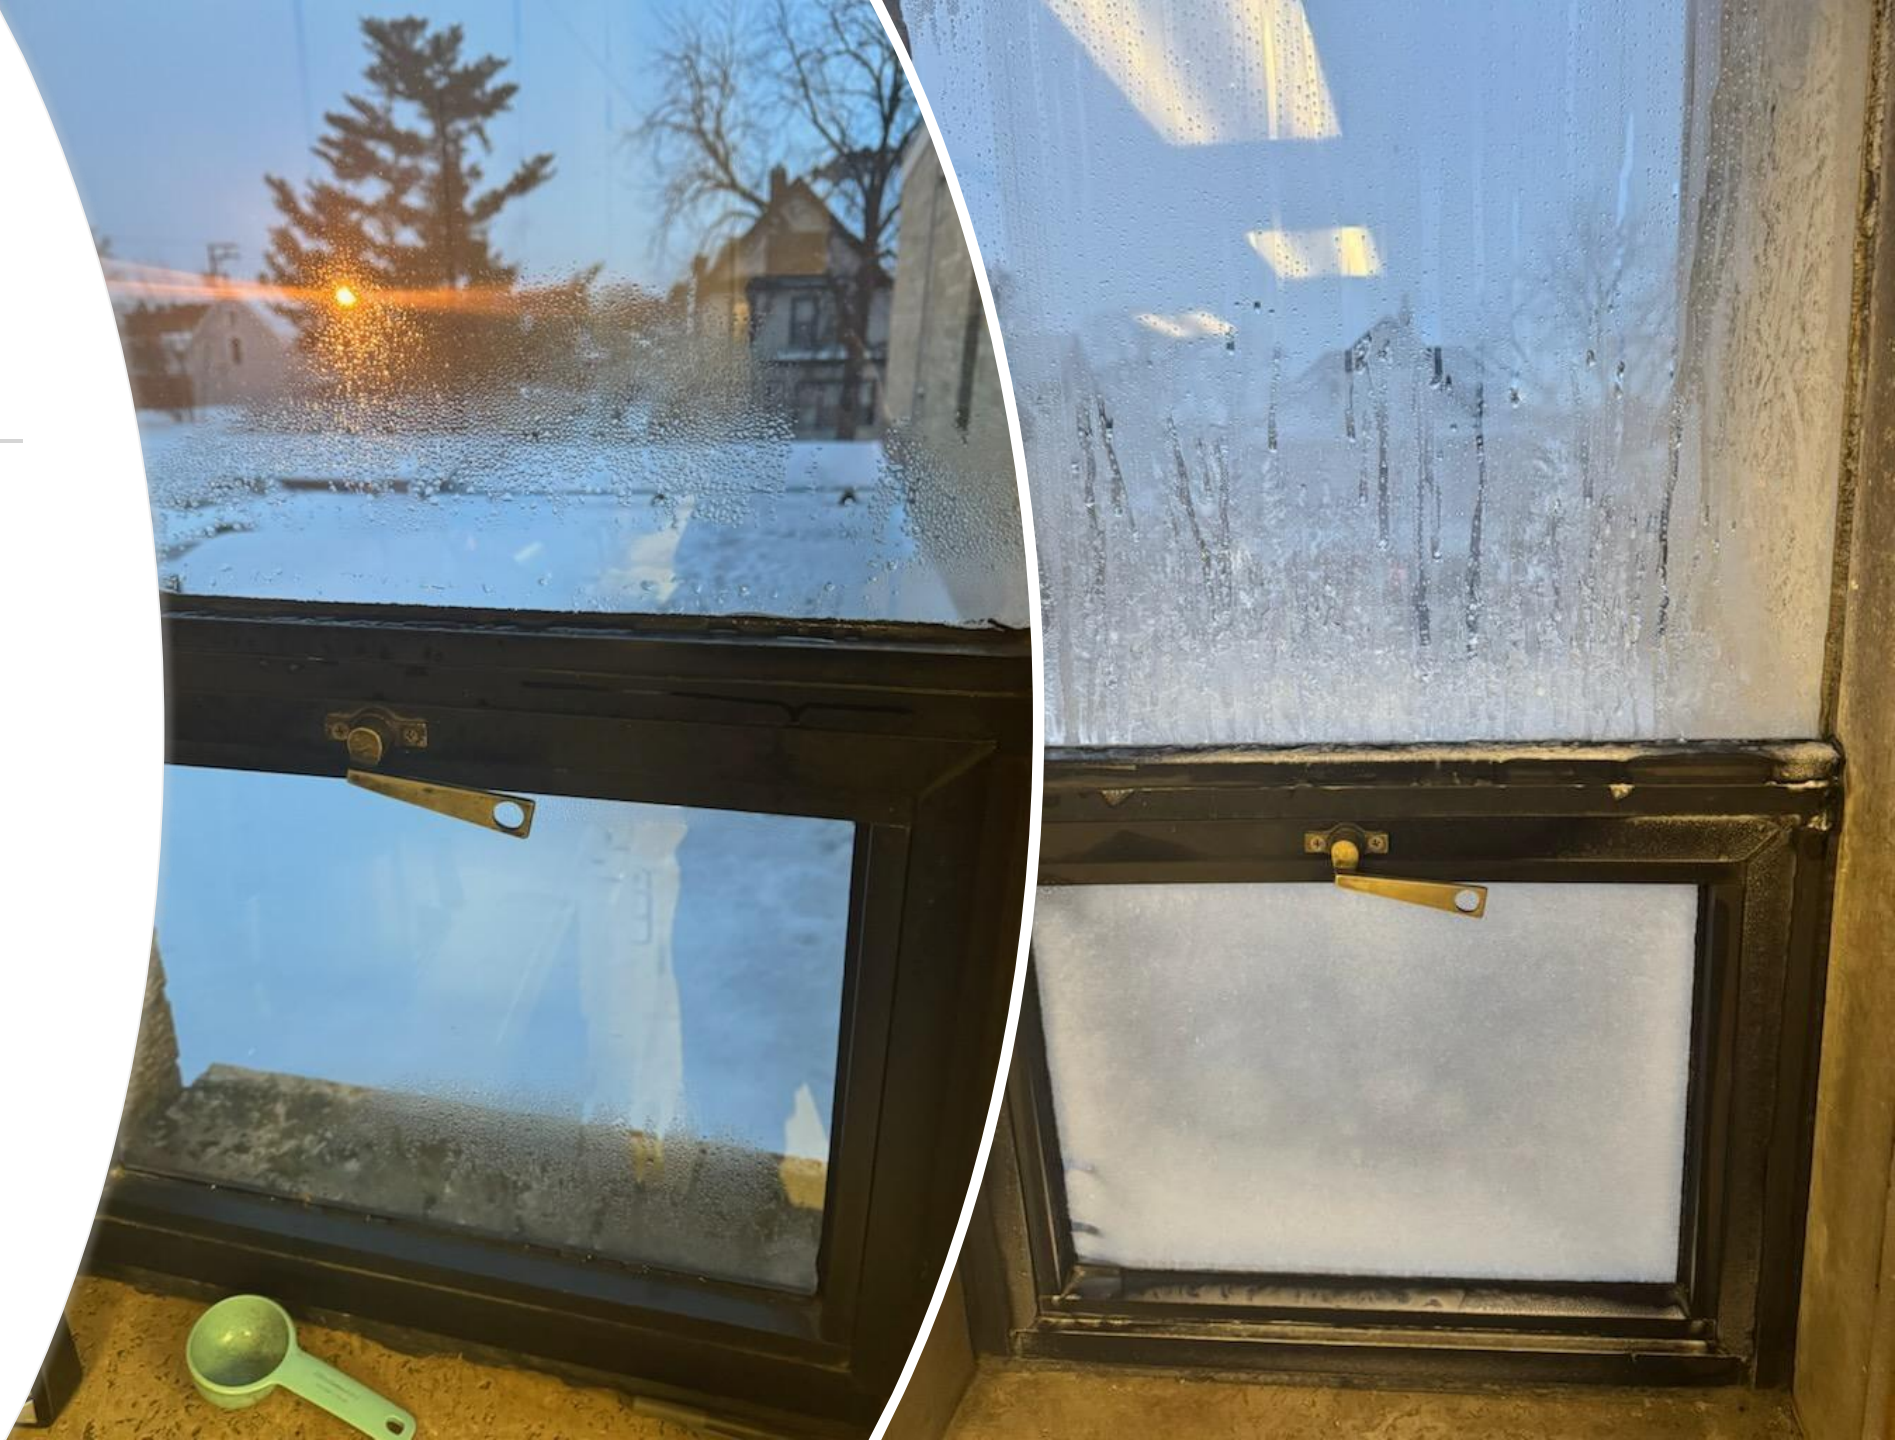
Frost

- Temperatures below 10 degrees cause a large amount of frost and moisture build up.
