# PROPOSAL TO INCLUDE GHOST SIGN LANGUAGE IN THE MUNICIPAL CODE

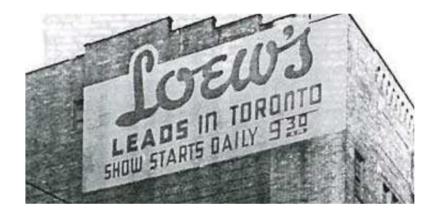
Photograph of the Queen Street "Loew's" sign in 1942

A sign from 1913 in Queen Street in Ontario, Canada that reads "Loew's leads in Toronto. Show starts daily 9:30 AM" was also recently restored to resemble its original appearance. This project completed by Lori LeMare Studio Inc and was overseen by the Ontario Heritage Trust. The restoration includes the repointing of mortar, removal and cleaning of several layers of paint, replacement of some individual bricks, hand cleaning the surface, use of a clear, breathable mineral paint to coat the original sign, which was then finished with a breathable colored paint to restore the negative space of the sign.

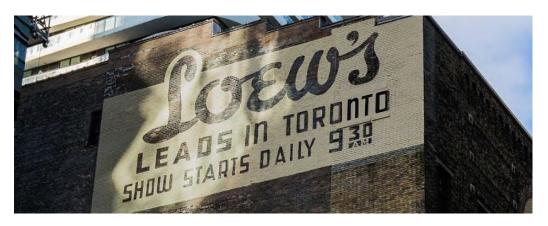
Photograph of the Queen Street "Loew's" sign after the Restoration Project
