PROPOSAL TO INCLUDE GHOST SIGN LANGUAGE IN THE MUNICIPAL CODE

STATEMENT OF INTENT

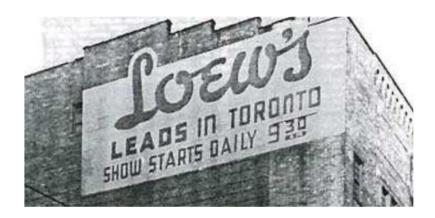
A sign from 1913 in Queen Street in Ontario, Canada that reads "Loew's leads in Toronto. Show starts daily 9:30 AM" was also recently restored to resemble its original appearance. This project completed by Lori LeMare Studio Inc and was overseen by the Ontario Heritage Trust. The restoration includes the repointing of mortar, removal and cleaning of several layers of paint, replacement of some individual bricks, hand cleaning the surface, use of a clear, breathable mineral paint to coat the original sign, which was then finished with a breathable colored paint to restore the negative space of the sign.

Photograph of the Queen Street "Loew's" sign in 1942

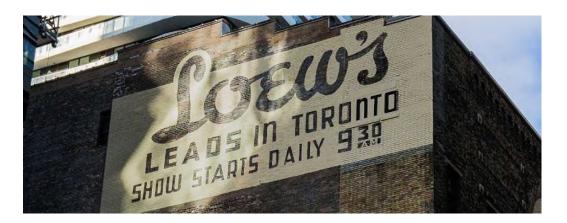
Photograph of the Queen Street "Loew's" sign after the Restoration Project
