Existing Conditions Summary: Summit Elementary School Zone

Known Safety Concerns at Summit Elementary School

Priority Observations for the Entire Analysis Zone

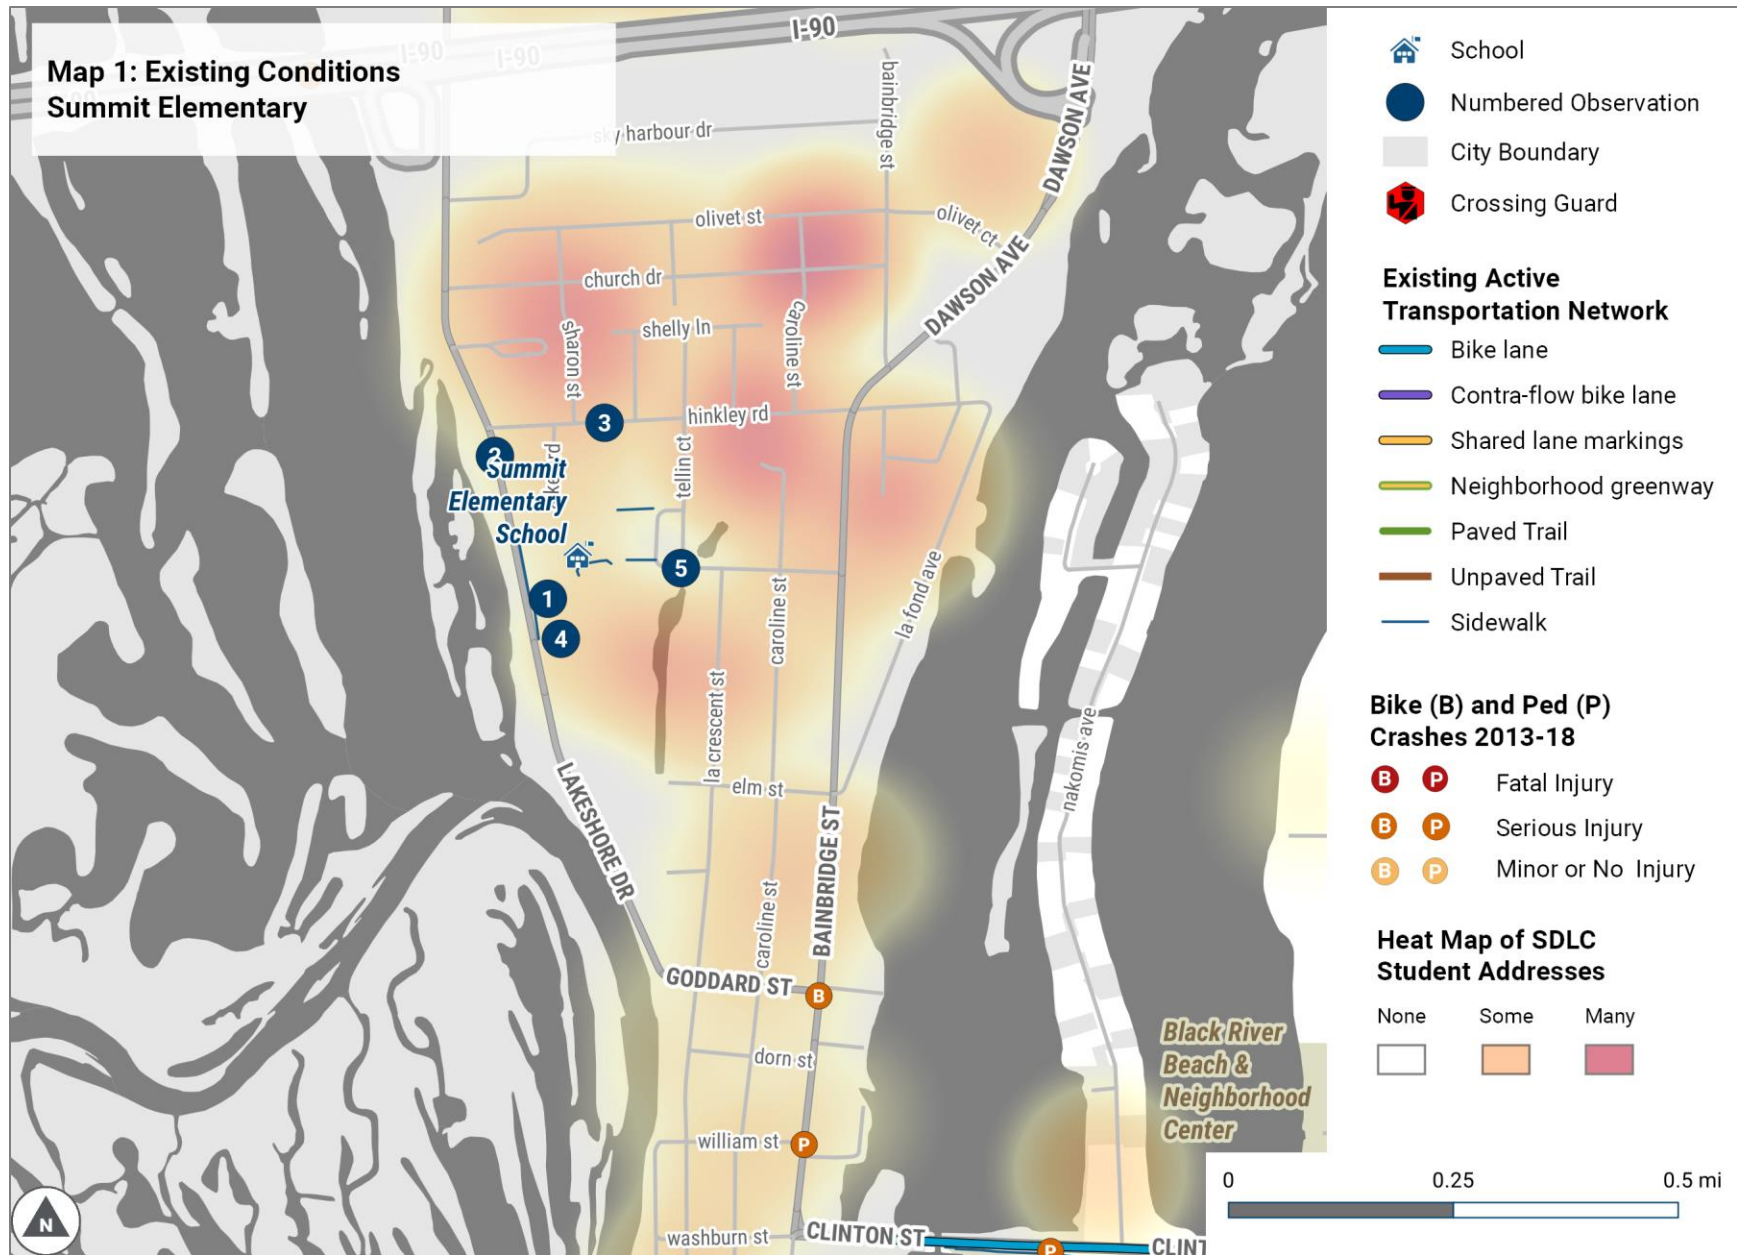
**Map 1: Existing Conditions
Summit Elementary**

The numbered observations in the table below correspond to the points in Map 1.

#	Location	Observations
1	Driveway entrance to school (off of Lakeshore Drive)	<ul style="list-style-type: none"> Missing sidewalks between Lakeshore Drive and school parking lot/entrance present a barrier to walking and bicycling to school No stop sign at bottom of driveway where it intersects with Lakeshore Drive
2	Lakeshore Drive	<ul style="list-style-type: none"> Missing sidewalks along Lakeshore Drive, which is a high-speed and high-volume street Most students living in the area would not need to walk along Lakeshore Drive
3	Hinkley Road	<ul style="list-style-type: none"> Missing sidewalks along Hinkley Road present a barrier to walking and bicycling to school Many students living in the area would need to walk along Hinkley Road
4	Leland Estates Mobile Homes	<ul style="list-style-type: none"> Private drive in mobile home park (Jackie Lane) is missing sidewalks, however a 10 mph speed limit and low volumes create a shared environment and opportunity for walking and biking

5	Tellin Court	<ul style="list-style-type: none"> Tellin Court is missing sidewalks along Tellin Court, however low speeds and volumes, along with stair and path connections to school property, present a relatively safe route for walking and biking to school
