PROPOSAL TO INCLUDE GHOST SIGN LANGUAGE IN THE MUNICIPAL CODE

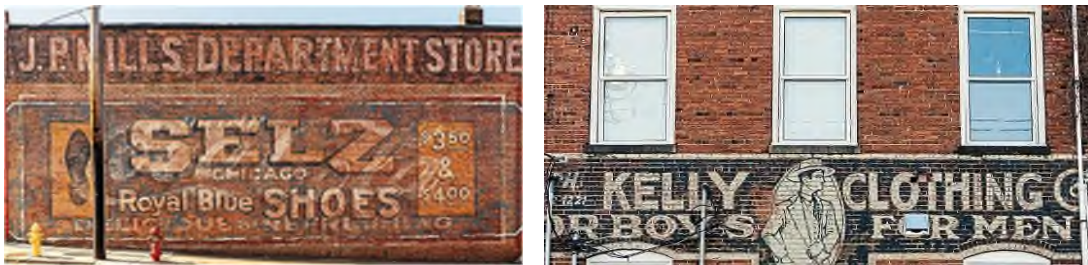
“Selz Chicago” and “Kelly Clothing” signs after the 2020 restoration project

Many Ghost sign restoration projects have been executed in a way to preserve the authenticity of the original sign, addressing only the necessary details to return the sign to or maintain its legibility. In 2020, Brushcan Custom Murals & Hand Painted Signs restored three historical signs in Mooresville, North Carolina. The company hand cleaned the signs, re-painted only the necessary details, and sealed the paintings with acrylic urethane finish.

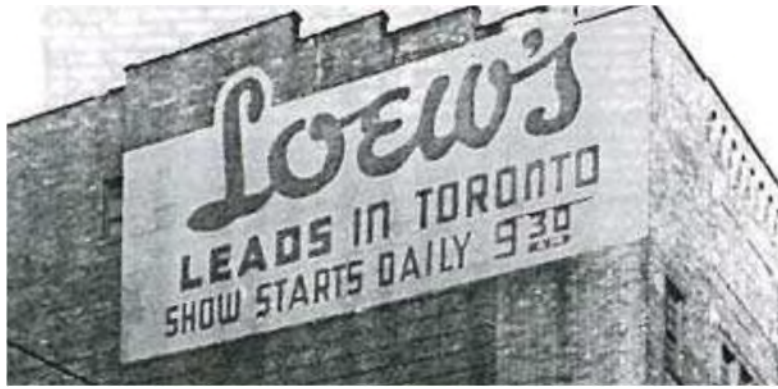
Photograph of the Queen Street "Loew's" sign in 1942

A sign from 1913 in Queen Street in Ontario, Canada that reads “Loew’s leads in Toronto. Show starts daily 9:30 AM” was also recently restored to resemble its original appearance. This project completed by Lori LeMare Studio Inc and was overseen by the Ontario Heritage Trust. The restoration includes the repointing of mortar, removal and cleaning of several layers of paint, replacement of some individual bricks, hand cleaning the surface, use of a clear, breathable mineral paint to coat the original sign, which was then finished with a breathable colored paint to restore the negative space of the sign.

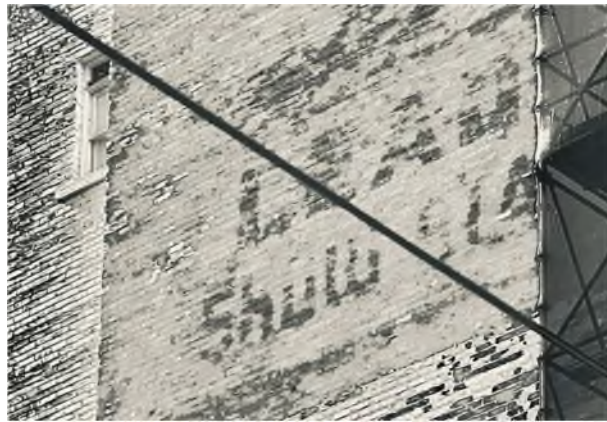
Photograph of the Queen Street "Loew's" sign before the Restoration Project

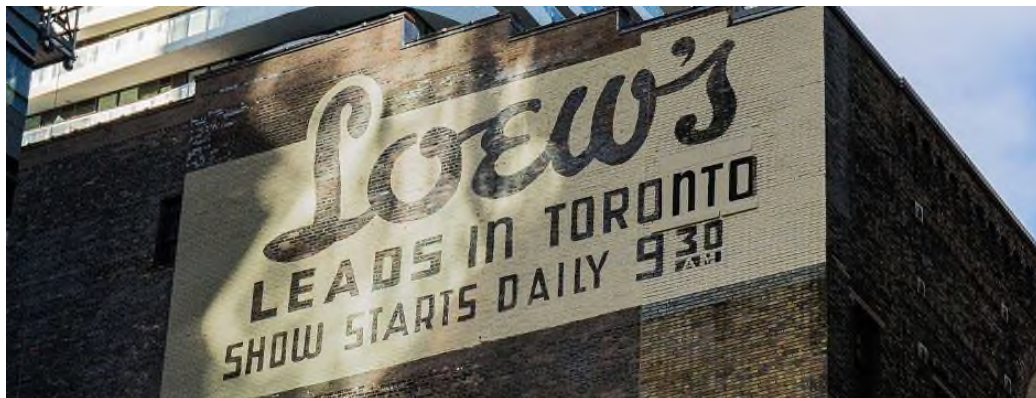
Photograph of the Queen Street "Loew's" sign after the Restoration Project
