# **THE CITY OF LA CROSSE**

## **Neighborhood/Community/Seniors Centers**

### **Facility and Programs Report**

December 2013

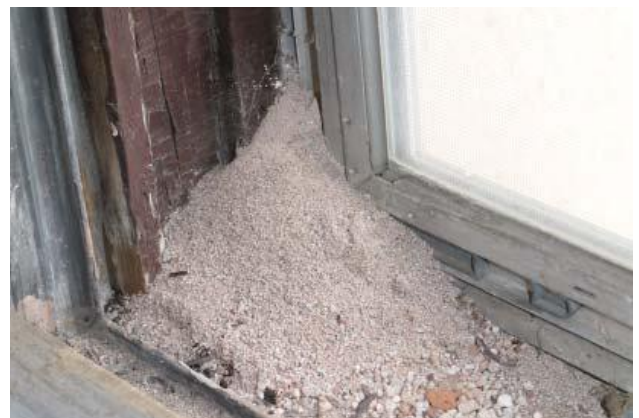
Brick debris at interior of second story window. (2012)

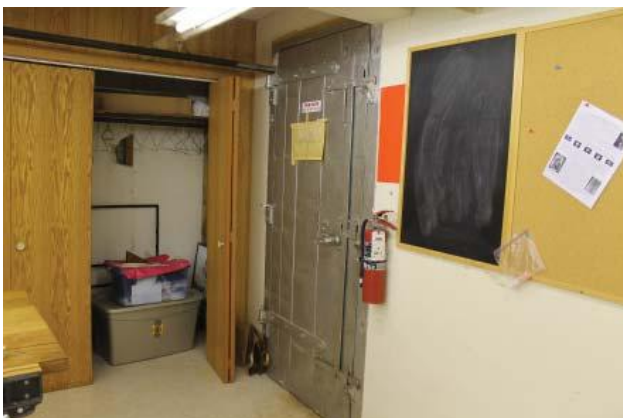
Closet on north wall and entrance to mechanical room. (2012)

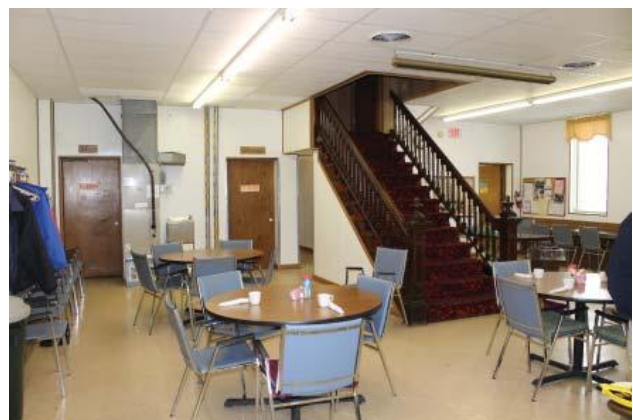
Original staircase to second floor in main space. (2012)

The original stair to the second floor is in good condition from the first floor to the first landing and overall has retained its historic integrity to this point. However, from this landing upward code violations and infill construction have altered this stairway. This stair is currently designated as the second means of egress from the second floor. The stair if not a required exit does not need to be enclosed. The enclosure that has been constructed violates code requirements for landings at stairs in the location of the door and is not a rated enclosure.

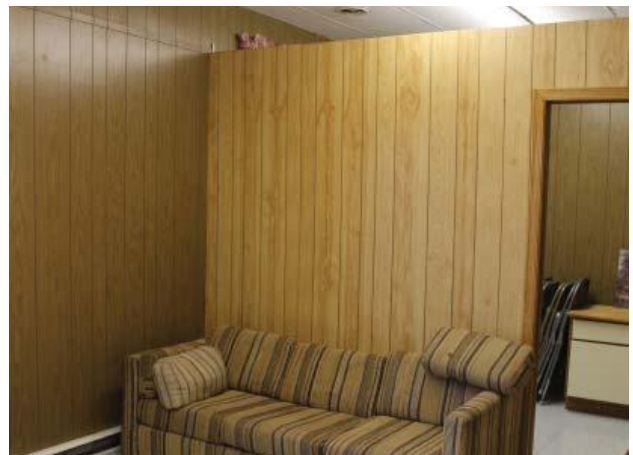
Partitioned western spaces. (2012)

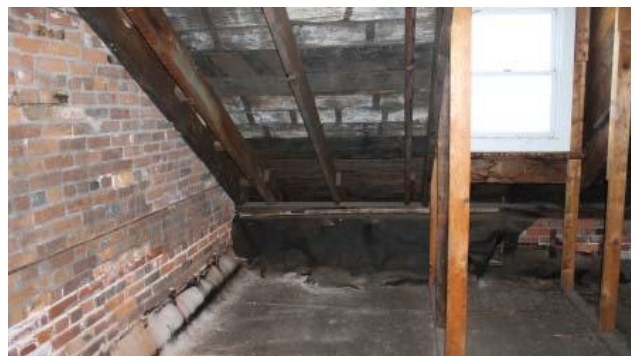
The north portion of the second floor however is in various states of being finished. The corridor walls and ceiling in this portion of the building have gypsum wall board that has not been finished or painted. The two northern-most rooms on this floor are completely unfinished with exposed structure and tar paper over the subfloor. If these spaces are to be used for any purpose they will be required to be finished properly.

Un-finished space on second floor. (2012)

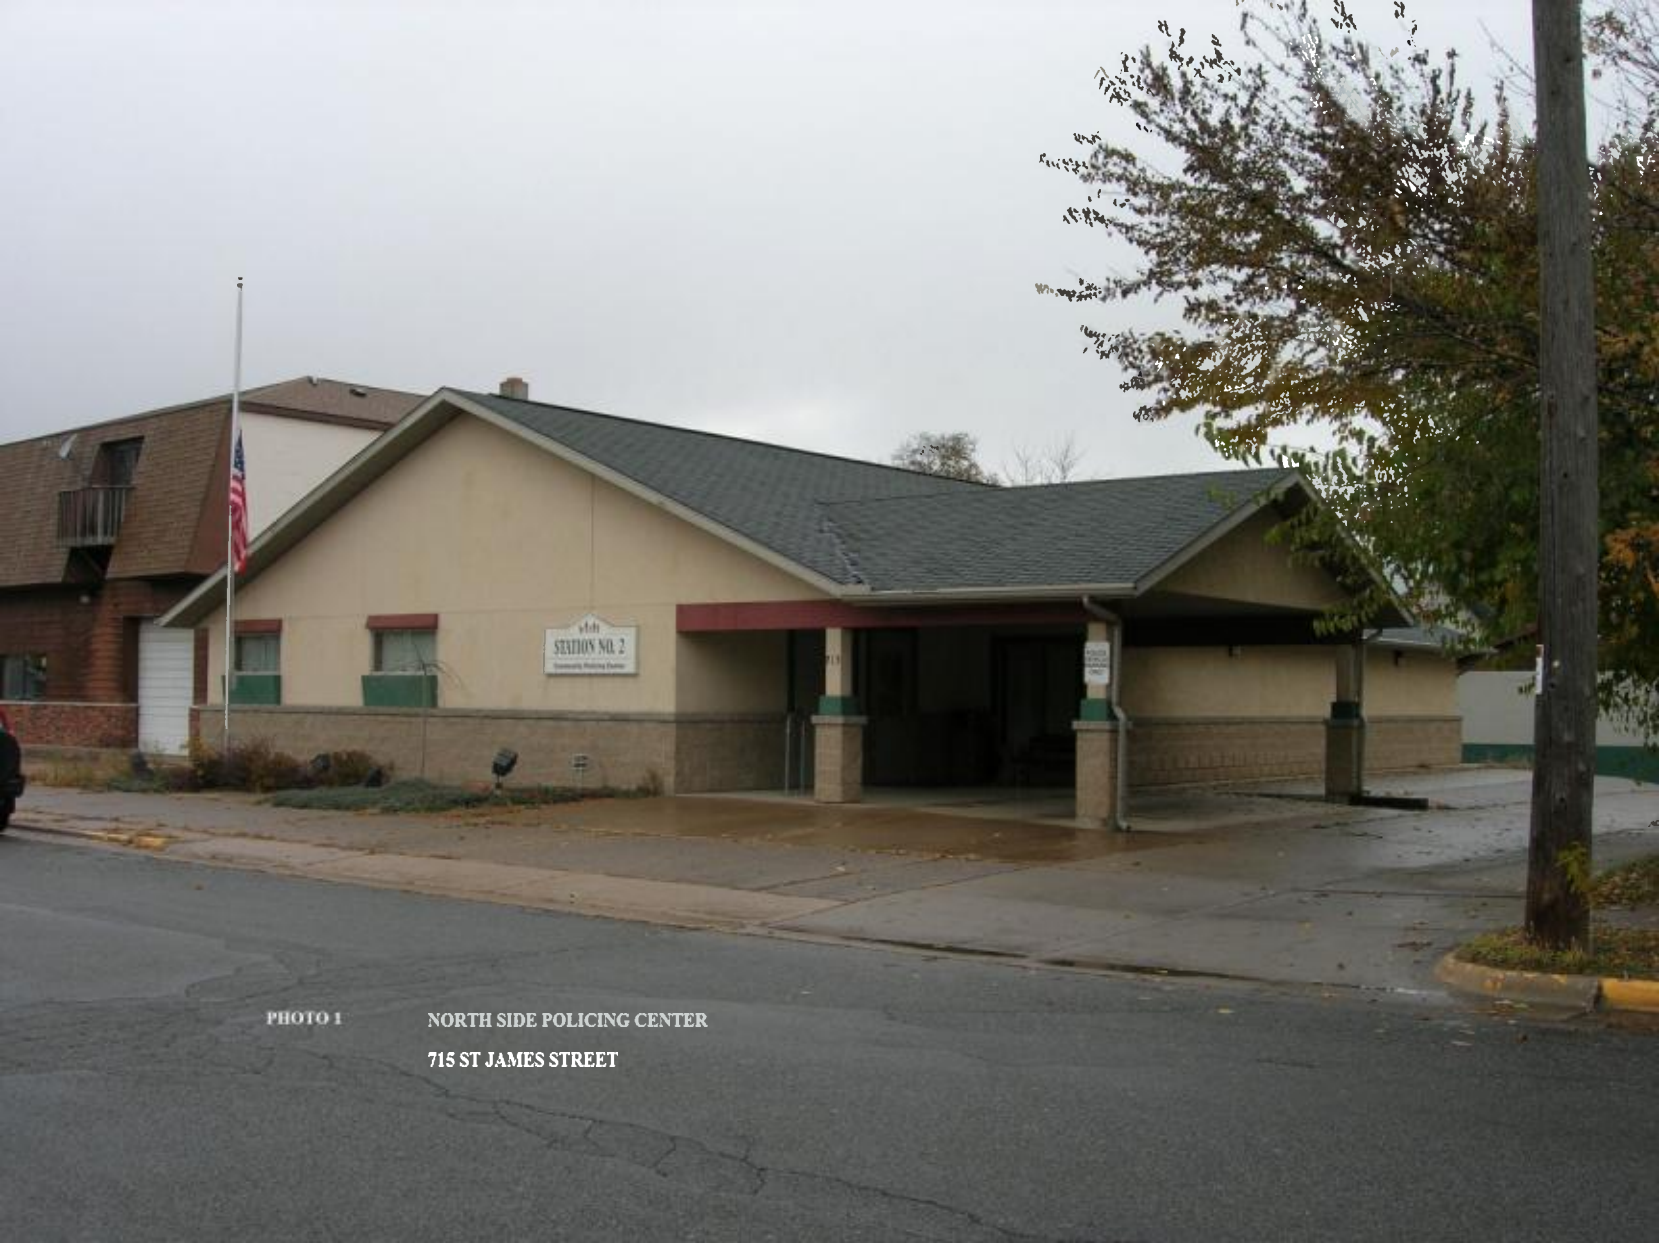
PHOTO 1

NORTH SIDE POLICING CENTER

715 ST JAMES STREET

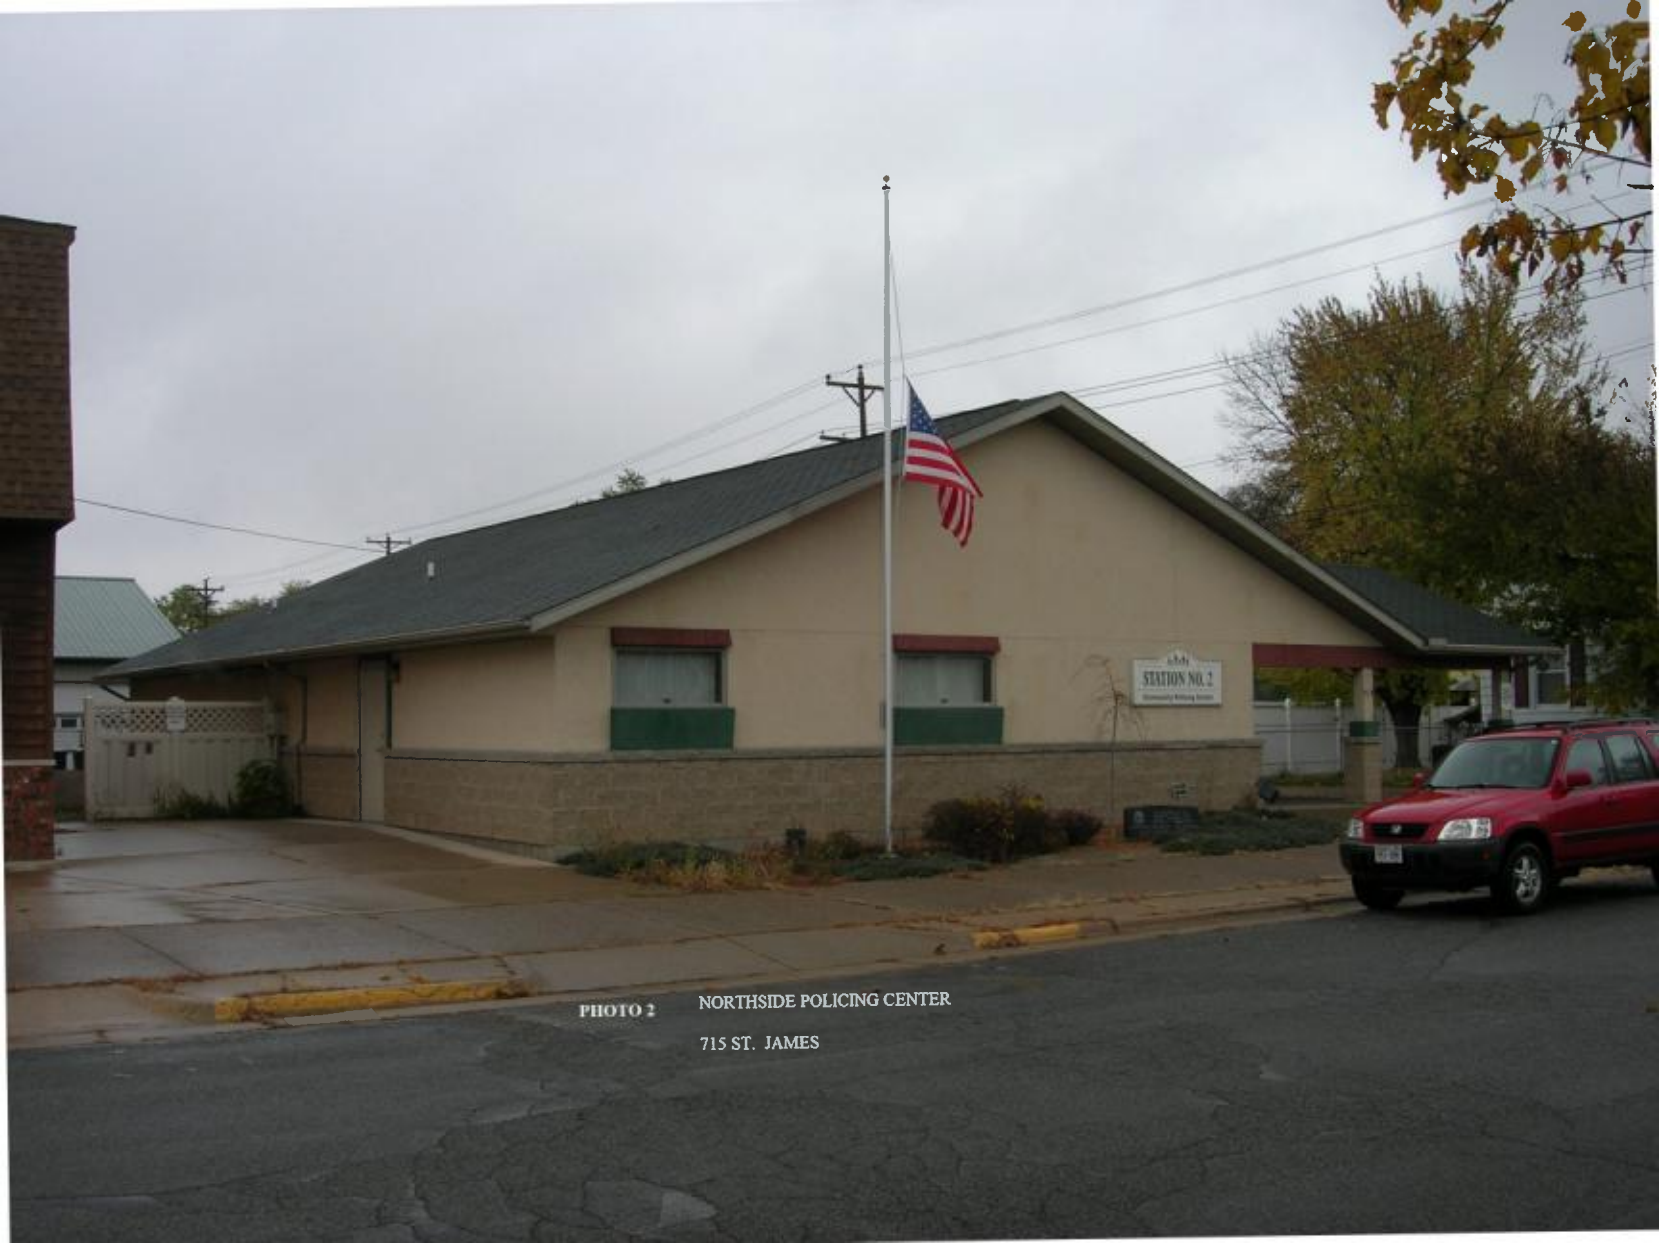
PHOTO 2 NORTHSIDE POLICING CENTER  
715 ST. JAMES

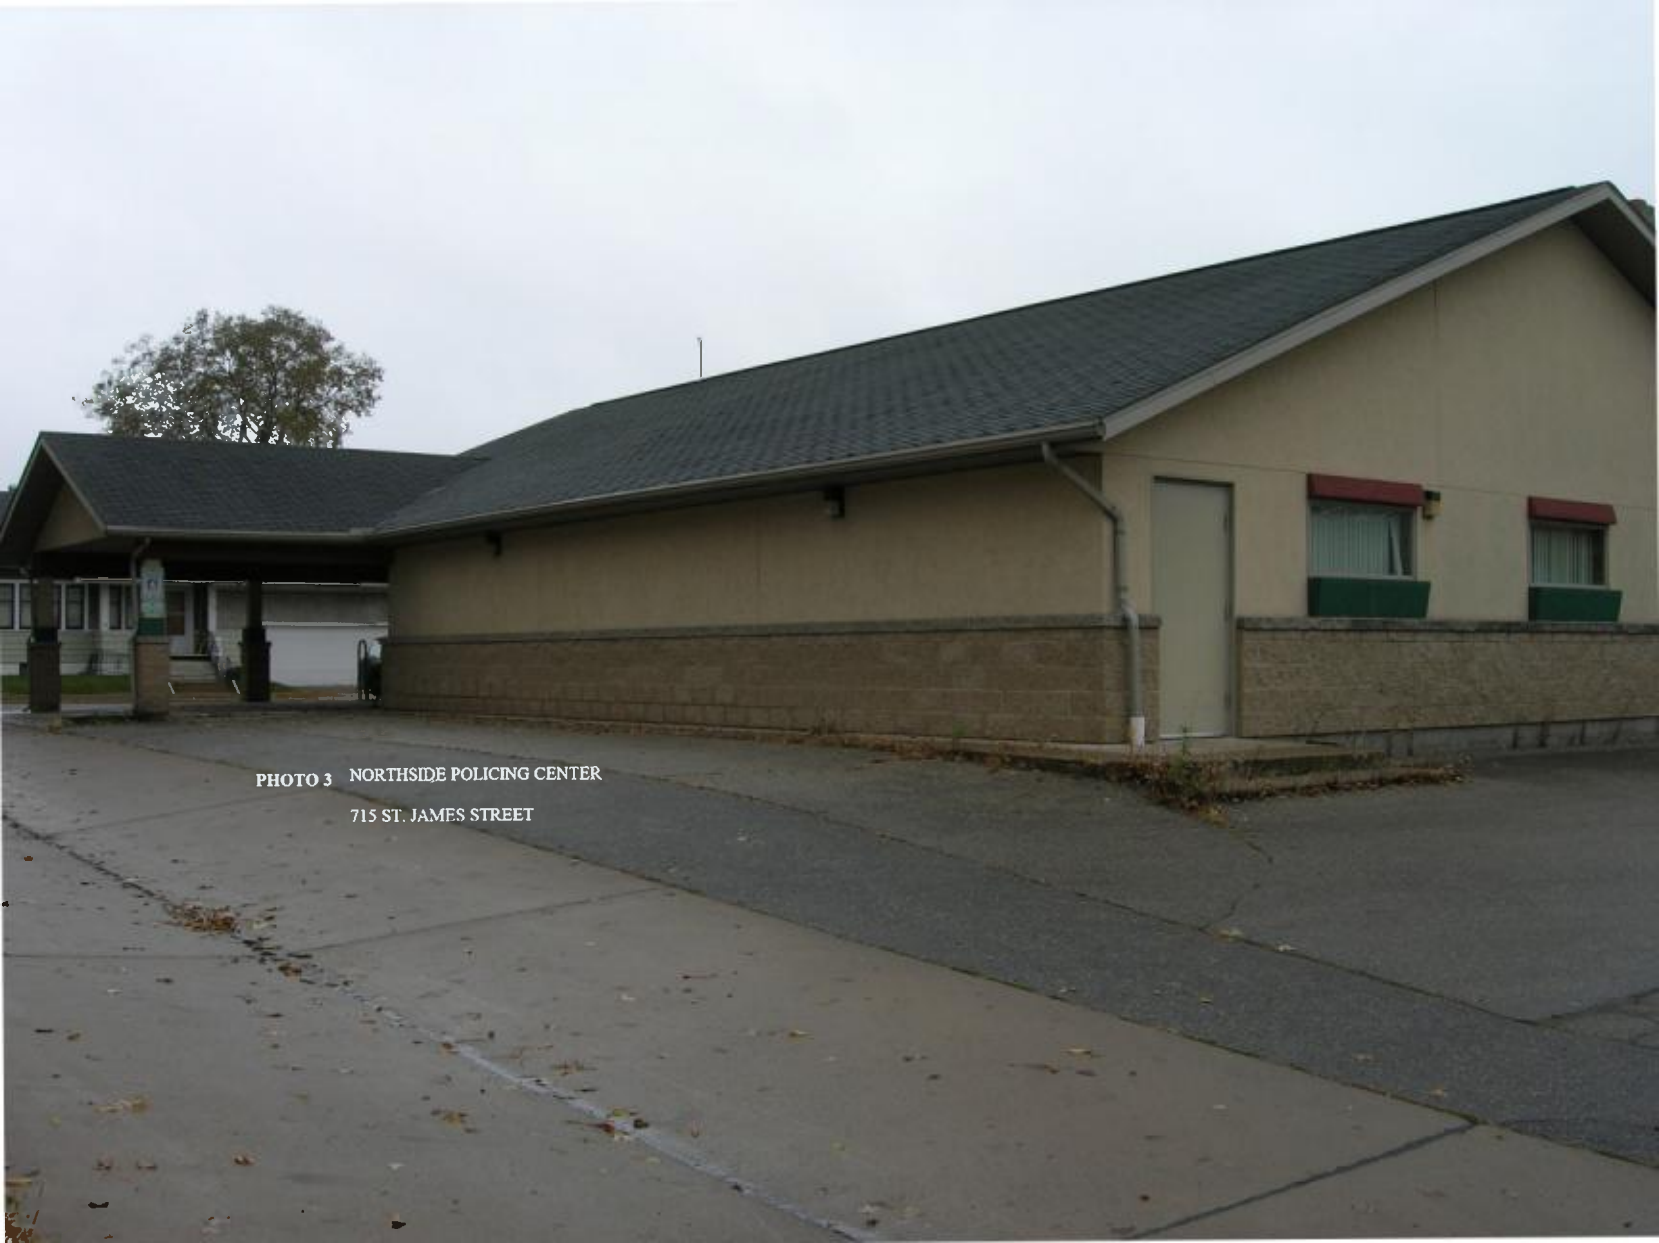
PHOTO 3 NORTHSIDE POLICING CENTER

715 ST. JAMES STREET

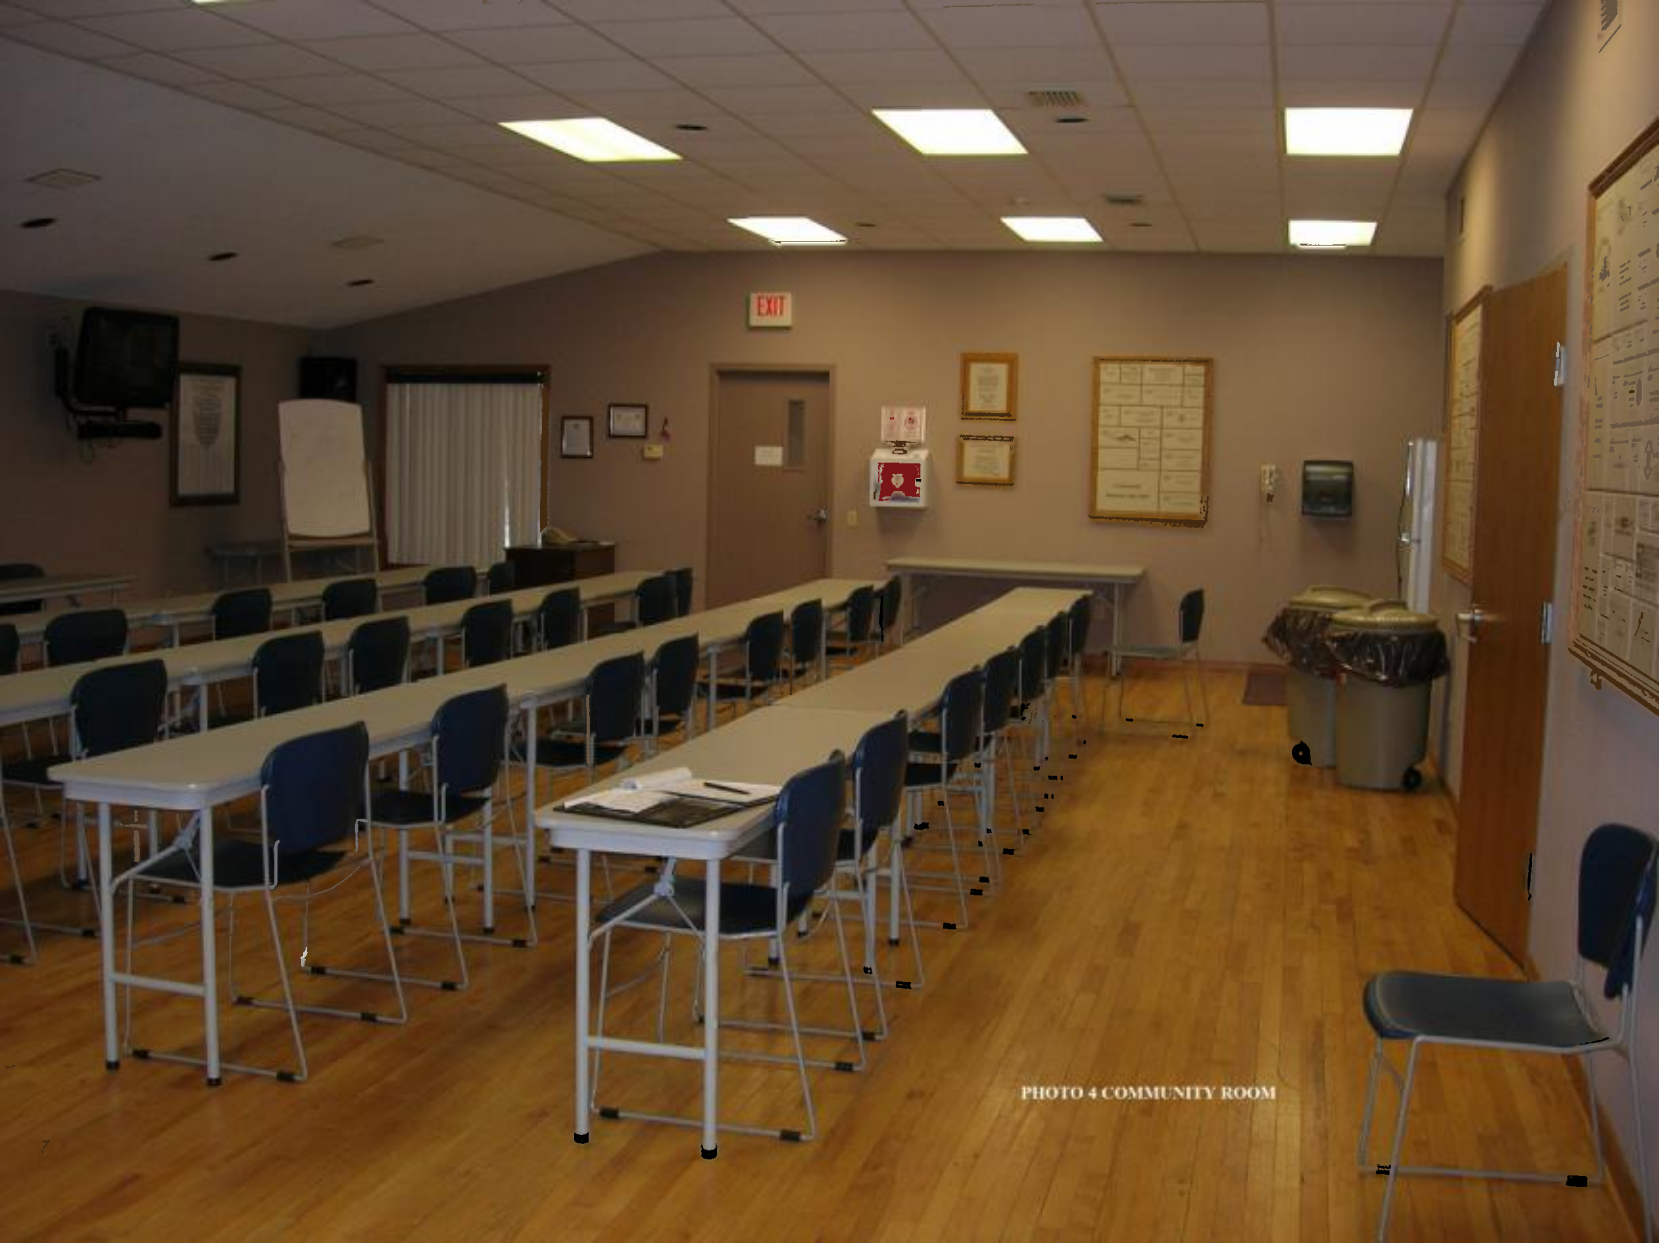
PHOTO 4 COMMUNITY ROOM

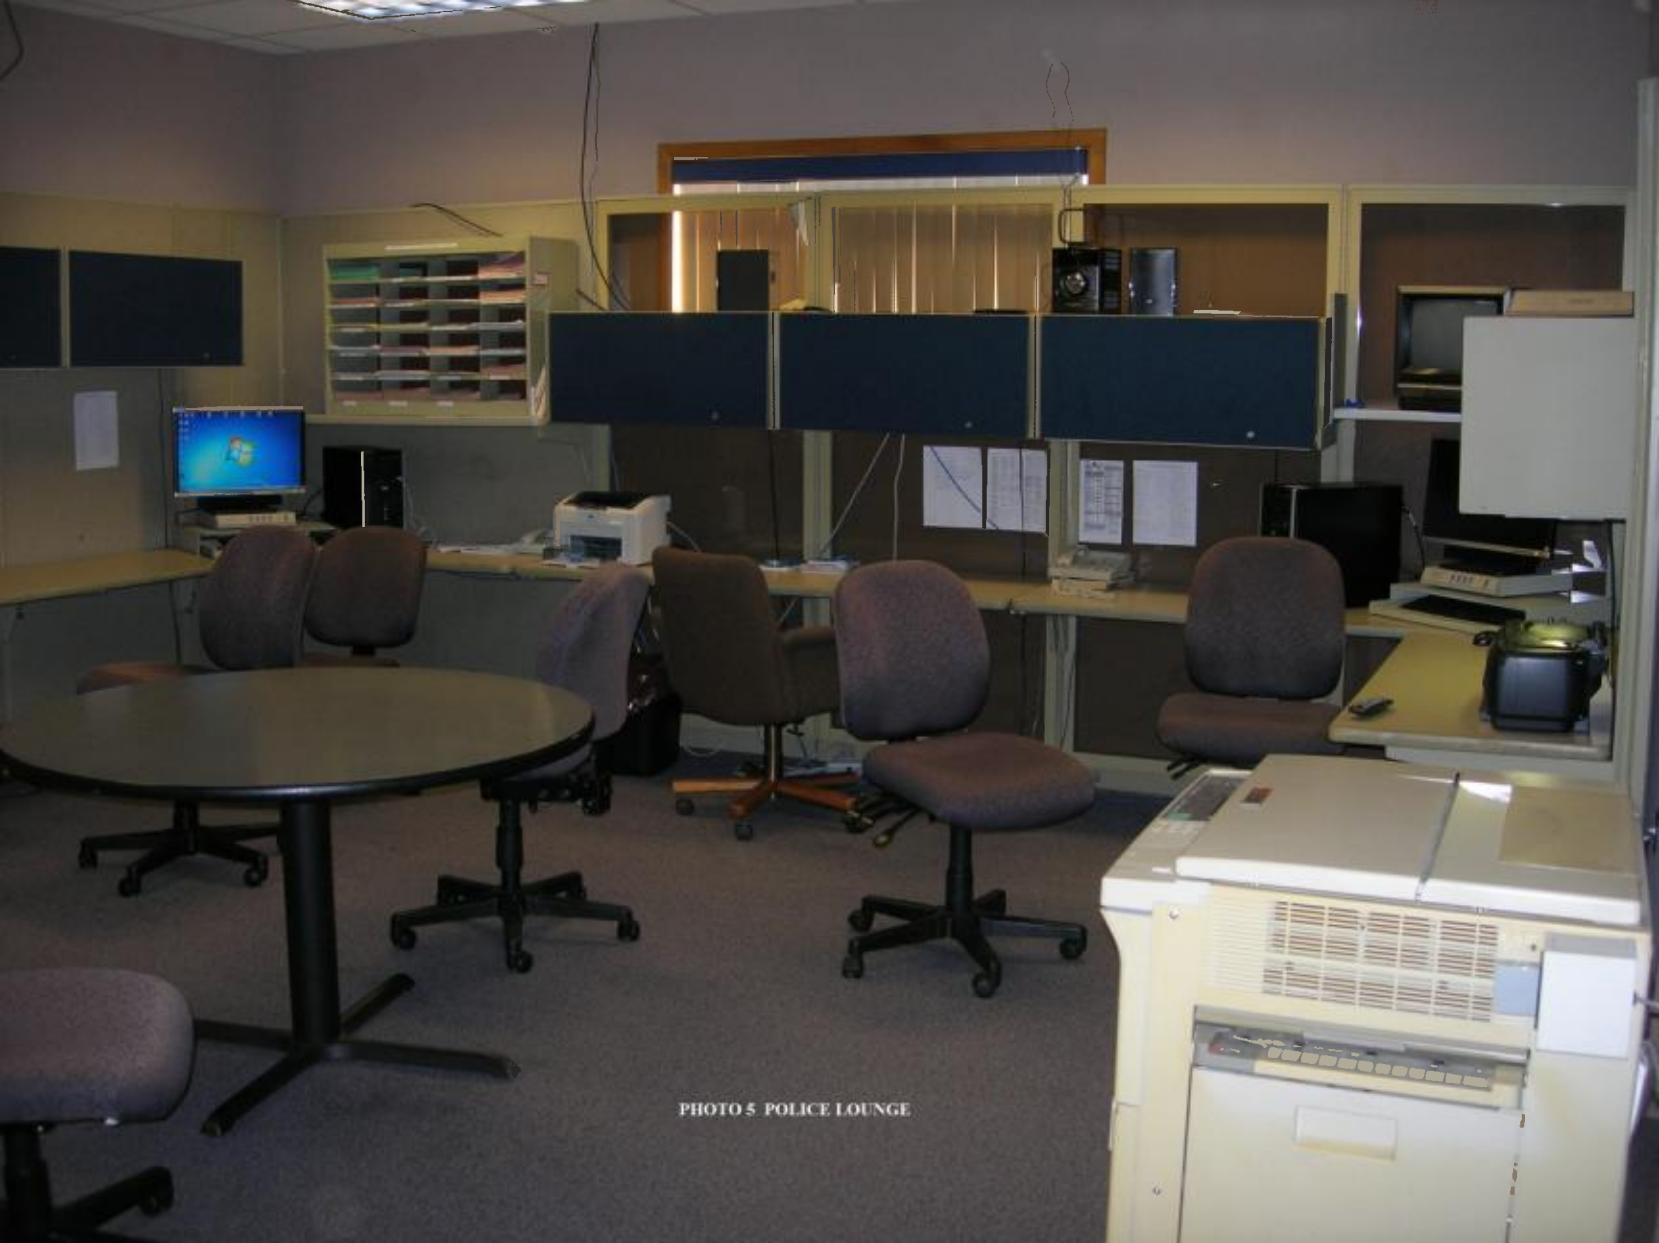
PHOTO 5 POLICE LOUNGE
